1 Compressed air rather than oxygen supplied to divers

2 Failure of proportional valve in saturation chamber control

3 Case study: saturation diver fatality due to hydrogen sulphide

4 Case study: confined space fatalities due to Hydrogen Sulphide

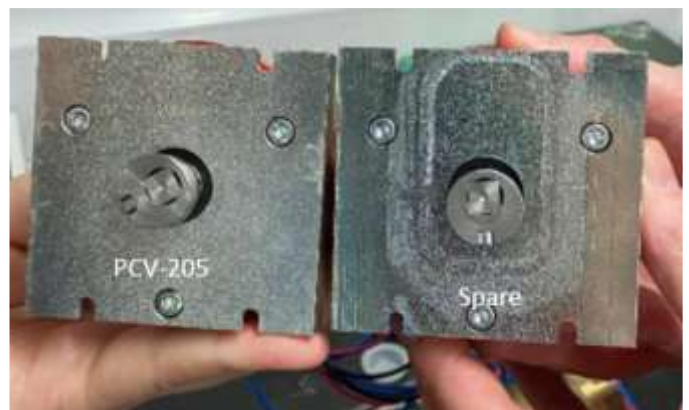
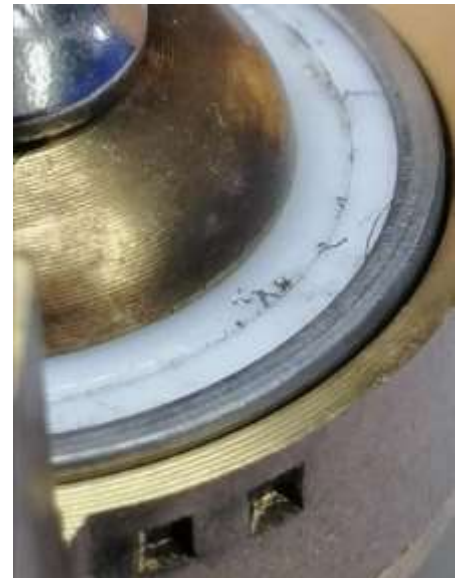
- The valve feedback did not respond correctly, the potentiometer was found defective;
- The diving contractor’s personnel had dismantled the valve (although this was prohibited by the manufacturer) in an attempt to solve the problem. It had to be reassembled 180° upside down because the drive shaft was out of alignment with its ‘set’ zero point. This made it impossible to understand if the potentiometer was damaged by wear of time or by wrong disassembly/assembly;
- Investigation found debris in the valve seat, which could have led to more serious problems (see second image).

- Share incident with operators of similar saturation systems equipped with that specific equipment;
- Ensure there is a stock of spares considered critical by the saturation system supplier;
- Amend planned maintenance system to include appropriate testing, maintenance or planned replacement of critical parts;

- Checking pipe cleaning status and filtering throughout the system;
- Ship all dismantled valves to the manufacturer for further examination;
- Perform appropriate tests before returning to dive operations.

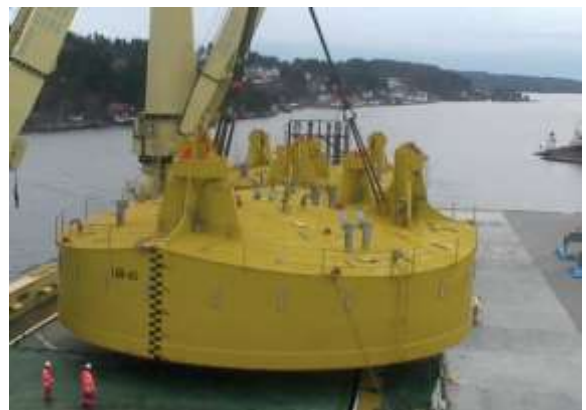
Jack-up rig leg "spud can" removed for maintenance

- Cause of death as determined by the Coroner as asphyxia. Circumstantial evidence pointed to inhalation of H₂S anticipated in the spud can. Spud can is almost 5 m in height and because of its typical internal construction, has numerous poorly ventilated nooks and corners;

- In addition, there were puddles of mud sludge which contain dissolved H₂S. The first person who went inside the spud can stirred up the collected H₂S in low areas and also the sludge containing dissolved H₂S. Being exposed to this, he became unconscious and collapsed;

- Ventilation exhaust could escape through a single opening only. The attendant who was at the bottom of the ladder was affected by the toxic gas produced and collapsed;

- Proper planning and appropriate training for enclosed/confined space entry, particularly for third-party contractors;
- Such training should include:
 - Active monitoring for H₂S gas, including both personal and area monitoring;
 - Understanding of the dangers of H₂S and how it behaves;
 - Where to wear personal detection monitors, preferably over the chest pocket or on the collar, i.e. as close as possible to the nose;
 - Proper use of correct breathing apparatus;
 - Use of the “buddy” system;
 - Training and drilling of emergency response team;
 - Proper use of Permit to Work system and safe systems of work;
