## 1 Compressed air rather than oxygen supplied to divers

## 2 Failure of proportional valve in saturation chamber control

**3 Case study: saturation diver fatality due to hydrogen sulphide**

## 4 Case study: confined space fatalities due to Hydrogen Sulphide

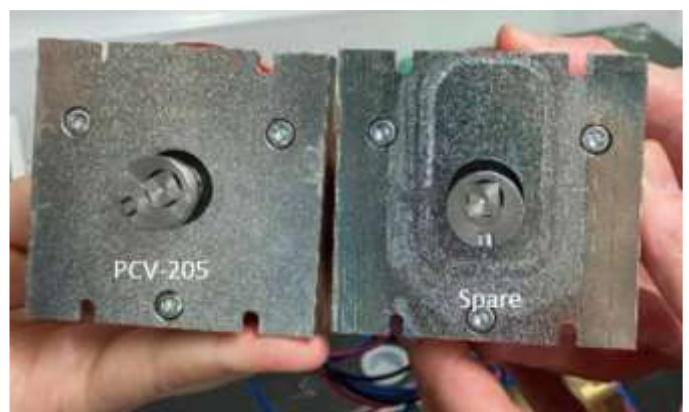
- The valve feedback did not respond correctly, the potentiometer was found defective;
- The diving contractor’s personnel had dismantled the valve (although this was prohibited by the manufacturer) in an attempt to solve the problem. It had to be reassembled 180° upside down because the drive shaft was out of alignment with its ‘set’ zero point. This made it impossible to understand if the potentiometer was damaged by wear of time or by wrong disassembly/assembly;
- Investigation found debris in the valve seat, which could have led to more serious problems (see second image).

- Manufacturers recommended maintenance should be followed. If operational experience falls outside this, the OEM should always be consulted with a view to ensuring manuals are updated and knowledge shared;
- Work with manufacturers and suppliers to ensure there are up-to-date maintenance procedures;

- Share incident with operators of similar saturation systems equipped with that specific equipment;
- Ensure there is a stock of spares considered critical by the saturation system supplier;
- Amend planned maintenance system to include appropriate testing, maintenance or planned replacement of critical parts;

- Checking pipe cleaning status and filtering throughout the system;
- Ship all dismantled valves to the manufacturer for further examination;
- Perform appropriate tests before returning to dive operations.
