1 NTSB: Lithium-ion battery fire destroys vessel bridge

2 LTI: gangway collapsed

3 LTI: Fingers injured during fender lifting operation

4 MAIB: Electrician injured in explosion

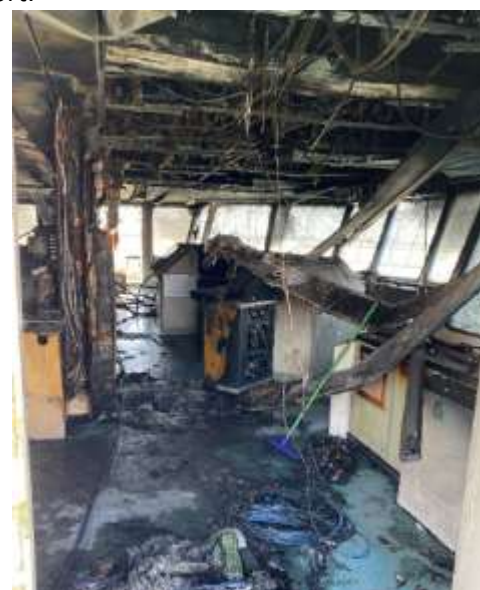
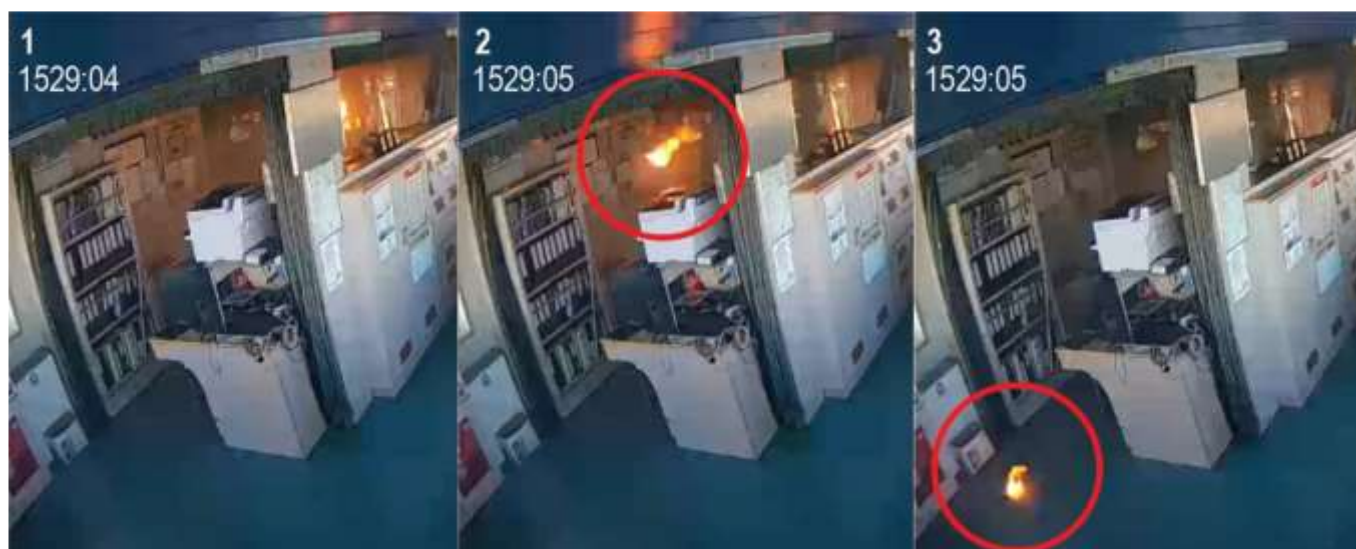
A fire started on the bridge of an oil tanker whilst alongside. Fire teams from the vessel extinguished the fire in less than half an hour after it had begun. There were no injuries, but the damage caused to the vessel was estimated at US\$3 million. There was extensive smoke and heat damage, and the vessel's navigation systems, communication systems, and alarm systems were destroyed.

The NTSB investigation determined that the probable cause was a "thermal runaway" of one of the cells in a lithium-ion battery for a UHF handheld radio on the communications table on the bridge.

- Due to the potential for rapid expansion of a Lithium-ion battery fire, detection, containment, and extinguishment are essential to prevent damage to a vessel;
- Crews can help prevent thermal runaways and ensuing fires by doing the following:
 - follow manufacturers' instructions for the care and maintenance of Lithium-ion batteries;
 - properly dispose of damaged batteries;
 - avoid unsupervised charging of Lithium-ion batteries;
 - keep batteries and chargers away from heat sources and flammable materials.
- Ensure that Lithium-ion batteries, the devices using them, and particularly Lithium-ion battery chargers, are sourced only from reputable and recognised suppliers.

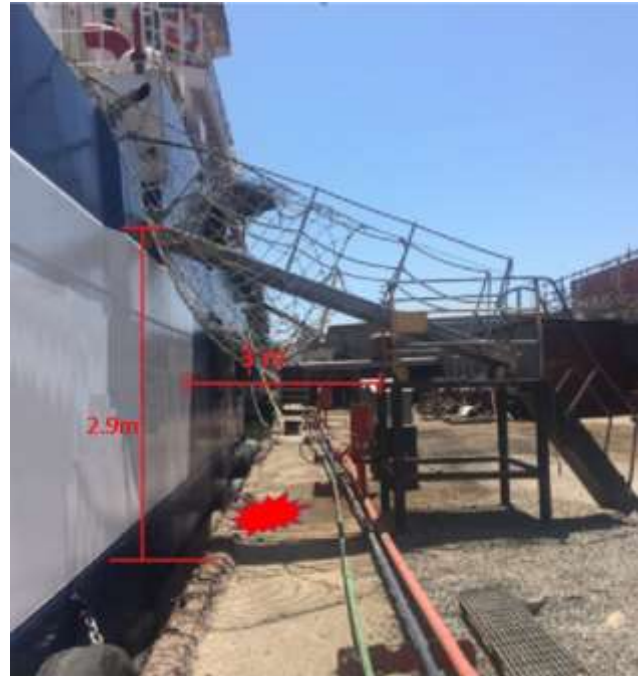
A person was badly injured when a gangway collapsed as he was using it. The incident occurred when the injured person requested permission to leave Vessel 2, which was moored outside of and alongside Vessel 1, which was alongside in a shipyard. The injured person was unaware that Vessel 1 was undergoing engine tests, and the gangway was not in use. However, the gangway had not been removed completely, due to scaffolding structure being in the way. There was no gangway watch nor were there any signs and barriers in place. As the injured person started to walk down the gangway, it collapsed causing the person to fall and break both heels. Medical evacuation was arranged and fracture of both heels was confirmed afterward.

- The vessel gangway was moved partially instead of fully and properly. This happened because scaffolding was installed on board the vessel, resulting in a lack of space to store the gangway;
- The partial removal of the gangway, though it was known to be incorrect, was left unchallenged by everyone involved;
- The removal of the gangways on both vessels (due to engine tests) had been announced and was recorded in the bridge logbooks, but the injured person was still granted permission to leave the vessel;
- There were no rigid barriers or safety signs at the access point (an open door) to dissuade or prevent persons from using the gangway;
- There was no gangway watch person present;
- There was no lighting over the gangway area (the event occurred in the hours of darkness).

- More “joined up thinking” needed – better communication of, and understanding of, what is going on;
- Ensure appropriate supervision of crew at all times;
- Ensure that there is a gangway watch – as mandated in ISPS – at all times, and ensure that access to and from the vessel is properly lit;
- Ensure barriers and signage indicating a hazard or dangerous area, are fit for purpose and cannot be got round in any way;
- **Stop and think! Take the time to think things through.**

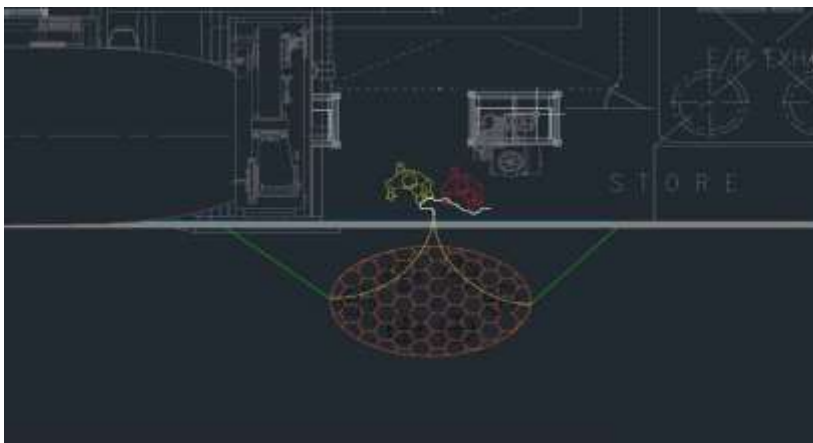
The crew member pulled the polypropylene rope to allow him to handle the webbing sling ends and untie the polypropylene rope from the railing. During this activity the swell caused the rope he was holding to slacken and then come under tension suddenly, and the rope jerked violently and was pulled out of his hand. He found he had badly injured two fingers of his hand; he was given first aid and then further treatment, and was medevaced ashore.

Sketch showing position of fender, the webbing straps and short hauling line

- The rope that was tied to the handrail did not have sufficient slack to allow the rope to be easily untied, the snatching could have been avoided either by having extra slack in the rope, or by cutting it.

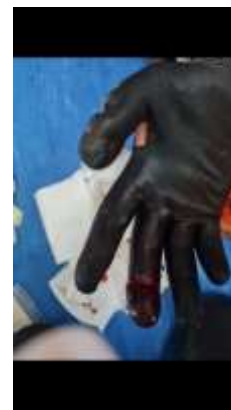
Glove prior to removal. Damage to thumb area was pre-existing

- Although the PPE was inadequate to prevent the injury, substitution with Impact Resistant Gloves, or any other available glove options for this activity, would have been unlikely to have prevented it. The injury was to the palm side of the glove which is not an area where armour or thick padding is traditionally found.

- PPE cannot always be relied on to prevent injury and is a last line of defence. In this case, our member considers that impact resistant gloves should have been worn because of the risk of pinch points and entrapment injuries;

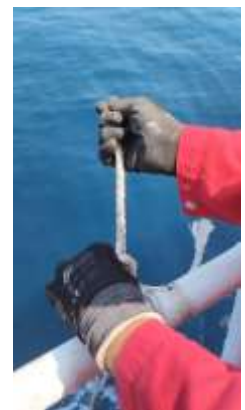
Final hand position (re-enactment).

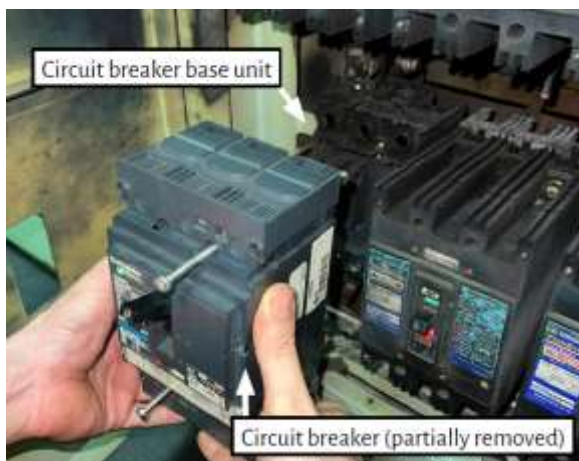
Figure 1: The circuit breaker arrangement

An electrician was badly injured while working on a switchboard. The circuit breaker was designed to be removed without the need to isolate the base unit (Figure 1); however, the electrician was unfamiliar with this arrangement and had loosened one of the live connections on the input to the base unit (Figure 2). The electrician used rubber gloves to insulate himself from the live 440 V alternating current terminals when working on the connections.

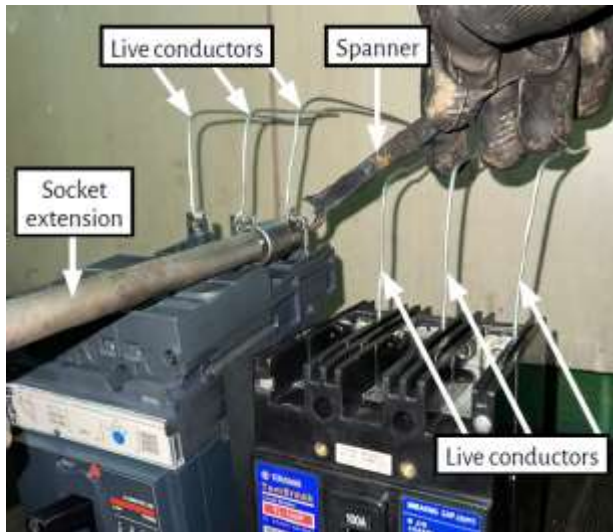
Figure 3: Reconstruction of the accident

The electrician tried to reconnect the cables to the base unit using a socket extension on the head of the bolt and a spanner to hold the nut in position at the rear of the connections. As the electrician tightened the bolt on the live input connection, the nut rotated and the steel spanner touched an uninsulated copper conductor on the adjacent circuit breaker base unit. This caused a short-circuit between two phases of the switchboard (Figure 3).

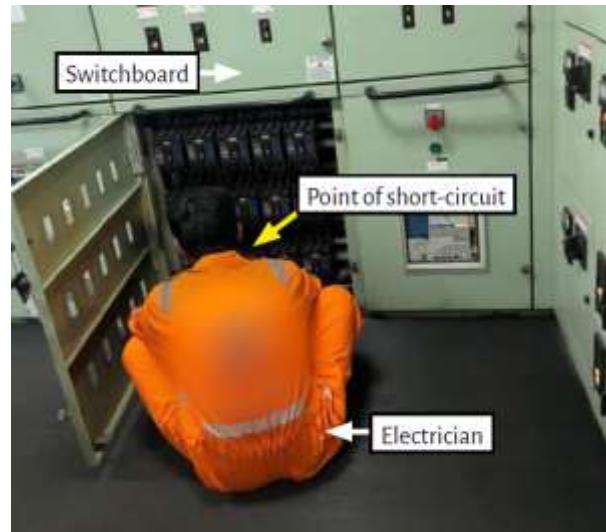
Figure 4: Position of the electrician

The short-circuit caused a high current to flow, vaporising the copper conductor and part of the spanner in an arc flash creating extreme heat and blinding light. A burst of hot gas and molten metal exploded from the panel onto the electrician's face and chest (Figure 4).

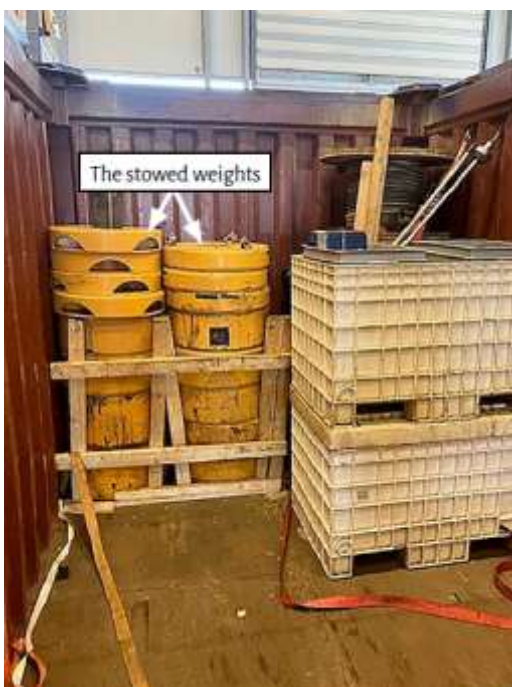
Figure 1: Weights loaded in container

The cargo was not secured properly and it shifted. Nearly 8 tonnes of weights had been stacked in the back corner of the container when the equipment was originally loaded into the container (Figure 1). When an unbalanced load is lifted, it will naturally swing to put its centre of gravity directly under the suspension point. Such a load will also alter the share of the weight that each part of the lifting gear bears. In this case, the imbalance from the stowed weights caused the container, which weighed more than 16t in total, to swing towards the banksman.

- The distribution of load is as important as the total weight when preparing a lift and its effect on the lifting operation should be carefully considered in the total lifting plan. In this case, neither the crew on board nor the crane driver were prepared for the swing that the unbalanced load caused when the container was lifted;
- Always have an escape route. Stay alert and keep well clear of any suspended load just in case something goes wrong;
- Sometimes an unbalanced load will need to be lifted. To facilitate this, use slings of different lengths to lift the load directly above its centre of gravity or a spreader beam to evenly distribute the weight and make sure the load is lifted vertically.

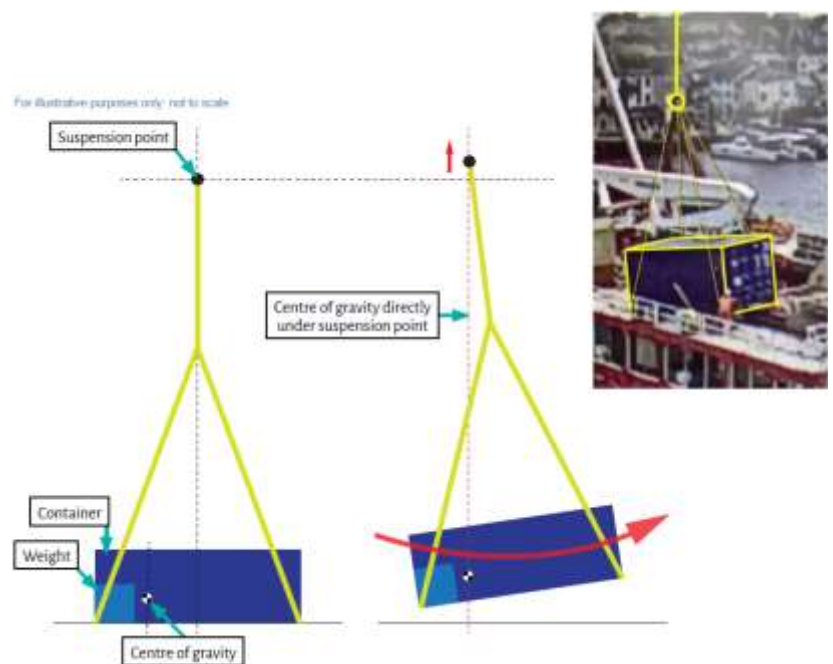
Three crew members were involved in the lift: the lift supervisor and banksman were positioned at the aft end of the container and the slinger was standing at the forward end. As the container was lifted it came clear of the twist locks that were securing it to the deck and rapidly swung aft and inboard. The lift supervisor was able to move out of the way, but the banksman suffered crush injuries when pinned between the container and the ship's handrails.

Figure 2: Effect of unbalanced load on lifting operation and (inset) CCTV still, showing container position following lift
