## 1 Line of fire near miss during lifting operations

**2 Failure of personal isolation procedures: crane damaged when it was used inappropriately**

## 3 Two hand injuries

## 4 LTI - Finger crush whilst operating safety gate

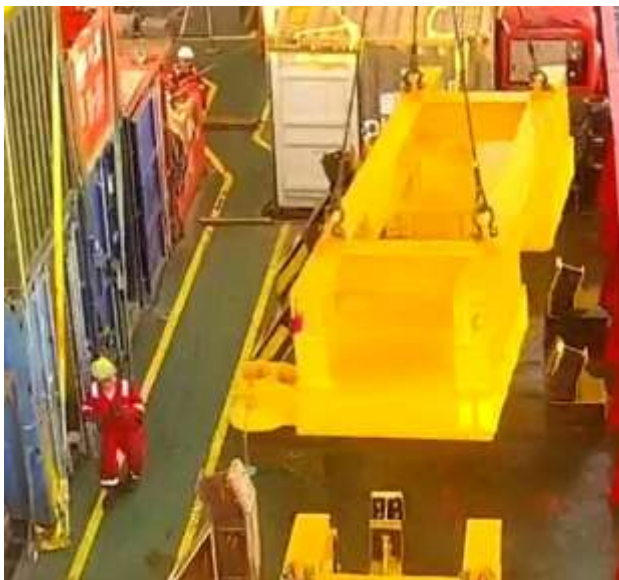
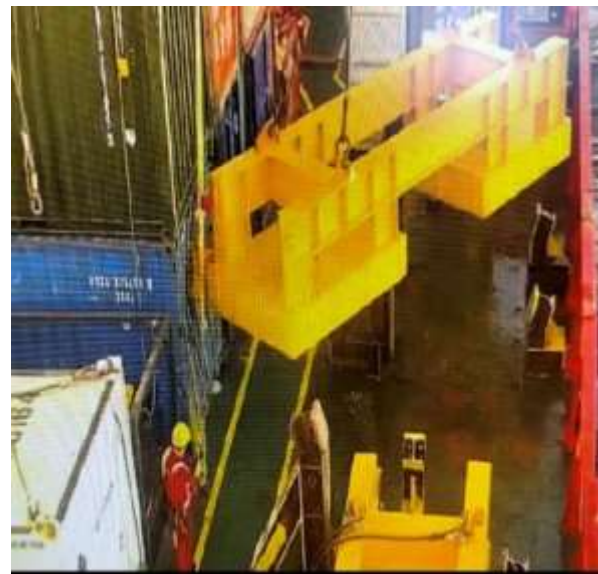
A member of the deck crew member put themselves in the line of fire during landing of a structure on the back deck of a vessel. The installation aids (bumper bars) were insufficient to stabilise the load, resulting in the structure being landed narrowly missing the individual, and damaging an adjacent container. The bumper bars were a critical barrier for keeping the banksman safe on the walkway but as they were not spaced far enough apart for the structure, they allowed a rotational movement of the load.

*Video footage from near miss showing swinging load impacting container*

- The individual was focused on landing the structure in a tight space and was relying on the bumper bars to keep him safe in the event of unplanned movement of the structure;

- Even though the design of the installation aids (bumper bars) was within the vessel’s design code, they were not there to protect people, but there as aids to landing and moving structures around the deck without damage. As they were not designed for personnel protection, the distance between them was not considered.

- There was a general misconception that installation aids can be used as personnel protection devices, but this is not their design nor their appropriate use;

- Moving the counterweight location and bumper bars was seen as an improvement by the vessel team and therefore they did not go through a Management of Change (MOC) process. Even perceived improvements may have negative consequences and need to be managed;

- Despite all the good work done in pre-job planning, the banksman still put himself in the line of fire. In hindsight, this area should have been a complete no-go zone.

- Take into account when planning work, the difference between “work as imagined” and work as actually done;
- Remain aware of your close environment and understand that during lifting activities, the **exclusion zone** may change;

- Review tasks where installation aids are being relied on for personnel protection. Should a wider exclusion zone be put in place for these tasks?

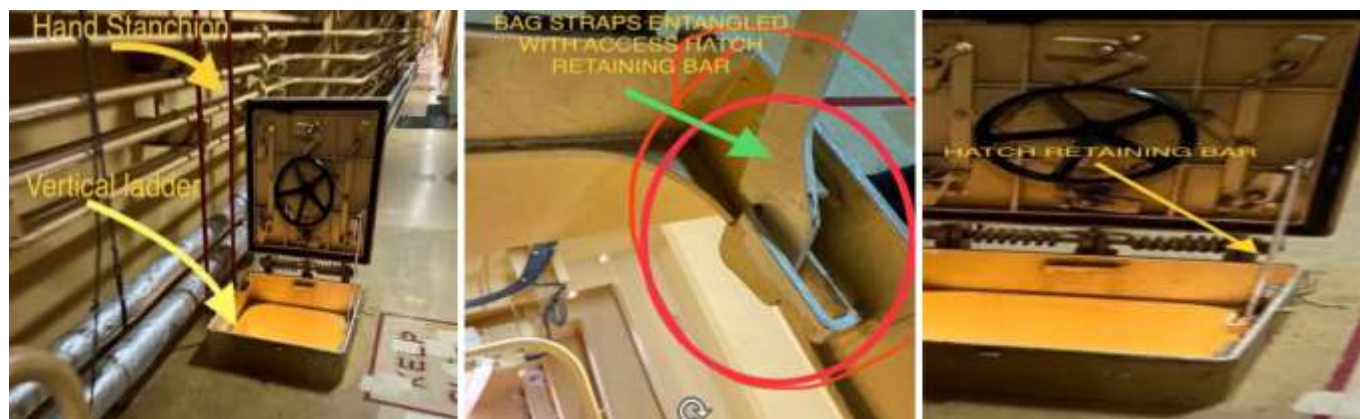
As a Pilot climbed the vessel's access hatch to the under-deck passage, his backpack straps entangled with the hatch retaining bar. A sudden release of the hatch caused it to abruptly close, causing pain and swelling to the Pilot's right-hand knuckle.

- The access hatch retaining bar was not being properly secured and this was not noticed by the Pilot;
- A third-party vessel duty officer failed to check the access hatch and proper rigging arrangements before the Pilot boarded;
- The access hatch is too narrow to pass through with bulky bags and this hazard was not recognized by the vessel crew or the Pilot.

- Ensure that access hatches are properly secured;
- Heavy bulky bags or accessories carried by Pilots should be transferred separately;
- Better identification of hazards associated with routine and non-routine tasks;
- Better communication – can we keep in the line of sight and so keep out of the line of fire? What about a hand-held radio?

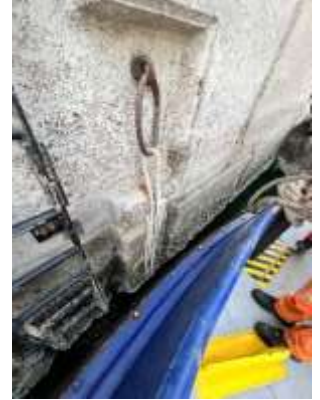
A sudden movement of a small boat caused a seaman's thumb to get caught between the fender and the quay, leading to injury. The small boat was being moored alongside at a mooring ring. It was high tide, so the mooring ring was about 0.5 m below the bulwark of the boat. As the boat approached the mooring ring, the seaman began securing the boat even though it was not yet hard up against the quay. The bow of the boat moved unexpectedly, causing his thumb to get caught leading to a crush laceration injury.

- Lack of proper risk assessment and job planning – the team failed to identify hazards associated with routine & non-routine tasks. Pinch point hazards were not considered or documented in the task risk assessment;
- There was a lack of communication and no visual contact between the skipper and the crewman;
- There was a lack of PPE compliance – the injured person wore no gloves at the time, though this was a company requirement for this work.

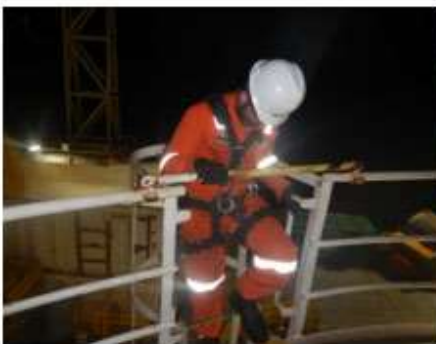
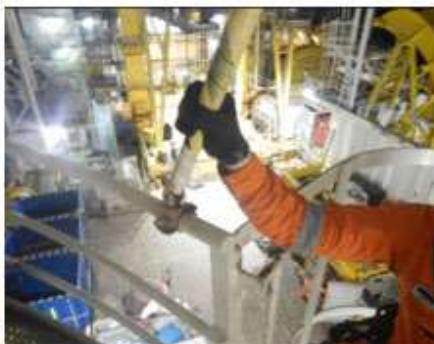
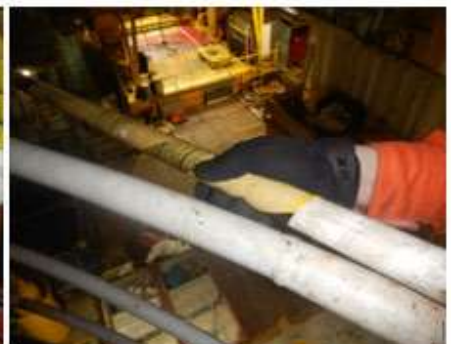
A crew member got his finger trapped in a hinged fall protection bar on a crane pedestal platform, causing a serious injury. The crew member was climbing the main crane vertical ladder; when he reached the top of the ladder, he used his right hand to raise the hinged fall protection bar to gain access to the crane pedestal platform. He kept his right hand on the bar until it was at 180 degrees, trapping his finger between the bar and the handrail.

Our member notes that this accident is still under investigation; however, it is recognised that there is potential for a similar event to occur elsewhere where the use of the same or similar type of hinged fall protection bar has been fitted.

The following action is being taken: An immediate review of all work areas and identify if the same or similar type arrangement is fitted anywhere else.

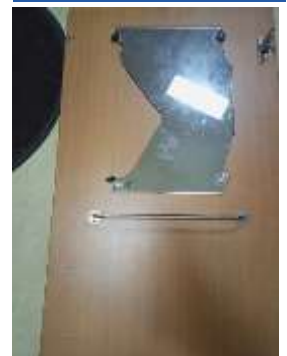
A crew person on a vessel sustained a deep cut on the left thumb while attempting to repair a broken mirror. The mirror had shattered because the closet (bathroom) door in his cabin had fallen off the hinges. The person had reported to the Chief Officer that the closet door in his cabin had become detached. The Chief Officer instructed the person to wait while he organized deckhands to assist in fixing the closet door. While the Chief Officer was on the deck coordinating with the deckhands, the person returned to his cabin. Shortly thereafter, he came back to the deck with a deep cut on his left thumb and promptly informed the Chief Officer about the injury. The Chief Officer administered immediate first aid and subsequently arranged for medical attention through an authorized medic.

- Lack of preparation and awareness about potential hazards: No proper work planning or risk assessment conducted for the task. Failure to consider environmental conditions, such as the vessel rolling and potential cut hazards;
- Didn't follow instructions – the injured person attempted to perform an activity that was beyond his qualifications and responsibilities. Assistance was offered, but not taken;
- Lack of PPE: IP did not use appropriate personal protective equipment, such as gloves and safety glasses.
- Condition of the furniture fixtures: The condition of the closet door fixtures was a factor that led to the door falling off and subsequently causing the injury.

- Our member took steps to assess the condition of furniture and fixings in vessel cabins.
