List of DP Events

1	Position Reference Problems again! – Dangers of recalibrating	2
2	Follow the ASOG – It’s there for a reason	3
3	Read the Room – Port Side Azimuth Thruster Shutdown and Subsequent Partial Blackout on DP Vessel	6
4	Thrust Incident Due to Dynamic Positioning System Mode Change on Construction Vessel	8
5	DP Drill Scenario	10
6	News in Brief from the DP Committee	13

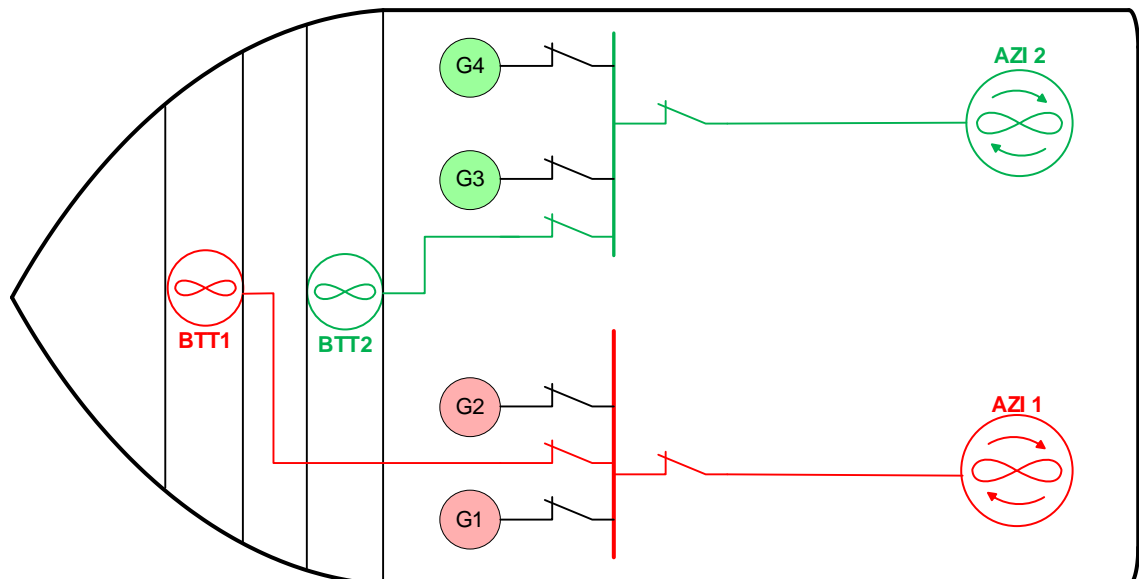
Figure 2-1 Power Configuration Prior to Event

Vessel Configuration: The vessel was operating in a split bus configuration, a standard practice in DP operations to enhance electrical redundancy and reliability. This set-up involved two generators connected to separate switchboards (port and starboard).

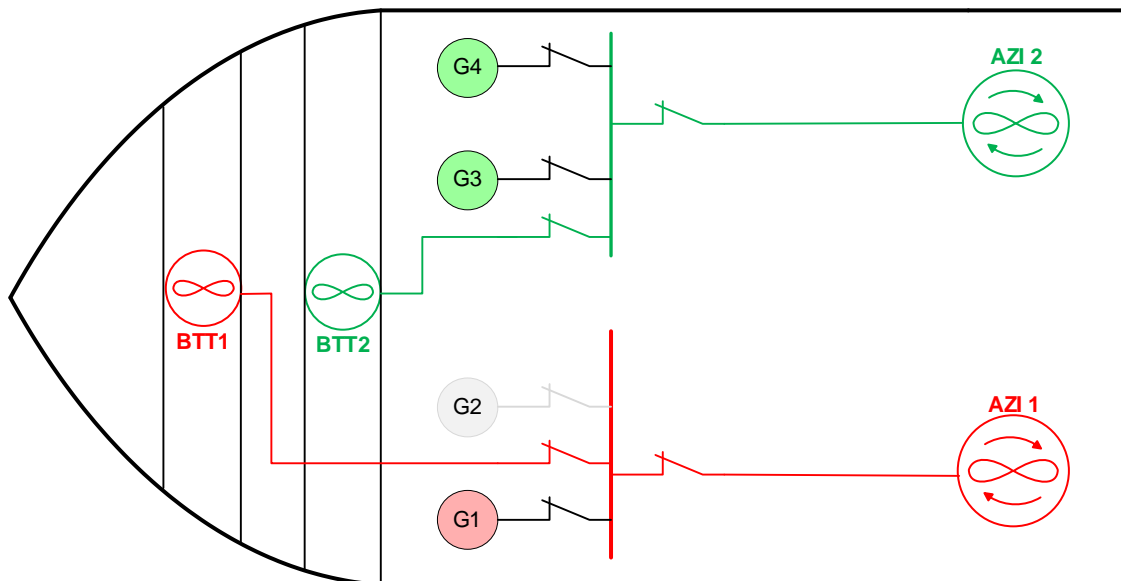
Figure 2-2 Power Configuration Following Initial Failure of G2

One of the generators connected to the port switchboard failed and tripped, there was no effect on vessel station keeping and the remaining connected generator was able to accept the extra load transferred. However, the vessel was operating in a degraded mode and the risk of worst-case failure was greater.

Initial Generator Failure: During operations, one of the generators connected to the port switchboard experienced a failure and subsequent trip. This incident posed a potential risk to the vessel's DP capability and, by extension, to the ROV operations and the nearby oil platform.

Immediate Response and System Resilience: The vessel's DP system demonstrated resilience through redundancy. The remaining generator on the port switchboard successfully accepted the additional load, ensuring no immediate impact on the vessel's station-keeping ability.

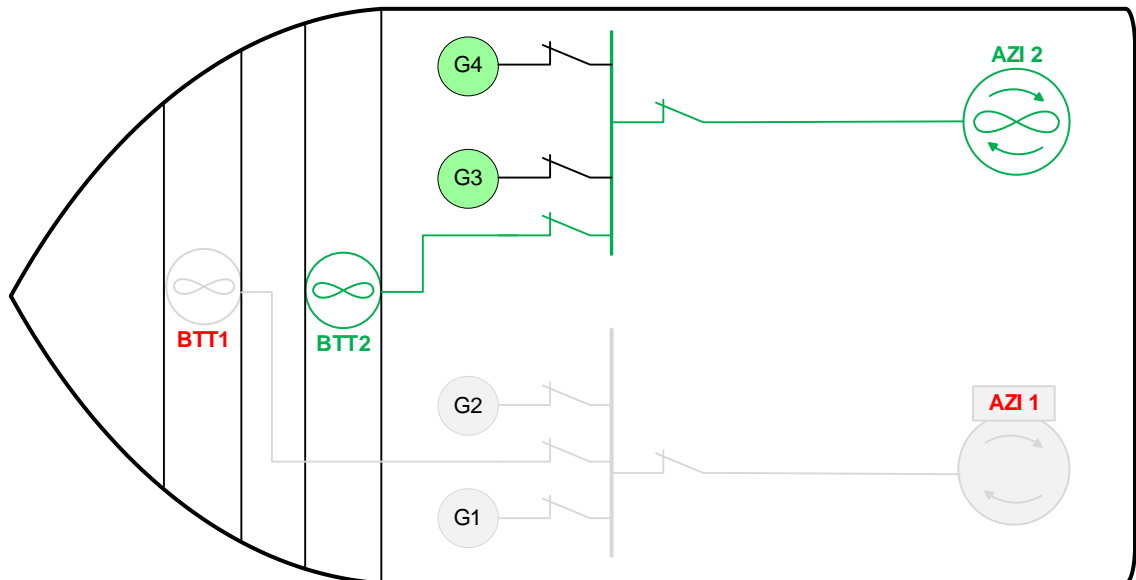
Figure 2-3 Power configuration after attempting to re-connect G2

Secondary Incident: Port Redundant Group Blackout: In a subsequent development, the port redundant group experienced a complete blackout. This incident occurred before the vessel exited the 500m safety zone around the platform.

Worst Case Failure Design Intent (WCFDI): The partial blackout represented a scenario equivalent to the WCFDI, a critical threshold in DP operations. This scenario envisages the most severe failure the DP system is designed to withstand while maintaining position.

After the generator failed, the vessel technical staff initiated the fault-finding process and, or so they believed, discovered the issue without delay. They attempted to reconnect the generator after incorrectly concluding that they had identified the problem – however, doing so resulted in a voltage spike on the main switchboard, which subsequently caused a complete blackout of that switchboard.

- ◆ The impact of attaining a Yellow alert status in the ASOG was defeated when the technical staff of the vessel bypassed the ASOG and re-established the generator connection. It was unequivocally stated by the ASOG that machinery should not be reinstated until the vessel was in a safe position or status, which effectively meant being outside the 500m zone.

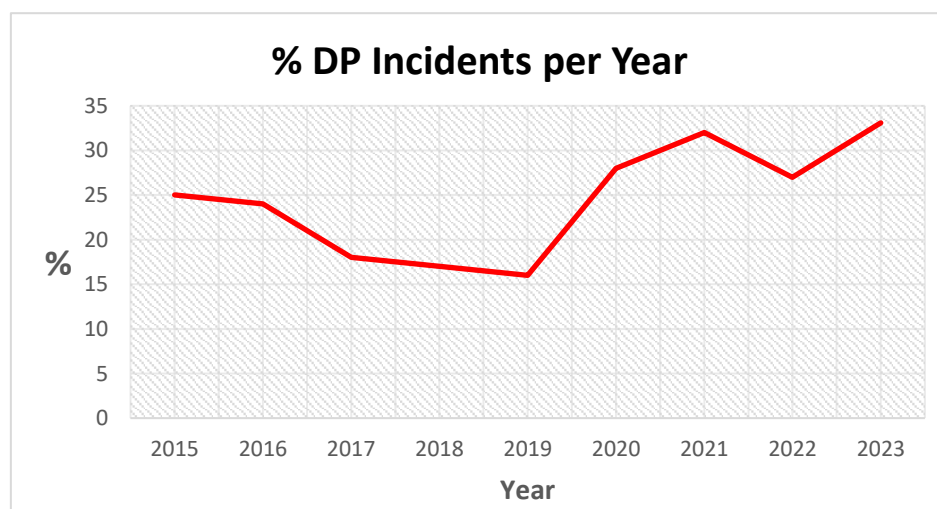
Figure 6-1 Percentage of DP Event Reports received resulting in DP Incidents (Loss of Position/Heading)

The percentage of DP incidents (loss of position/heading) reported per year has increased since 2019, a year before the pandemic, which is a concerning trend. The 2022 figures showed that the percentage of incidents had decreased, and this was encouraging. However, so far this year we are seeing a sharp increase to date. See the graph below:
