1 Diver in the bell hit by falling object

2 Divers lifted off seabed by Clump Weight

3 Leak in hot water system for saturation divers

4 Chain hoist paid out unsupervised near running main engine

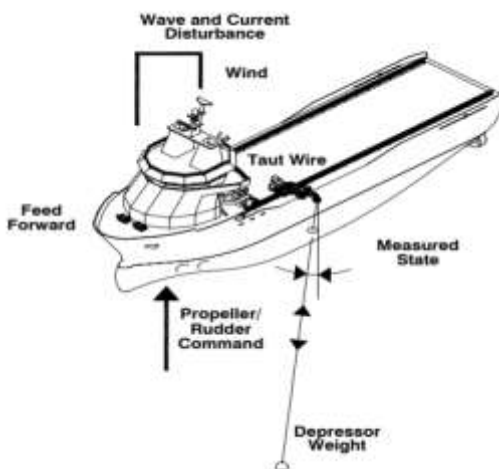
Whilst the Diving Support Vessel was conducting subsea diving operations, the bridge team recovered the taut wire pulling the divers from the seabed to 18m above the diver’s maximum excursion depth. This rapid change in depth had the potential to cause pressure induced injuries or injuries with direct contact with the taut wire clump weight. Thankfully, in this instance, both divers reported well post-transfer and following subsequent tests.

Drawing on the left shows basic set up of a taut wire system during diving operations.

- Open comms system was installed but silenced and set to 'closed circuit' – delaying the bridge team's reaction to the lifting of the divers;
- The bridge team made the incorrect assumption that Dive Supervisor was aware of the taut wire recovery – it was recovered without final repeat back and approval by Dive Supervisor.
- It had become customary practice to recover taut wires when divers were 'seen' as being in a 'Position of Safety' and not with verbal confirmation from the divers that this was so;
- There was a gap in the management system, taut wire 'weight' lifting operations were not covered by a lift plan.

- Internal company diving information notice issued, including requirement that "divers return under bell and clear umbilicals prior to any deployment or recovery of taut wires";
- Lift plans for taut wire deployment / recovery now include step to 'confirm divers are in a place of safety' before start of operations;
- Ensure sufficient diver awareness on umbilical management to prevent entanglement;
- Operational communications instruction issued to all company vessels involved in diving operations,
 - Ensure communication is in clear and concise language to avoid any potential for misinterpretation;
 - Ensure commands and/or instructions are repeated back prior to carrying them out, to verify understanding;
 - If communication is not clear or there are any doubts on the command issued, an ALL STOP should be called.

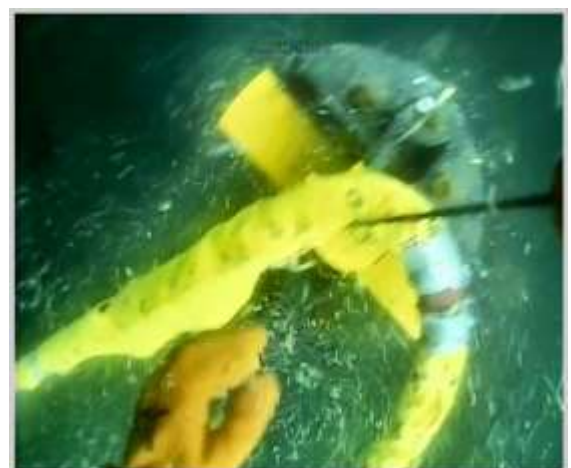
Picture on the right taken from divers hat camera as he was freeing his umbilical from taut wire and clump weight.

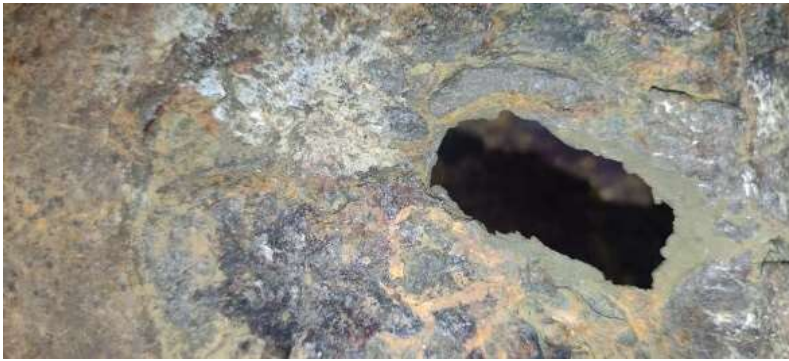
During saturation diving operations between bell runs it was noted that Divers Hot Water Unit #2 had a water leak. The leak was investigated and located, but was found to be in a place with very poor access. There was a small hole in a pipe, which on investigation was found to be a bigger hole under surface corrosion.

- Due to very limited access, it was not possible to inspect the tank outlet of the 4" closed circuit pipework;
- External corrosion had over the years completely corroded the 4mm pipe in a very limited area.

- The direct cause: corrosion over many years;
- The root cause: The inaccessible location [for visual inspection] of the pipe.

The hole at 6 o'clock in the water intake.

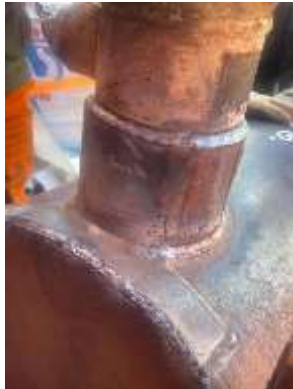
Sleeve welded at the area of corrosion.

- Sleeve welded on the leaky area;
- Hot Water Unit #1 was inspected and no defects found;
- Consider wall thickness measurements of old pipes.

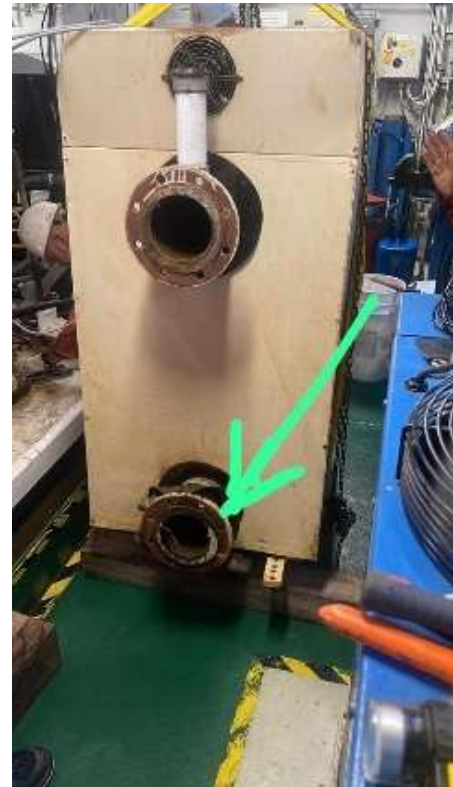
Location of the hole, inaccessible for visual inspection. Picture shows the back part of the unit mounted against a wall.

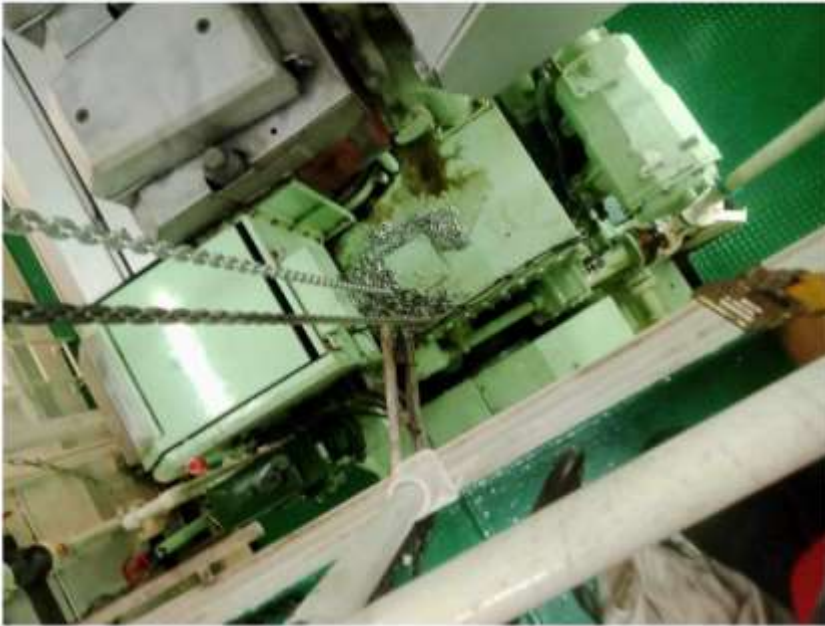
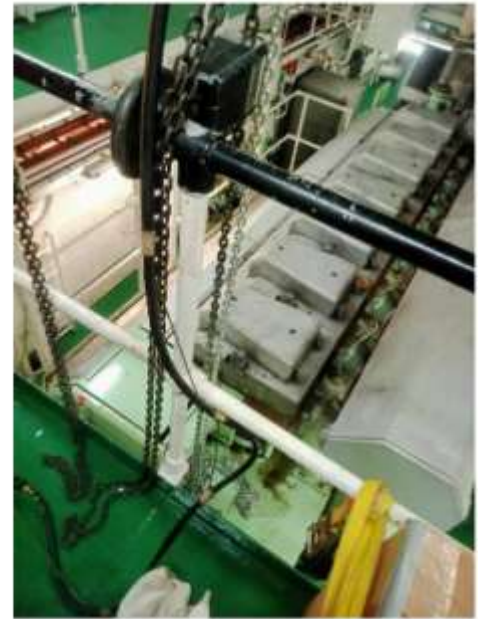
An electric chain hoist on the beam above one of the main engines in a vessel, was left unattended after use. The chain hook paid out and coiled the chain onto the running main engine close to the generator drive shaft. The incident occurred when the chain hoist was being used to lower spare parts required for maintenance in the engine room. Two lifts took place above the running main engine. After their completion, the chain block was lifted into its highest position.

Later on, during routine rounds, the motorman observed the hoist's chain with hook to have "paid out" fully and created a dangerous condition near to main engine no.3. The chain was made safe and then removed from service for inspection.

- The push button for “pay-out” on the pendant controller for the electric winch, was found to be defective, resulting in hoist being given a continuous payout command;
- The operator of the hoist was aware that the chain continued to pay out after push button was released in the first instance, but after repeated operations of the button assumed the intermittently ‘sticky’ button had been freed and that the equipment was safe for use;
- The emergency stop button was not engaged after use which enabled the faulty button to allow the hoist to continue uncontrolled pay out;
- The hoist, although paid in, was not stowed and secured as per the routine working practice onboard;

As a result of the continuous payout operation, the motor was found to be burnt out and will require to be replaced.

- Ensure crew are familiar with original equipment manufacturer (OEM) operator manuals for all hoist equipment before use;
- Review control function of hoists and where no designated isolation switch is in place, determine a safe, and practical means of safe isolation.
- Ensure visual and function tests for lifting equipment are conducted with defects/ damage corrected before use.
- Review whether hoists can be safely used parallel to or in close proximity to running machinery.
- Review frequency of planned maintenance for electrically driven, operated and controlled lifting hoists, to minimize risk of control functions degrading due to infrequent usage, and to ensure an annual function test is completed.

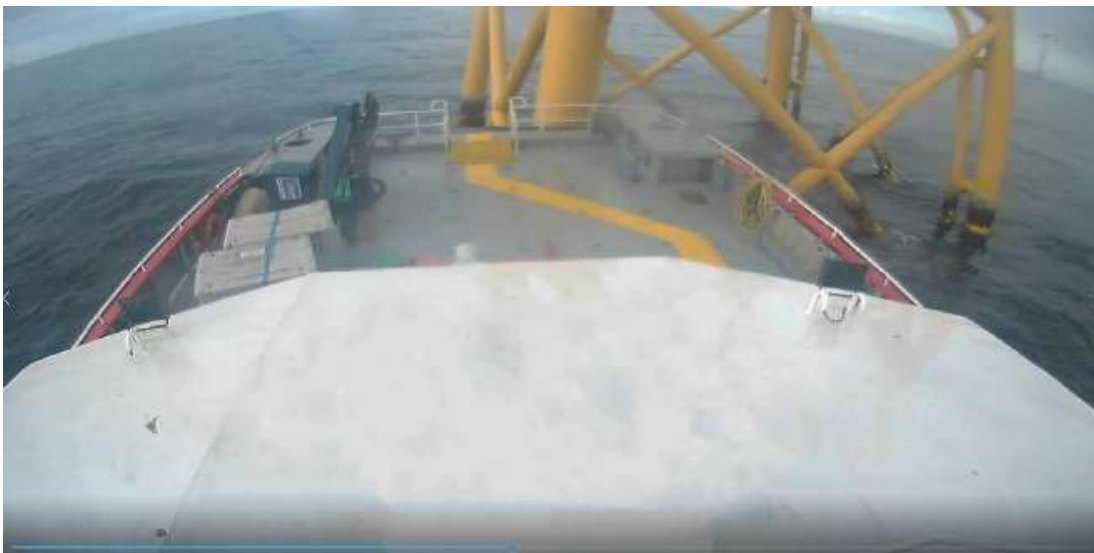
A workboat collided with a turbine platform in an offshore wind farm, causing injuries to one of the crew and minor damage to the workboat itself. The incident happened during transfer of two teams to carry out maintenance tasks on two different wind turbines. The master set minimum power ahead and steamed on a course between the wind turbines, intending to use the time to complete some administrative paperwork. He was working at the aft-facing chart table on the bridge, but had become engrossed in paperwork and lost track of time, when the boat, having gone off-course, collided with one of the towers.

The workboat took the brunt of the impact on its off-centre protected bow section. The crewman was thrown against a shelf and sustained two broken ribs. The master assessed the crewman's injury and the damage to the workboat and returned to harbour to evacuate the crewman for treatment at the local hospital. There was little damage to the workboat other than small dents and abrasions.

- The workboat's crew of master, mate and crewman were relatively new to the wind farm and still adjusting to local practices and their new contract;
- The master was not keeping watch; he had become distracted by paperwork and had lost track of time;
- The workboat was travelling at 5kts and, without the autopilot switched on, started turning slowly to starboard (use of the autopilot while navigating through wind farms was not permitted in the company's standing orders);
- The mate was on the aft deck completing some familiarisation training and the crewman was busy elsewhere;

The moment the workboat bow collided with the wind turbine tower platform

- **Crew and vessel safety remains the priority:** Where paperwork must be completed, someone else should keep watch or a look out to maintain proper and effective visual navigation;
- **Watch what is going on!** Use all available sensors and instruments. The slow turn to starboard may not have been evident from the bridge windows alone. Watchkeepers ought make regular checks of data from an Electronic Chart Display and Information System (ECDIS), rate of turn indicator, and directional gyro, etc. to identify hazards and take preventative action to avoid collisions;
