IMCA Safety Flashes summarise key safety matters and incidents, allowing lessons to be more easily learnt for the benefit of all. The effectiveness of the IMCA Safety Flash system depends on members sharing information and so avoiding repeat incidents. Please consider adding safetyreports@imca-int.com to your internal distribution list for safety alerts or manually submitting information on incidents you consider may be relevant. All information is anonymised or sanitised, as appropriate.

1 Day Signal mast broke off and fell to deck

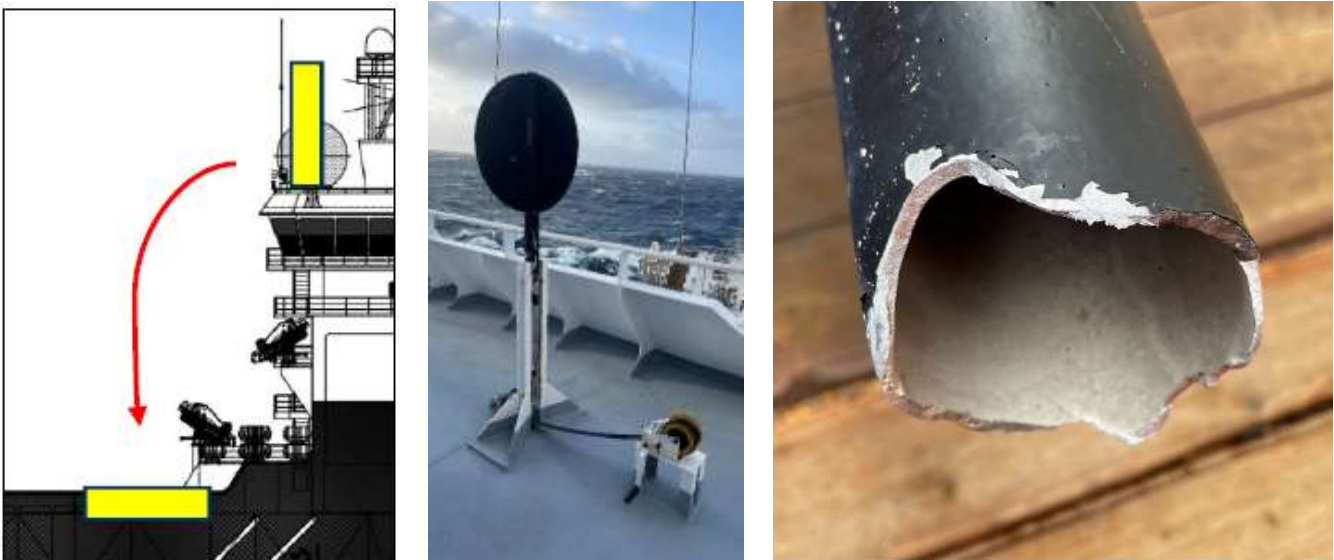
On a offshore field support vessel waiting on poor weather and experiencing high winds, the Day Signal mast on the roof of the wheelhouse broke off and part of it weighing 35kg, fell 16m to the main deck.

The weather was deteriorating and Hs (Significant Wave Height) was over 3m. The bridge team had discussed lowering the Day Signal but agreed that the wind and vessel movement could cause an increased and unnecessary risk for working on the roof of the wheelhouse. It was decided to leave the Day Signal in the raised position. The weather continued to deteriorate and the wind increased to 45-50 knots, gusting 60 knots. Later that day, a loud slamming noise was heard on the bridge. Deck lighting revealed that the Day Signal mast had broken off and was lying on the main deck. Owing to the weather situation the decision was made to leave the broken signal mast unsecured on deck until the weather improved. No-one was harmed.

- The mast was made of lightweight Aluminium in order for it to be light enough to raised and lowered manually;
- The mast design was considered sufficient to withstand the forces from high winds;
- The mast had not been identified as a potential dropped object.

- Reviewed procedures for closing the back deck during bad weather, to ensure sufficient barriers or warnings are in place when required;
- Includes Day Signal Mast in Dropped Object survey. Implemented additional securing wiring;
- Check for similar items onboard, for example, Helideck Windsock Mast, and include in Dropped Object survey if necessary;
- Review maintenance and inspection regime on Aluminium masts or similar.

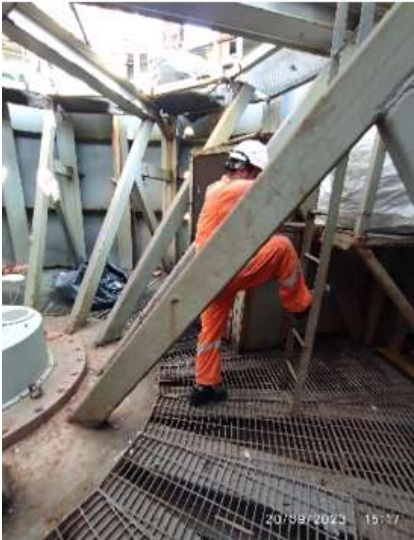
Position on ladder

A person was descending the fixed ladder of a carousel manhole. He lost his footing on the last three rungs, approximately 87 cm from the flooring. Falling backward, his helmet came off, and his head struck the edge of a steel structure and he was injured. Immediate medical attention was provided on board by the ship's medic. A follow-up medical assessment was subsequently organized ashore, where he received stitches.

- Inattention: Misjudgement of the remaining steps while descending the ladder contributed to the slip;
- Improper PPE Use: The IP did not properly secure the chinstrap of his safety helmet, causing it to fall off during the incident;
- Inadequate Working Environment: Poor lighting at the bottom of the carousel manhole may have contributed to the incident;
- Lack of Signage: No signage was present to indicate the mandatory use of safety harnesses for work in the carousel's manhole.

- Improved lighting in the area;
- Be aware of your working environment and keep a focus when you are moving – watch out for complacency;
- Ensure that all PPE, especially the helmet, is worn and secured correctly.

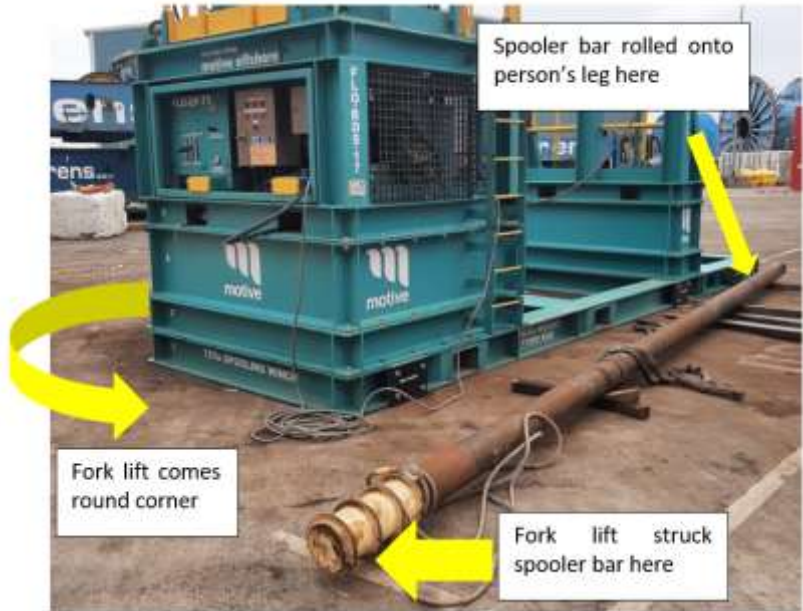
While helping with spooling operations at a third-party yard, a person was injured in the lower leg, when a forklift truck struck the edge of a spooler bar causing it to roll onto his legs, resulting in soft tissue damage. The injured person was working on a spooling winch, with the spooler bar positioned behind him, resting on wooden chocks. The forklift truck reversed from the rear of the spooling winch and struck the edge of the spooler bar, resulting in it rolling from the wooden chocks onto the persons' leg. He was unable to work for four days.

- There were only two personnel involved in conducting the operation, and the supervisor was also fulfilling the role of forklift truck operator and rigger;
- There were no hard barriers in place to mitigate hazard of impact/collision;

- The impact sensors on the forklift truck did not detect the spooler bar when reversing, as the sensor was positioned at the top of the forklift truck and the spooler bar was below this level;
- The forklift truck operator unexpectedly decided to reverse the forklift truck through a congested working area with no banksman.

- Verified that existing risk assessments for fork-lift truck operations were fully aligned with company requirements and specifically cover:
 - Access, moving the fork-lift truck, the travelling surface and obstructions at the work location;
 - Signalling and communications protocol.
- If the fork-lift truck operator’s vision is obscured, always use a Banksman to guide the fork-lift truck;
- Reviewed use of sensors and alarms on fork-lift trucks to mitigate impact/collision risk;
- Subsequently, the subcontractor involved installed reversing cameras on all forklifts.

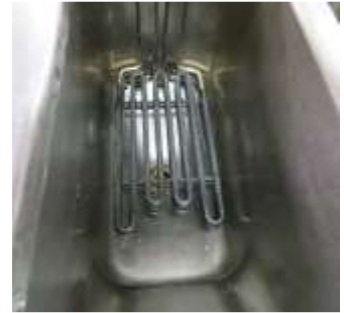
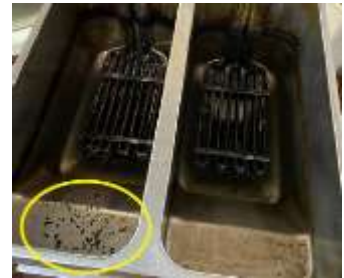
The two deep fat fryers had been drained of oil for cleaning and the cause of the fire was found to be residual food scraps saturated with fat that had ignited when the fryers were switched on.

*A clean deep fat fryer (top)
and the deep fat fryers
with residual food scraps
(bottom)*

- Ensure lock-out/tag-out (LOTO) procedures are fit for purpose and followed fully during maintenance and cleaning tasks.
 - Displaying a simple do not use notice on out of service equipment can improve safety and prevent careless mistakes
- Ensure equipment is ready to go back into service when work has been completed;
- Check circuit breakers, trip switches and fuses, which prevent electrical systems becoming overloaded or causing harm. Always check equipment before resetting its electrical supply to ensure all is well.
- Drills: robust safety procedures and well-practised drills prepare crew to deal with the unexpected. In this case the rapid organised response to a small fire prevented injury to crew and serious damage to the ship.
