IMCA Safety Flashes summarise key safety matters and incidents, allowing lessons to be more easily learnt for the benefit of all. The effectiveness of the IMCA Safety Flash system depends on members sharing information and so avoiding repeat incidents. Please consider adding safetyreports@imca-int.com to your internal distribution list for safety alerts or manually submitting information on incidents you consider may be relevant. All information is anonymised or sanitised, as appropriate.

1 BSEE: Are your emergency procedures and your emergency equipment good enough?

2 High potential: navigation near offshore wind turbines

3 Failure of self-righting frame on Fast Rescue Craft (FRC)

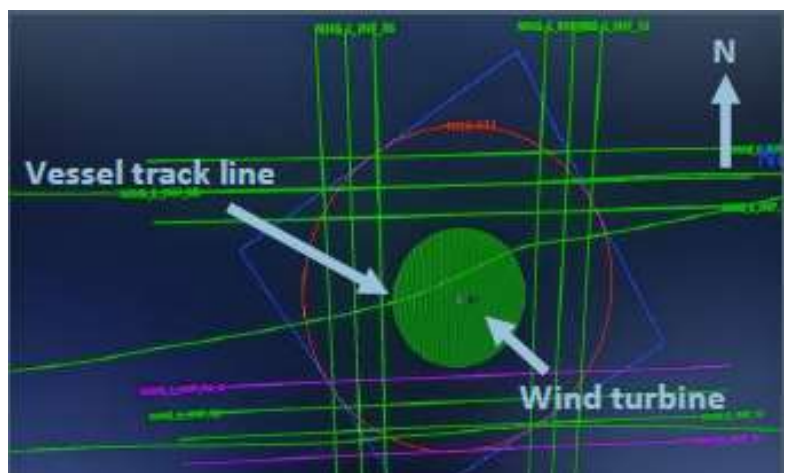
The incident investigation established that the Officer on Watch (OOW) lost situational awareness and turned the wrong way – to port instead of to starboard. Given that the tide was running north to south, the OOW should have changed course to starboard for safe clearance of the wind turbine. Misjudgement resulted in a miscalculation of the vessel track, significantly contributing to the near miss incident. Agreed onboard procedures and standing orders were not followed.

- Further requirement for enhanced bridge watchkeeping standards and voyage / survey route planning during close quarter navigation;
- Shift change toolbox talk and handover was realigned to include more detail and time to focus on confidence, awareness, communication and contingency scenarios;
- Closer assessment and vetting was required for crew competency, experience and suitability by our member and their vessel charter company during the vessel vetting procedure. This was to be checked and rechecked before starting a project.

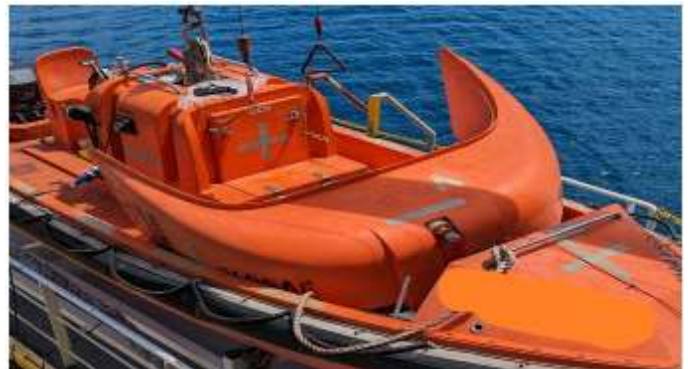
During a routine rescue drill the self-righting frame assembly fell off the Fast Rescue Craft (FRC) into the water while the FRC was transiting at approximately 15 knots. The self-righting frame was recovered by the FRC crew and returned to the vessel, where the cause of failure identified, and repairs completed.

Self-righting frame pictured after incident

- A third-party inspection of the FRC had been completed two months before the incident. The inspection required only a visual check of the self-righting frame and did not include checking the integrity of the frame securing arrangements;
- Over time the securing arrangements were stressed and showed signs of galvanic corrosion.

- The integrity of self-righting frames should be periodically inspected. This may involve the removal of the frame;
- Reviewed FRC inspection checklist and procedure to ensure the self-righting frame is periodically removed and inspected.

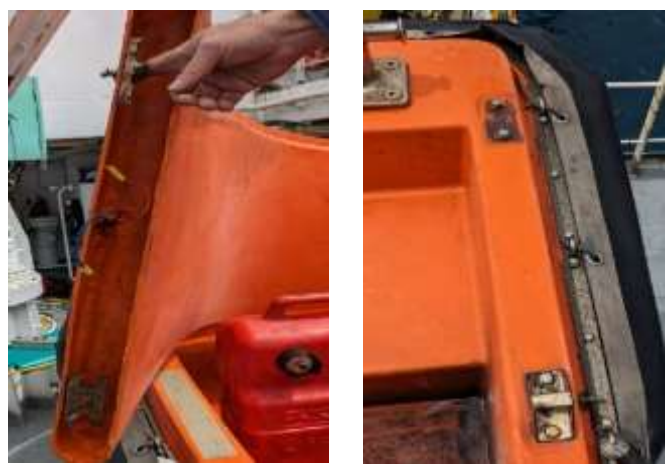
The corroded bracket on the frame and FRC

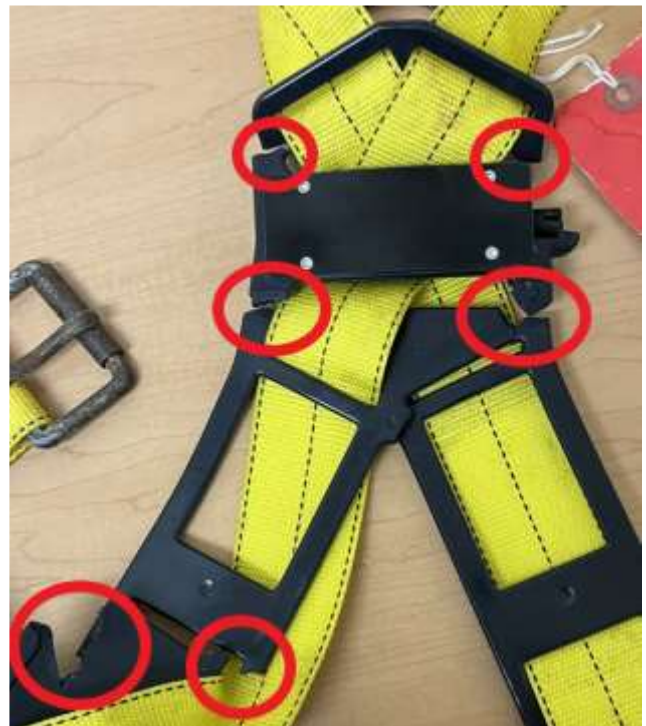
3M™ DBI-SALA® Delta™ Vest-Style Harness
(Model:1102000)

During equipment recovery operations on the back deck of a vessel, a technician felt something unexpected around the Dorsal 'D' ring on the back of his safety harness. Operations were immediately stopped. On inspection, several points of failure were identified on and around the area of the plastic back pad of the harness (see photo).

- Before project mobilisation, the task of inspecting the harnesses was assigned to an untrained short service employee, which was contrary to company requirements;
- There was a failure to adhere to existing internal requirements and control mechanisms associated with the periodic inspection, maintenance and record keeping associated with fall protection equipment systems;
- There was no evidence that a pre-use inspection - as was required by the company - had been completed by the technician before putting on the harness and starting work;
- Wear and tear of the harness and metal components indicated exposure to adverse environmental conditions, suggesting that the harness had not been stored and maintained per the original equipment manufacturer's instructions.

- Ensure thorough visual inspection of fall protection safety harnesses by an appropriately trained person. Safety harnesses found unfit for service should be quarantined or destroyed;
- Maintain a comprehensive fall protection equipment register;
- Always store fall protection equipment in an environment protected from the elements and in accordance with the original equipment manufacturer's requirements.

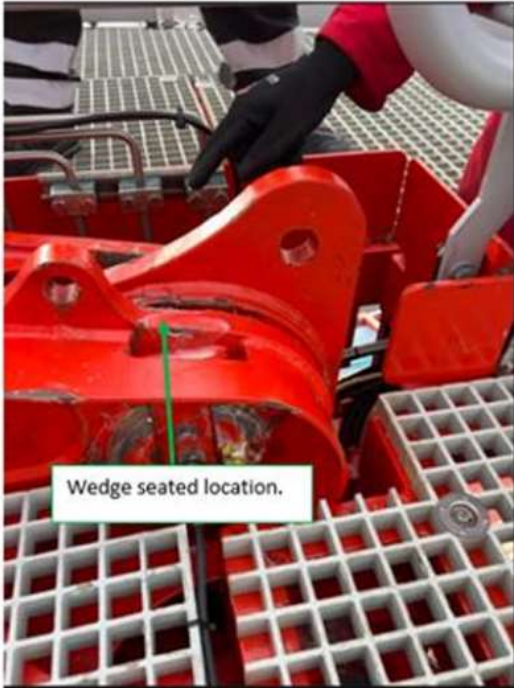
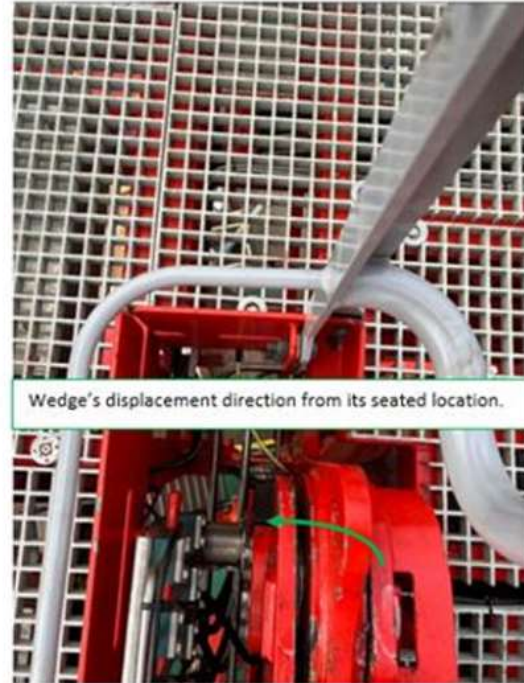
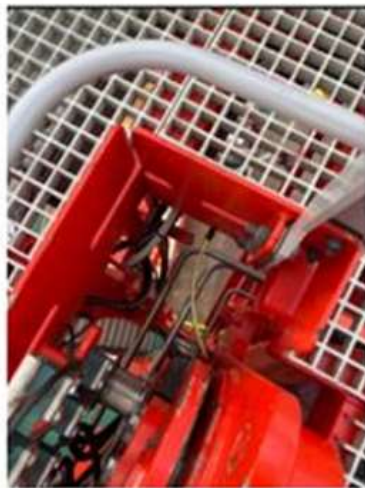
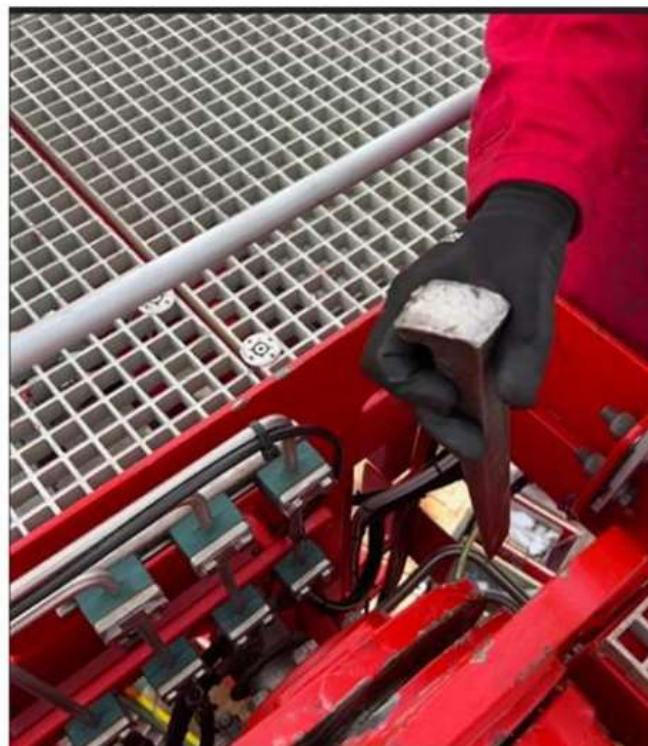
A pin was required to be pulled on a hinge system for the dynamic gangway system on a W2W (walk-to-work) vessel. As part of this task metal wedges were used to hold some of the gangway components in place. The job of pulling the pins was not going as expected due to space limitations, the effects of surface corrosion on the pins and the chosen method of pulling the pins. While pulling the pin out, the metal wedge in place was dislodged and fell between the gangway components, 13m to the deck below. No-one was underneath the gangway at the time. [MSF Safety alert 23-17](#)

- The metal wedges did not have a place to secure a tethering device;
- The method chosen to pull the pin was not optimal;
- Not all the tools could be secured from dropping and there was no collective dropped object arrest system to catch smaller tools or items;
- The aft area around the gangway was not fenced off and personnel could have walked underneath the drop zone;
- Simultaneous operations were taking place in the area on deck around the gangway and there was a risk of someone accidentally walking into the DROPS zone.

- Modified the metal wedges to accept a tethering device;
- Investigated how a collective dropped object arrest system such as a net could be installed under the gangway for future work;
- Identified an optimal solution for pulling the pins on gangway;
- Improved guidance and training for personnel on barriering-off areas in a DROPS zone.
