IMCA Safety Flashes summarise key safety matters and incidents, allowing lessons to be more easily learnt for the benefit of all. The effectiveness of the IMCA Safety Flash system depends on members sharing information and so avoiding repeat incidents. Please consider adding safetyreports@imca-int.com to your internal distribution list for safety alerts or manually submitting information on incidents you consider may be relevant. All information is anonymised or sanitised, as appropriate.

1 Unauthorised entry into confined space

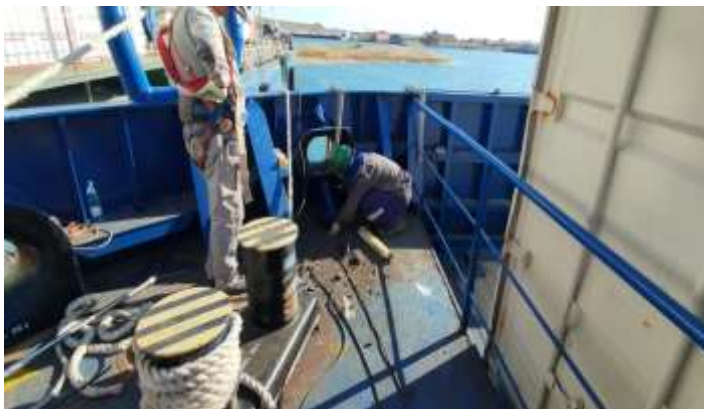
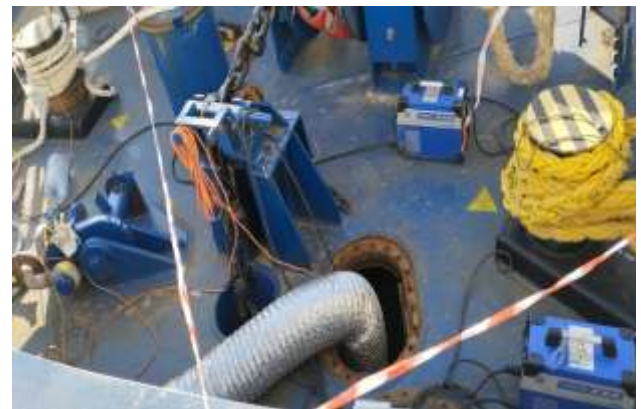
Planned repair works were taking place on a barge. The work involved hot work (welding & grinding). During the works, the stand-by person, controlling several areas, observed sub-contract personnel accessing a confined space in which welding was taking place. Stop Work Authority was exercised immediately, and the unauthorized personnel requested to leave the area. There was an immediate stand down to discuss the consequences of unauthorized personnel access to confined spaces and the potential consequences. No-one was harmed.

Photographs from member showing where work was taking place

- Working environment: A lack of physical barriers and appropriate warning notification around the confined space;
- The contractor did not have adequate personnel for CoW (Control of Work) and the third-party crew did not have awareness of the specific hazards relating to confined space entry;
- There was insufficient or inadequate supervision of the third-party personnel onboard.

- Contractor management was approached to reiterate importance of compliance with vessel access and control of work procedures;
- Improved signage and barriers around confined space areas;

- Ensured completion of Risk Assessment, Permit to Work, and robust access controls for Confined Space entry;
- Ensured that only trained & authorized personnel can access Confined space areas and that their access is authorized and controlled by immediate management and the stand-by person.

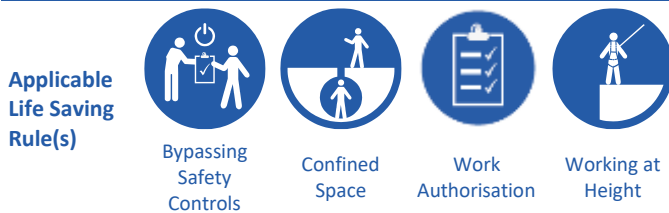
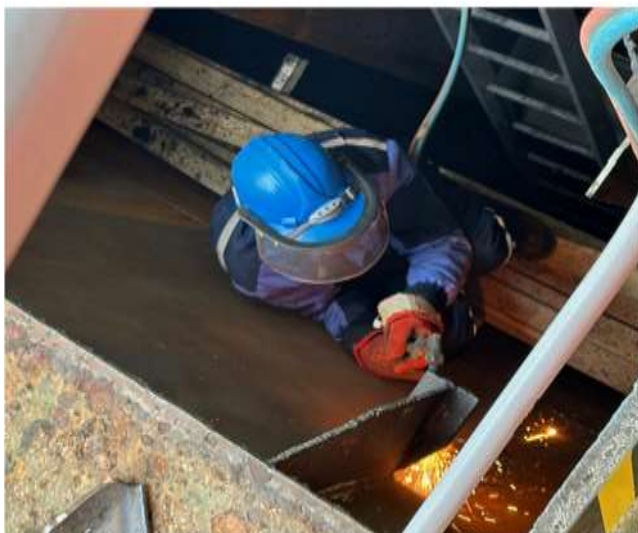
During a site visit to a vessel, it was observed that a third-party contractor’s welder was standing on the wooden platform (the actual height was over 1.80m) inside a confined space (a ballast tank) doing some flame-cutting jobs. No fall protection guards were installed around the worker, not was the worker wearing fall arrest equipment.

Welder’s initial position without any fall protection

- The personnel authorizing these activities – working at height doing hot work within a confined space:
 - Made no Permit to Work application for hot work nor for working at height nor for working in a confined space;
 - Did not conduct a review of the risk assessment for the task in hand;
- Inadequate supervision: there was no proper Control of Work by vessel crew or management at the site before the job started, and no ongoing verification of safe working as the job continued;

- There was a lack of hazard appreciation and risk perception by the persons involved; it took someone coming in from outside, observing the job, to actually stop it.
- It was easy to work unsafely: crew members misunderstood differing internal company procedural requirements for working at height;
- Various hazards were not recognised at all. Had the worker fallen within the tank, protruding metal elements meant that there was high potential for a very serious injury.

- Reiteration of importance of thorough Risk Assessment, Permit to Work process, and Control of Work, including regular monitoring;
- Ensured more robust control of Working at Height activities and prioritized availability of engineering controls (e.g. a scaffolding platform).

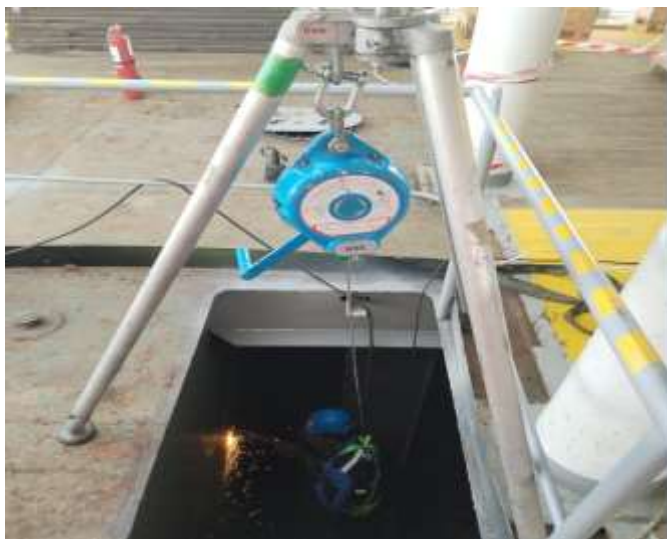
Temporary solution (full body harness attached to the tripod system with inertia reel)

The job was stopped immediately and a temporary alternative working method was arranged where the worker wore a full body harness attached to with an inertia reel to a tripod.

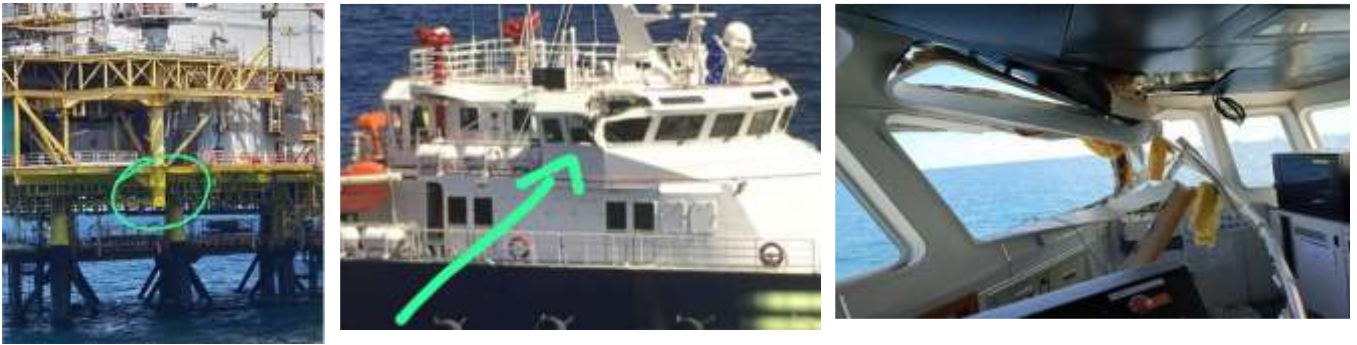
A CTV (crew transfer vessel) collided with a fixed platform when one of the engines failed. The CTV was approaching a platform to transfer crew onto it, when there was a failure of control of the port inner main engine, causing it to continue to drive the vessel forward. Whilst control of the engine and hence the vessel was regained before coming into contact with the platform, collision could not be avoided, and there was damage to the starboard side of the wheelhouse. No-one was injured.

- The vessel's port inner main engine got stuck in forward movement as she approached the platform.

- Our member's investigation discovered that there was a failure of the pitch control propulsion actuator. The response to regain control and time taken to do so, was insufficient to avoid contact;
- The actuator froze because of worn-out carbon brushes in a motor. There were no OEM or company planned maintenance system recommendations for actuator electric motor maintenance.

- Checked across fleet for similar actuator motors, then checked carbon brushes within these motors;
- Amended Planned Maintenance System on relevant vessels to include actuator electric motor maintenance program as specified by manufacturer;
- A reiteration of the importance of **Loss of Power** drills.
