1 Pipeline End Manifold yoke dropped from 45° position

2 LTI: Damage and personal injury arising from heavy weather

3 Crew Transfer Vessel (CTV) hit protruding scaffolding on a supply vessel

4 Heavy equipment fell over during manual handling

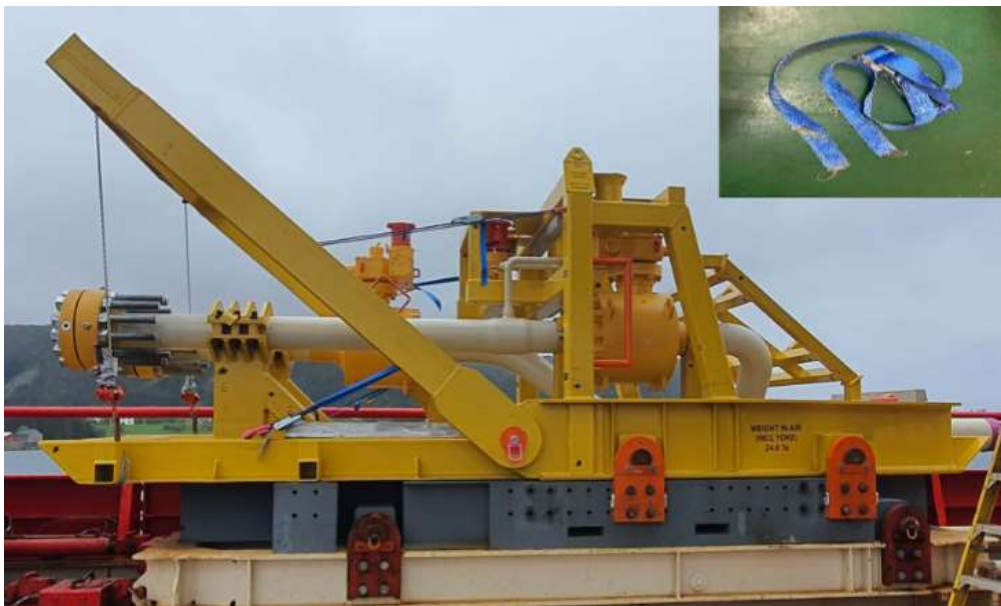
During adjustment of the yoke securing arrangement for a PLEM (Pipe Line End Manifold), the cargo strap failed resulting in the yoke falling and landing in its horizontal resting position. Two persons were working inside the PLEM in close proximity to the yoke at the time. Neither were injured.

While the rigging team on the vessel were re-arranging the rigging securing the PLEM yoke at a 45° position, the port side top cargo strap tension was released. This resulted in sudden movement of the yoke, causing the starboard cargo strap to fail and the yoke to drop to its horizontal position. Note: re-arrangement of the rigging was initiated after a safety observation on weak rigging was raised by deck crew...

- The wrong kind of cargo strap was used;
 - Old 4 tonne straps were used instead of the new 5 tonne straps provided;
 - Specific rigging described in the task plan was not used.
- The cargo strap was used in an incorrect way;
 - The team copied the use of cargo straps from how it had been done on previous projects;
 - The yoke was not recognised as a suspended load;

- There was a lack of understanding of the correct use of cargo straps, which were not to be used for lifting or holding the load.
- There was inadequate risk assessment of change.
 - The port side holdback was released without considering if the single holdback was sufficient;
 - There was no MoC (Management of Change) process undertaken, so planning did not break the task into steps and was not properly risk assessed;
 - “Task seen as routine” - the task was considered standard deck work.

- Design teams to:
 - review standard designs to incorporate engineered securing of yokes & wings;
 - review checklist for standard designs.
- Take caution when handling or working near temporarily restrained yokes and wings and consider additional controls to prevent or mitigate unexpected movement;
- Review boundaries between changes that require formal “Management of Change” and those that are more general;
- Review TRA’s (Task Risk Assessments) to ensure a better understanding of task limitations;
- Use the rigging and equipment provided for the specific project task in hand;
- Review the practice of securing suspended loads using cargo straps.

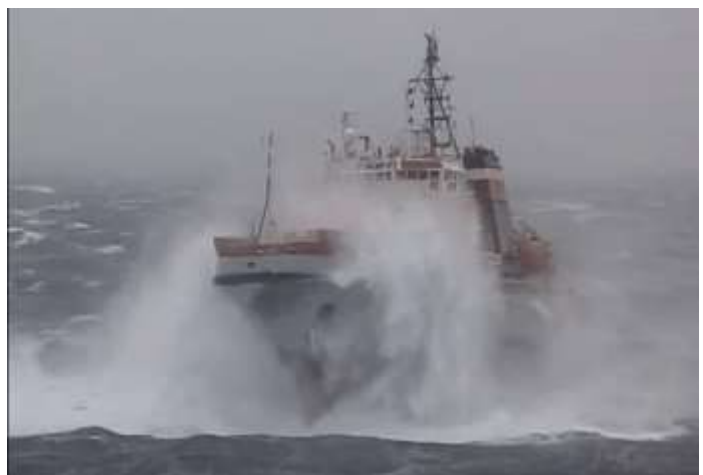
On a vessel waiting on weather, a weathertight door in the crane pedestal from the main deck to the crane room was forced open by a large wave coming from a different direction than the prevailing wind and sea. During operations to close the weathertight door, a vessel crew member was hit by water gushing through the door, and was washed down two flights of stairs within the crane pedestal, causing serious injuries.

- This was a rogue wave, not consistent with the general wave pattern;
- The seas were 10-11m at the time and the distance from the waterline to the top of ships bulwark (railing) was approximately 3.1m;
- The existing weathertight door had not been installed in the optimal direction.

The design of the weathertight door was such that it opened forward rather than aft. Typically, waves can be expected from the bows of the vessel. The force of seas impacting on the door forced it open rather than closed.

- Redesign the positioning of the weathertight door: If the hinges were mounted on the opposite side then the force acting on the door would close it instead of forcing open. Thus the door opening should be sheltered from the ingress of water on deck;
- Vessel crew to continue to maintain good situational awareness of any change in weather conditions.

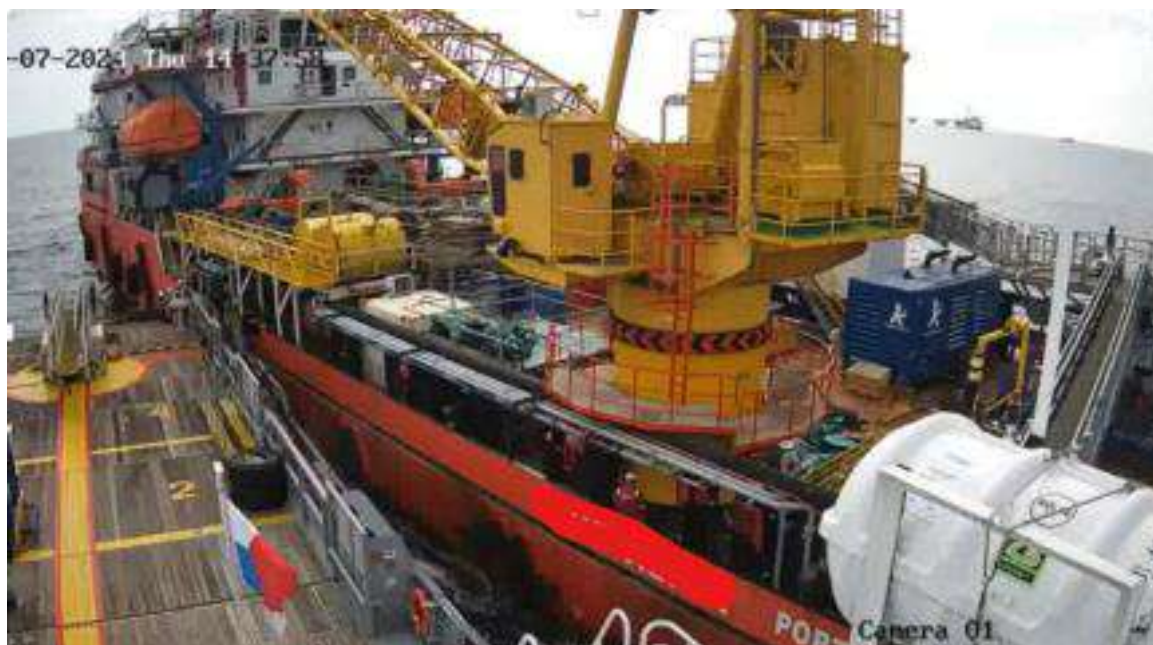
During transfer of crew to an Offshore Supply Vessel (OSV) at anchor, a Crew Transfer Vessel (CTV) came into contact with protruding scaffolding on the OSV, causing minor damage to a railing on the CTV. This was the fifth such transfer of personnel without incident; the Master was aware of the protruding scaffolding. The fifth time, during manoeuvring the CTV stern towards the OSV, the CTV contacted the OSV protruding scaffolding, causing minor damage. There were no injuries. The Master of the CTV under-estimated both how far the scaffolding protruded and how the OSV would swing round whilst at anchor.

- Task seen as routine: the CTV Master and crew had carried out multiple passenger transfers in similar conditions on several occasions. Crew members did not see this as an imminent hazard and no changes were made to their approach, no need was seen for additional safety measure at that point in time;
- The existing risk assessment did not address the protruding scaffolding nor the risk of the OSV swinging round whilst at anchor.

Showing the moment of collision

- Greater account should have been taken of the repair works requiring protruding scaffolding. A more comprehensive risk assessment was required, covering protruding objects and covering the potential for continuous swing on an anchored vessel.

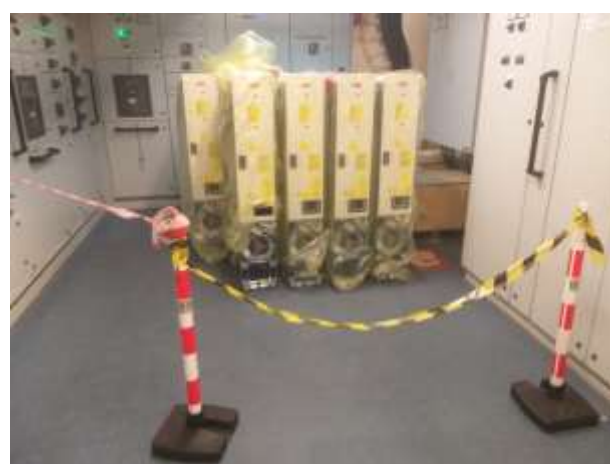
During manual handling of a heavy control cabinet, the centre of gravity was compromised, and the cabinet fell over onto a crew member's leg, resulting in a bruise to their knee. The incident occurred when crew were moving control cabinets each weighing 130kg. Each cabinet was fitted with wheels by the manufacturer to facilitate handling. The activity required manual handling of the wheeled equipment to clear the access to the electrical panel in the switchboard room where they were to be installed.

- The crew member attempted to prevent the cabinet from falling over, which placed them in the line of fire;
- The risks associated with manual handling of wheeled loads were not included in the Task Risk Assessment (TRA);
- The handling instructions were not followed;
- Persons were not positioned correctly during the manual handling.

Showing wheeled control cabinets each weighing 130kg

- Manual Handling assessments should address requirements based on the task, load, work environment and also on the individual capabilities of the crew members involved;
- Line of Fire assessment should be a part of task risk assessment and pre-work discussion;
- Look closely at safe positioning when conducting manual handling of wheeled loads;
- **Read the manual!!** Instruction manuals and guidance documents provided by suppliers/manufacturers should be reviewed by the work team with safety precautions adopted into TRA and work activities;
- Our members' crew fabricated a ramp to facilitate safe handling of such heavy cabinets – see illustration.

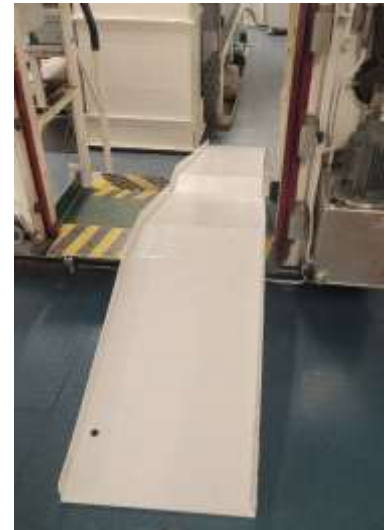
Showing new ramp constructed subsequently

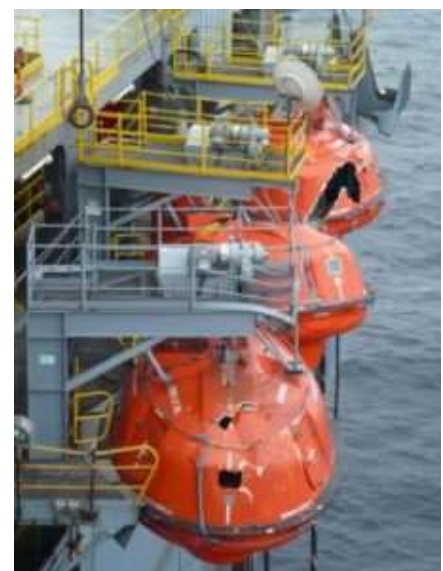
The event occurred as crew were preparing to recover a faulty submersible pump. As the crane operator raised the boom to clear one of the three legs of the installation, the boom failed catastrophically and collapsed. Three of the four boom sections fell to sea between the rig and the supply vessel alongside which was pumping dry cement to the rig via a flexible hose. The crane’s auxiliary hook, cables, components, and rig debris landed on the deck of the supply vessel. The boom tip snagged the flexible hose, dragging it below the sea surface, causing it to rupture and whip back onto the deck of the vessel engulfing it in fine cement dust.

- The immediate cause of the crane collapse was that a limit switch had not been checked. The limit switch, designed to prevent the crane boom being raised to the point of mechanical failure, had not been correctly set;

Damage to the lifeboats following the collapse

- Safety mechanisms, designed to prevent inadvertent operation of the slew, hoist, and boom joystick controls in the port bow crane cabin had all been overridden to prevent them returning to their locked neutral position.
