IMCA Safety Flashes summarise key safety matters and incidents, allowing lessons to be more easily learnt for the benefit of all. The effectiveness of the IMCA Safety Flash system depends on members sharing information and so avoiding repeat incidents. Please consider adding [safetyreports@imca-int.com](mailto:safetyreports@imca-int.com) to your internal distribution list for safety alerts or manually submitting information on incidents you consider may be relevant. All information is anonymised or sanitised, as appropriate.

## 1 Person struck and injured during lifting operations

**2 Person pulled to deck by fall arrest harness**

**3 High potential: sea water inlet pipe leakage in engine room**

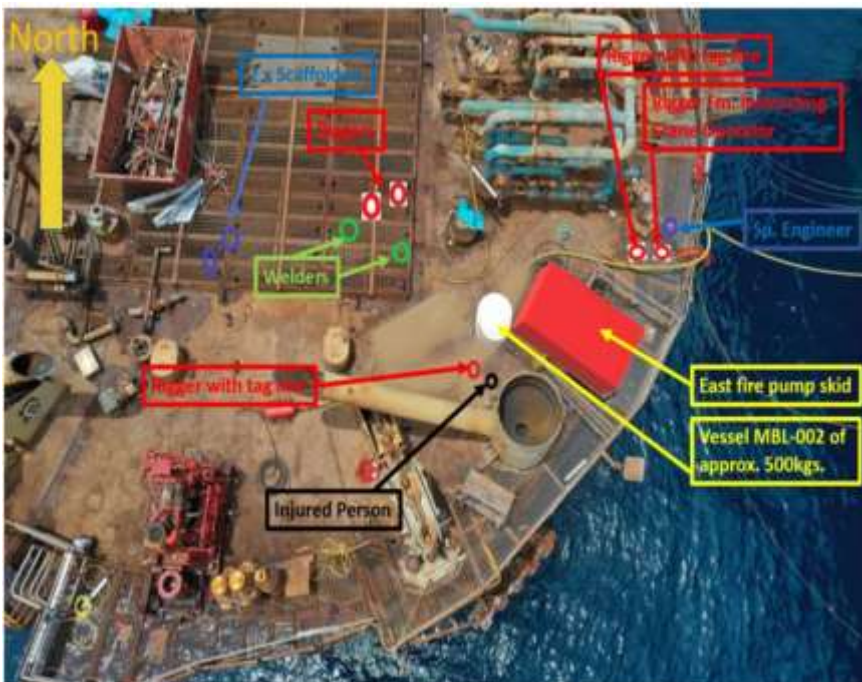
The crew stopped work and exchanged the rigging for a more robust solution. During the second lift attempt, the skid unexpectedly came free and made contact with an adjacent nitrogen vessel, which had previously been cut 95% loose. The sudden and unplanned release of energy led to the nitrogen vessel tank striking the injured person, who was standing in the line of fire. He fell backwards and hit his head on a diagonal bracing, causing him to lose his helmet as he fell down. The injured person was transferred back to the vessel, where a medivac was waiting to transport him to a hospital onshore.

*Where people were at the time of the incident*

- The skid was still attached to the deck of the spar by inner/underneath welds, which were unknown during the work preparations;
- The decommissioning project had been prepared in a short time frame, which had an major impact on resources;
- There was no appropriate Control of Work nor Management of Change before the second lift attempt;
- Some objections / feedback given by crew members before proceeding with the second attempt, had not been acted upon.

- Allocate enough time and resources to perform project preparations;
- Ensure that Control of Work and Management of Change processes are rigorously applied in order to identify unknown hazards and mitigate any potential risks;
- **LISTEN** when concerns are raised;
- **STOP** when things are not going according to plan;
- Take the time required to **REASSESS** the situation with your boss and with your colleagues before proceeding.

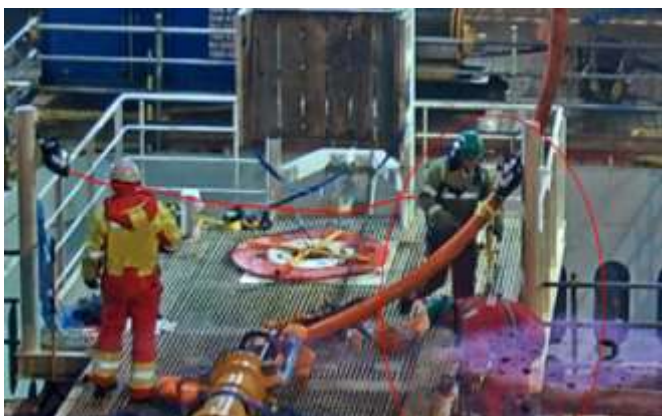
*Showing person in green helmet before incident. His fall arrest line illustrated in red*

- The whip line was lowered into area while operations were ongoing;
- The workers’ fall arrest was connected to the opposite side of the moonpool;
- There was a lack of situational and operational awareness – the person placed themselves in the line of fire;
- Parallel or simultaneous activities were being conducted.

- Improve communication between personnel working together (deck crew and third-party contractors);
- Use taglines particularly in rough conditions or in congested areas;
- All personnel should remain clear when whip line is being lowered in the area;
- Take care to consider the safest connection point for your safety harness.

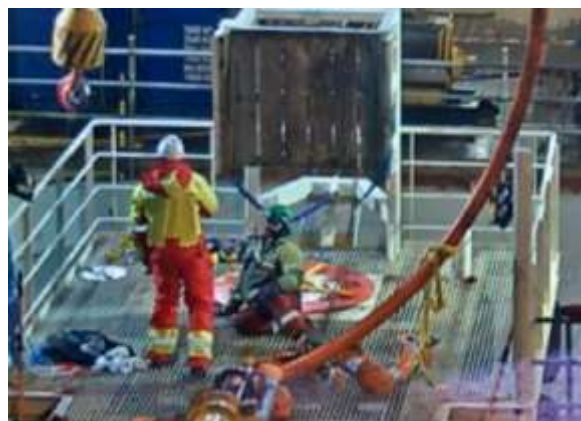
*Showing person in green helmet pulled to the deck and crane block at top left*

- The immediate causes were:
  - Inadequate preparations/planning.
- The root causes were:
  - Inadequate discipline;
  - Inadequate supervision;
  - Inadequate reinforcement of proper behaviour.

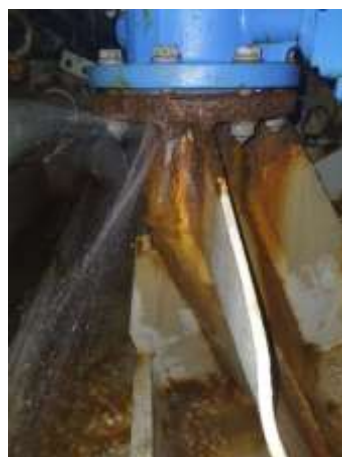
Vessel crew noticed seawater ingress on a pipe very close to the inside of the hull. The leak was noticed whilst the vessel was offshore when engine crew were conducting routine weekly maintenance of the sea chest. While working on this, they noticed sea water leakage in the adjoining tank room from a condenser pipe of the AC system, just a few centimetres length from the ship’s side just underneath the connecting valve flange. This pipe is always underwater and thus subjected to continuous hydrostatic pressure.

- The vessel planned maintenance system had no documented general condition checks of such ship side valves and associated piping systems;
- The affected pipes had last been inspected before the vessel’s 5 yearly renewal dry dock in 2020;
- The pipe section was heavily corroded and could have resulted into more leakage with potential catastrophic results.

*Deteriorated condition of sea suction pipe leading to leakage*

- Identify all such seawater ship-side valves and associated piping and ensure that a general condition check is added to the vessel's planned maintenance system and conducted on a regular basis;
- Carry out a thorough inspection and condition check of such pipes before intermediate & renewal dry dockings to analyze their health and anticipated longevity, and use such opportunities for renewal works to avoid emergency dockings.

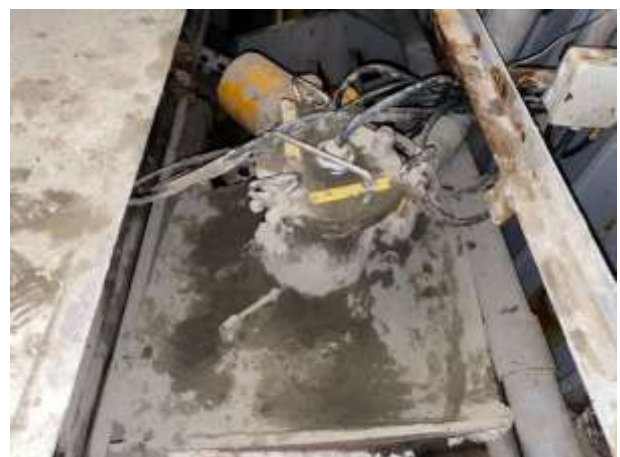
*Temporary repairs with a cement box to restrict water leakage*

- Immediately a cement box was constructed around the pipe/valve, to contain the leakage;
- The vessel went subsequently into emergency dry dock for permanent repairs.

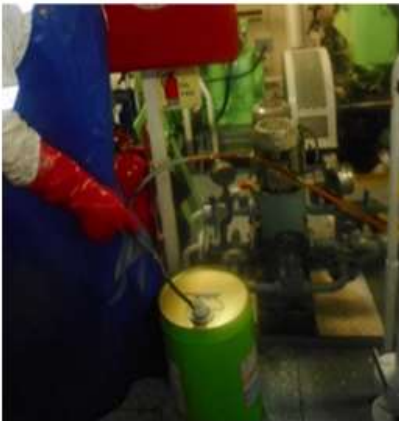
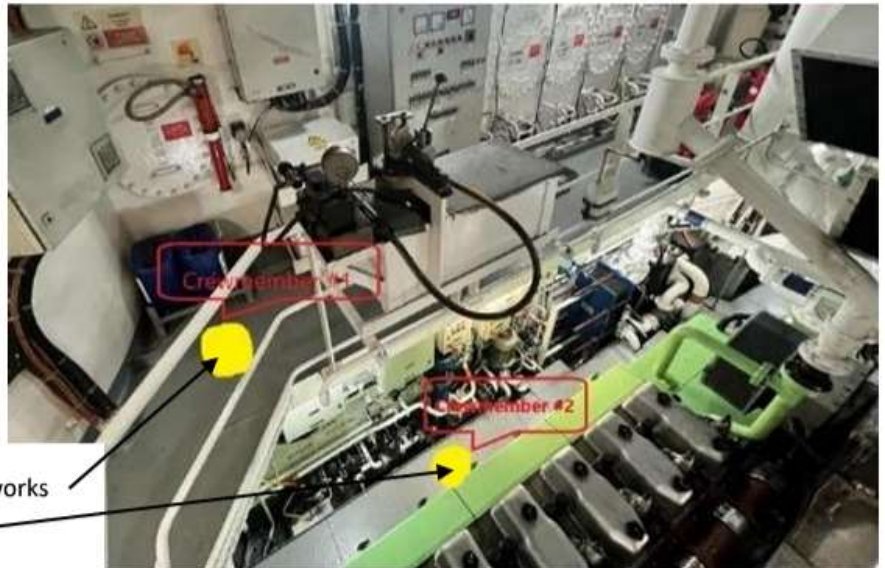
Crewmember #1 – Engineer performing works

Crewmember #2 – Injured Person

- A toolbox talk had been held but no safeguards were put in place to prevent encroachment around or below the area of the chemical transfer operation;
- The areas around and below the chemical transfer operation had not been taped off, (hazard tape) or signage posted to prevent personnel not involved in the operation from entering the area.

There was inadequate assessment of the risks involved: even drops of fluid are dropped objects. The area underneath ought to have been barriered off.

- Relocate this chemical transfer operation to a more suitable location;
- Review risk assessment;
- Reiterate chemical handling issues in toolbox talks / safety meeting.
