List of DP Events

1 Closed Bus – PMS Failure Leading to Thrust Limitation of All Thrusters

2 Button Trouble

4 The Cascade Effect

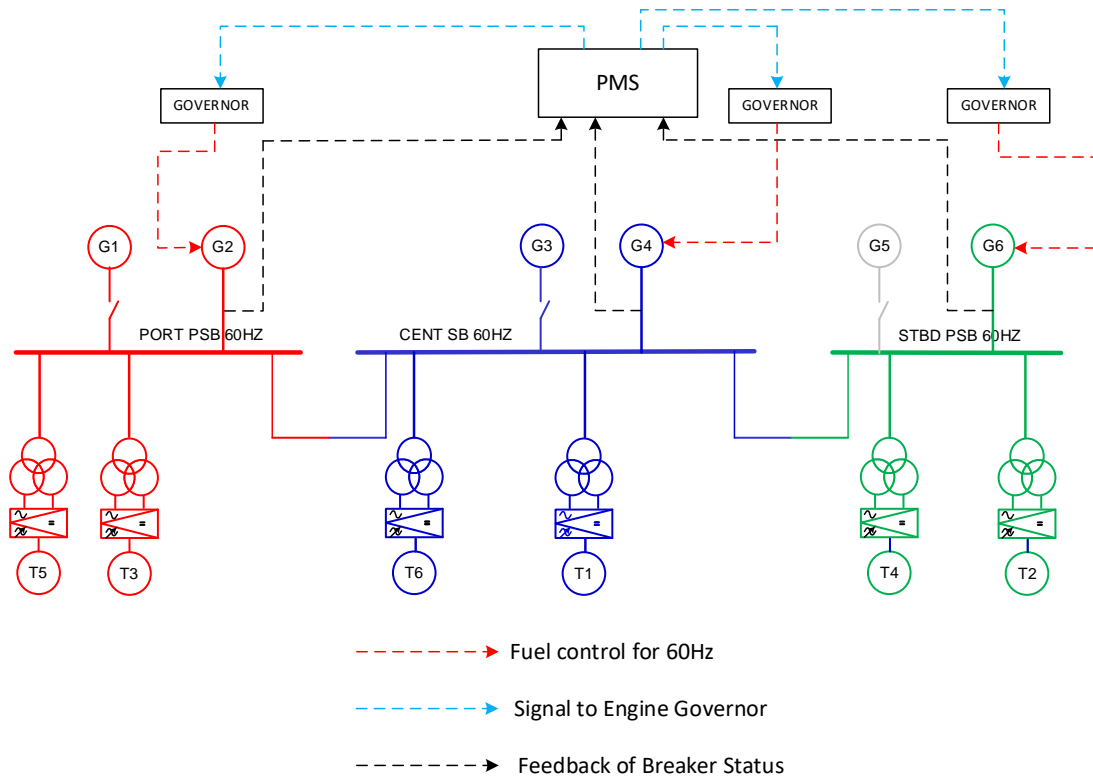
Figure 1 – Intact state prior to failure

The vessel encountered a critical situation due to a fault in the Power Management System (PMS). A malfunction in the Input/Output (I/O) module for the No. 4 centre generator triggered a series of events leading to a loss of vessel position and an emergency disconnect.

- 1) **Misleading Alarm and Response:** An alarm signalled a generator fault, leading the engineer to disconnecting the faulty generator by opening the circuit breaker but leaving the effected generator running. However, due to the I/O module fault, the breaker status incorrectly showed to the PMS as still closed/connected.

- 2) **I/O Module Fault:** The I/O module for the No. 4 centre generator developed a fault, causing the generator circuit breaker status to freeze in the 'closed' position when the breaker was physically opened.

- 3) **Load Sharing Imbalance:** The disconnection of the generator caused a load sharing imbalance. The PMS attempted to correct this imbalance, but as the disconnected generator could not take any load, the imbalance persisted. The PMS believed it was controlling three generators not two, the status signal was not just for indication but an important input to the PMS control. PMS lowered the fuel setting to G2 & G6 and increased fuel setting to G4.

- 4) **Bus Frequency Decline and Thrust Limitation:** The persistent imbalance led the PMS to reduce the bus frequency, eventually triggering a frequency-based thrust limitation function on all thrusters. This resulted in the loss of the vessel's position and necessitated an emergency disconnect.

- ◆ **FMEA Inclusion of PMS Interface:** The vessel's Failure Modes and Effects Analysis (FMEA) should be revised to include the PMS interface, ensuring that similar failure modes are identified and mitigated.
- ◆ **Testing of PMS in Closed Bus Operations:** The incident suggests that the PMS was not adequately tested for operations in closed bus mode. Comprehensive testing in this mode is recommended to prevent similar occurrences.
- ◆ **Generator Protection Evaluation:** The occurrence of frequency issues points to a lack of advanced generator protection or its malfunction. This aspect must be investigated and rectified.
- ◆ **Review of Operational Manuals:** The vessel's Dynamic Positioning (DP) operations manual, Standard Operating Procedures (SOPs) and Well Specific Operating Guidelines (WSOG) should be reviewed and updated in light of this incident.

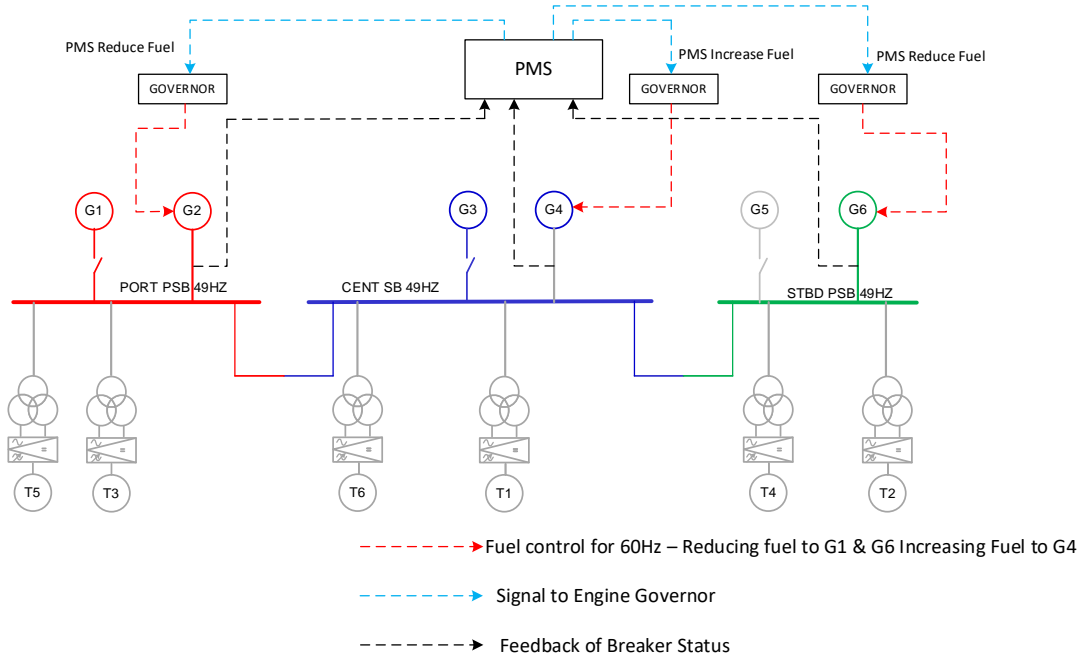
Figure 2 – During failure, thrusters phase-back on low frequency

G4 eventually tripped off on overspeed, once this trip happened the 2 connected generators returned to normal load sharing and returned the bus frequency to 60Hz, however this was too late as the thrusters had already reduced their thrust output to zero.

The standby generators were prevented from connecting prior to G4 trip due to the low bus frequency. Once G4 tripped, the PMS return to normal load sharing and as the frequency returned to normal level the standby generators were able to connect.

Once the thruster drives detected the normalisation of the bus frequency the thrusters were able to return from phase back allowing DP Control.

The time duration was relatively short (approx. 3 mins) – however, the position excursion was in excess of 75 metres.

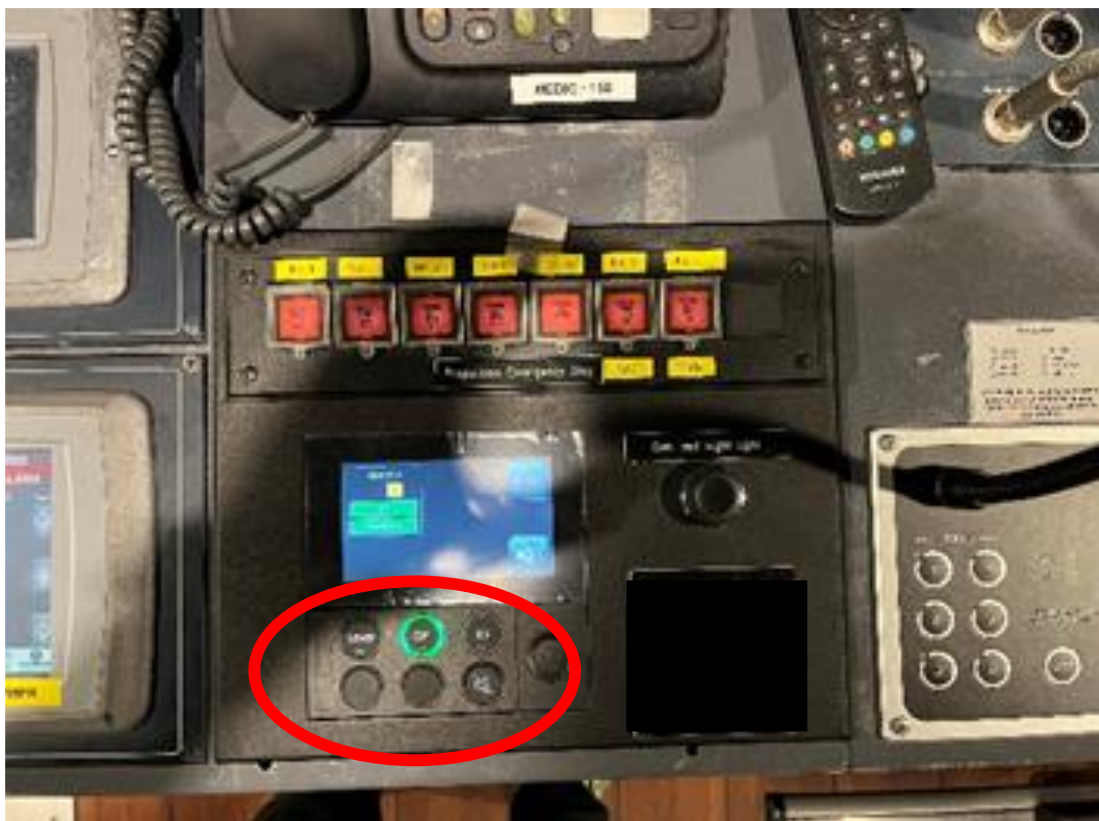
Figure 3 – Typical mode change button arrangement

The incident occurred during the cable lay operation. The DP manual override command on the navigation bridge was inadvertently activated, which caused a loss of DP control over 6 of the thrusters, resulting in the vessel drifting off position.

Investigation revealed that this command was activated inadvertently, leading to the loss of thruster control.

The vessel's DP Control system was upgraded during a recent vessel life extension. Part of the upgrade included the addition of a manual override button.

- ◆ To prevent recurrence, the manual override button on the navigation bridge could be replaced and the single manual override functionality removed.
- ◆ Vessel owners/operators should assess their DP systems to eradicate such single action override buttons or ensure they are adequately protected.
- ◆ The crew's understanding of the DP functionality should be assessed, and additional training to be provided to ensure full comprehension of a new system.
- ◆ Emergency drills should be conducted to ensure crew preparedness for various scenarios.
- ◆ The DP checklist should reflect the change to the Master's DP standing orders.
- ◆ Due to system upgrade, MOC needs to be put in place and to be included in the handover note. Familiarisation to highlight changes which occurs during system upgrade.

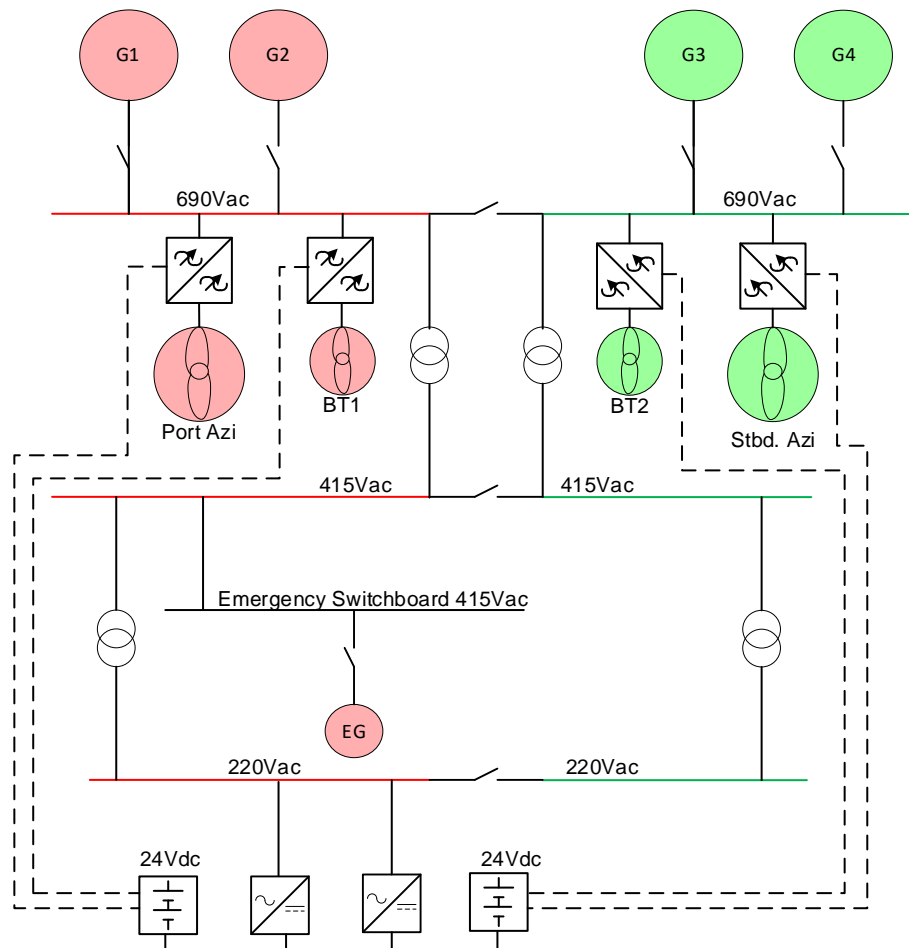
Figure 4 – Overview of power system

The incident initiated when the engine room watchkeeper attempted to replace the left filter of the duplex fuel oil filter of Diesel Generator (DG) No. 1. This generator, integral to the port redundant system, was responsible for powering the 415v and 220v bus A and the emergency switchboards.

- 1) **Failure of DG No. 1:** Following the filter change, DG No. 1 experienced a blackout due to fuel oil starvation, attributable to incorrect operation of the duplex fuel filter.
- 2) **Inadequate Power Supply from DG No. 2:** DG No. 2, also part of the port redundant group, was initiated but failed to supply power to the bus.

- 3) **Emergency Generator Disconnection:** The emergency generator did not engage with the emergency switchboard as the breaker was inadvertently left in manual mode, resulting in a loss of power to the emergency bus bar.
- 4) **Battery Failure:** Control power for DP essential equipment, typically supported by batteries during such failures, was compromised as the batteries were drained.
- 5) **Design Flaw in Power Distribution:** Despite no failure in the starboard redundant group, the loss of all propulsion control power occurred due to a design fault. The 220v AC and 24v DC systems, providing control power for all propulsion, were sourced solely from the port redundant group.

This design flaw was not identified in the Failure Modes and Effects Analysis (FMEA) or during the annual DP trials, the most recent of which was conducted less than three weeks prior to the incident

- ◆ prohibition of maintenance on active or passive DP components within 500 metres of an installation
- ◆ to be indicated in the Engine Room DP checklist and handover checklist
- ◆ permanent modification of the switchboard setup to ensure propulsion control power is supplied from different redundant groups
- ◆ verification of switchboard setup by two separate watchkeepers
- ◆ regular DP blackout drills
- ◆ regular training on switchboard setup
- ◆ enhanced battery checks and testing routines
- ◆ review and update of the company's test and trials programmes.
