IMCA Safety Flashes summarise key safety matters and incidents, allowing lessons to be more easily learnt for the benefit of all. The effectiveness of the IMCA Safety Flash system depends on members sharing information and so avoiding repeat incidents. Please consider adding safetyreports@imca-int.com to your internal distribution list for safety alerts or manually submitting information on incidents you consider may be relevant. All information is anonymised or sanitised, as appropriate.

1 Loss of heading control on an FPU during diving operations

2 Implosion of chemical tank

4 Person injured when chain hoist container failed at securing point

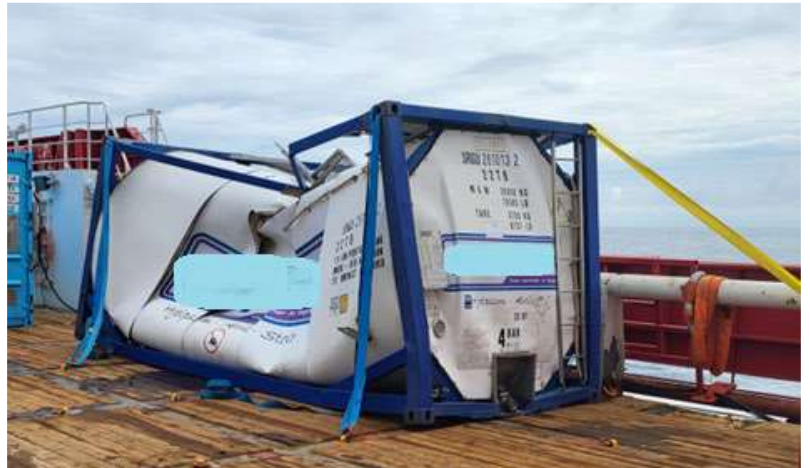
A chemical tank, partly filled with Monoethylene Glycol (MEG), imploded on the back deck of a vessel, resulting in a spillage of around two cubic metres of MEG to the back deck and to sea, and unrepairable damage to the tank itself. There were no injuries. The tank was a 26 cubic metre tank, containing 10 cubic metres of MEG.

The implosion happened due to a vacuum created in the tank because the MEG was pumped out into a storage reservoir on the vessel during a mobilisation.

- A 20 cubic metre tank had been planned for and agreed, but a different and larger type of tank, of 26 cubic metre capacity, was actually delivered;
- The new tank was unfamiliar to the third-party operators and no documentation was available before starting pumping operations. This type of tank requires a manual air inlet valve to be opened on top of the tank, to allow for air inlet and avoid vacuum. Due to lack of knowledge and documentation, this valve was not opened as it should have been, hence creating sufficient vacuum in the tank to cause it to implode five days later.

- Increased focus and follow-up of new suppliers, with specific onboarding arrangements to offshore routines and in-depth familiarisation to scope of work;
- Ensure that operators of equipment are familiarised with equipment specifications and modes of use, including risk assessment and documentation requirements;
- Ensure that Management of Change (MoC) is properly applied when equipment is changed out, also when it involves third-party equipment.

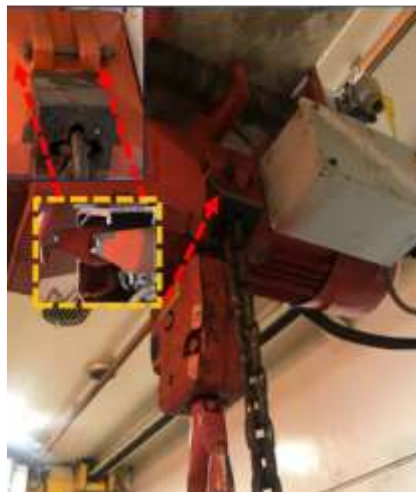
An overhead electric chain hoist container/box weighing approx. 30kg fell around 0.8m onto a crew member. The incident occurred whilst crew were working on adjustment of a heavy clamp used as part of a pipelaying operation. A permanently installed 3.2 Te SWL overhead electrical chain hoist, mounted above on a structural beam, was being used to support the clamp end. One of the securing points of the hoist failed, and the chain hoist container fell onto one of the crew present. It hit the right shoulder/back, causing contusion and bruising.

- An improvement/alteration of the chain hoist container had been carried out locally without proper engineering calculation for the change (the original bag removed and a sheet metal box had been added);
- There was inadequate engineering/design: secondary DROPS retention had not been considered;
- There was inadequate maintenance/inspection: the inspection of exterior container was in the planned maintenance system, but it lacked important detail such as fixing point and wear.

Hoist chain container attachments points

- If you are required to make a change to a component, communicate this change with your supervisor/engineer to ensure the correct method and/or Management of Change is being applied;
- Amend planned maintenance system to include regular inspection of the chain container to ensure hardware (brackets, links, fasteners and other supports) are in good condition and replace any

parts of hoist showing wear or damage – BEFORE using the hoist;

- Check of any similar hoists elsewhere; install secondary retention where required.

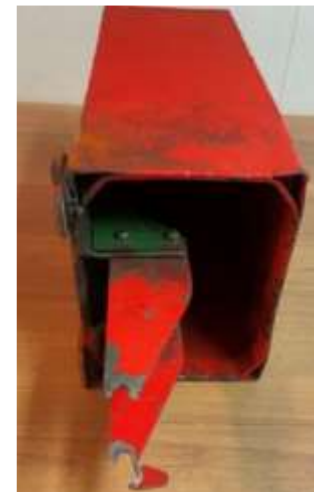
Failed/fatigued attachments points

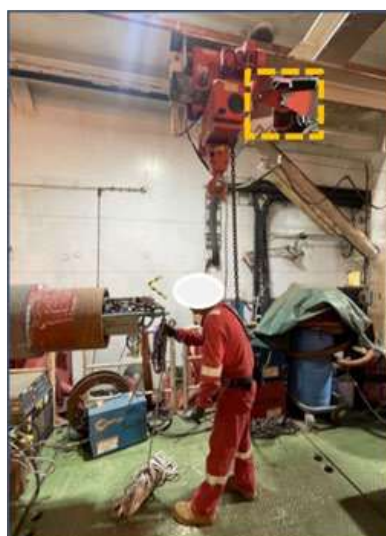
Position of injured person before the event

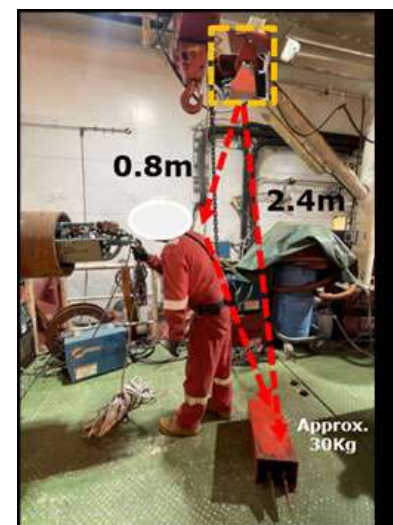
Position of injured person when the chain container box fixings failed and struck him (reconstruction)

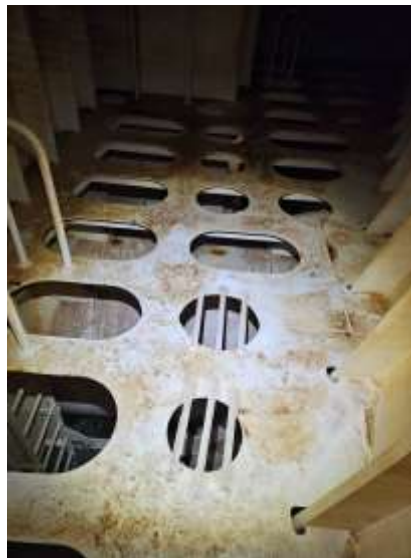
Inside the tank

Our member's investigation noted that the root cause was a slippery surface in the tank due to water pooling from the cleaning operation. The inner surface of the tank was a painted smooth surface, i.e. becoming slippery when wet.

- Review schedule for Fresh Water Tank inspections to see if they are being completed too frequently and exposing crew to risk;
- Review the coating requirements for tank to see if it is feasible to apply non-slip coating to the tanks to prevent slips.
