1 Injuries to the eyes and face

4 MAIB: Crew member injured by rotating crank handle - LTI

5 Near miss: dislodged grating with potential fall to sea

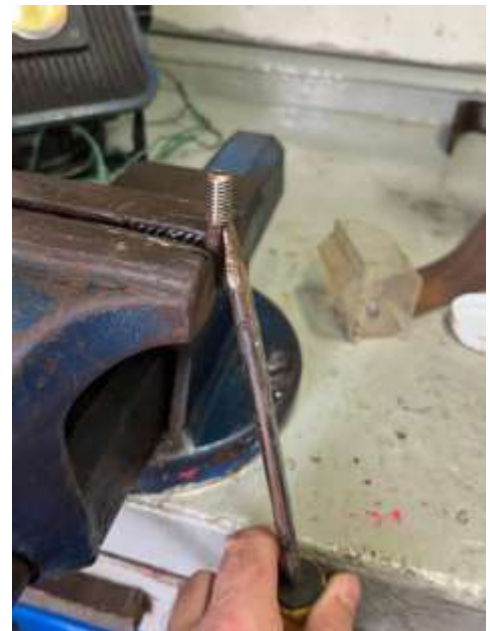
A crew member was using a large screwdriver to pry out a jammed bit from a grub screw. The prying was done upwards; the screwdriver slipped and hit the person in his left cheek. He sustained a 30-40 mm cut, 4-5 mm deep.

The wrong tool was used; the injured person made no ongoing or continuous assessment of the risk involved of the screwdriver slipping.

Just **stop and think for a minute** before applying force to tools that could slip and fly back into your face. Could you get this task done in a different and more safe way? If not - consider your position – have some “spatial awareness”, and wear appropriate PPE.

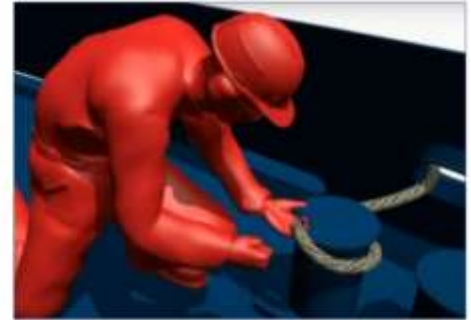
A deckhand injured the fingers on his right hand during mooring operations. The incident occurred when a vessel was headed to the pontoon to moor alongside her regular berth. As the vessels' aft port quarter came alongside the pontoon, the deckhand used the boat hook to pick up the 'in-situ' mooring line and began the process of feeding the spliced eye through the fairlead. He then began placing the line over the bitts, this is where the deckhands' fingers on his right hand became trapped. One finger was seriously injured, and minor injuries to the other two.

- The immediate causes were:
 - There was insufficient slack in the mooring line to allow the task to be completed safely;
 - The vessel was moving forward as the task was performed;
 - Whilst there was a risk assessment in place for the task, including gloves, it did not specifically include impact gloves, nor had an assessment been made on whether they were required;
 - The newest and least experienced deckhand was completing the task and there was only a mooring line with a splice eye available.
- The root cause was seen to be a lack of risk perception.

- The investigation highlighted several corrective actions to be put in place:
 - More thorough Toolbox Talks for mooring arrangements;
 - Review risk assessment for mooring operations;
 - Obtain and try out certain high impact gloves;
 - Review of training and follow up supervision and review of design of vessel mooring arrangements.
- Ensure that sufficient slack is allowed when handling mooring lines;
- Where practicable, vessel should be stopped before mooring lines are placed over bitts, bollards, or cleats;
- Ensure new personnel (persons who are not yet experienced on a particular vessel) are appropriately familiarised;
- The use of single ended lines or the use of small rope extensions on the spliced eyes would avoid exposing fingers and hands to risk.

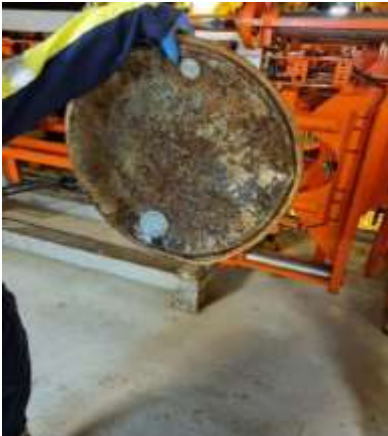
The lid on a waste container barrel blew off due to a build-up of excessive pressure within the waste container, caused by hot ash being deposited inside. The build-up of pressure was observed by a member of the crew, who attempted to gradually open the compression ring on the waste container to allow for a slow and controlled release of pressure. The worker did not foresee the risk involved in this action; due to the pressure within the waste container the lid was forcefully dislodged from the locking clamp, releasing the lid from the waste container and causing it to fall 11m to the main deck below. No other personnel were present in the area during this incident.

Waste container lid

- Hot ash from the vessel incinerator was discharged into the waste container (used for offloading) and the waste container lid was closed immediately;
- Because the ashes of the incinerated waste were not yet cool, there was a build-up of hot gases. Pressure built up within the insufficiently ventilated container, causing it to inflate;
- When the crew member went to release the lid from the container, there was a loss of control and the lid was violently flung off;

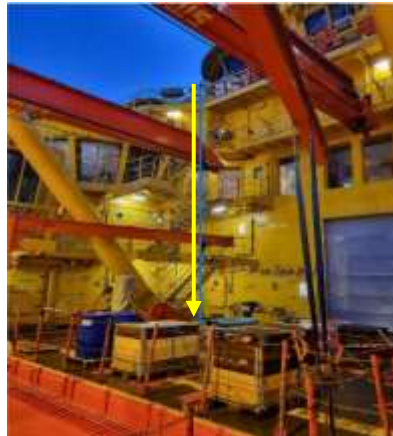
Distance dropped – 11m

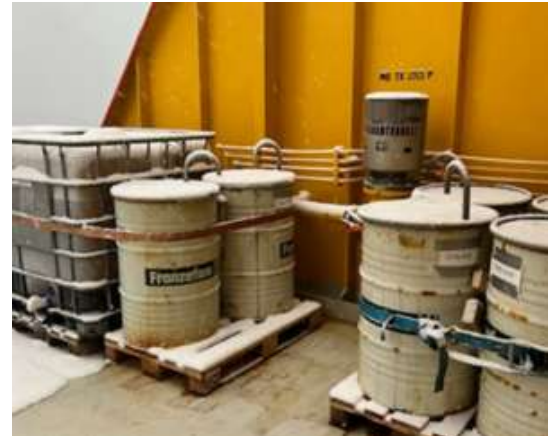
New "goose neck" vents on waste containers (post-event)

- Improvement (a goose neck vent for waste containers) quickly identified and implemented;
- Updates in waste management procedure made, including risk assessment for handling and storage of hot ash.

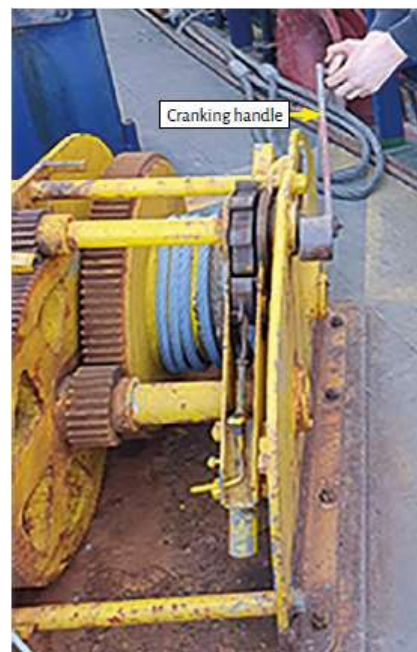
A winch drum, with cranking handle still attached, began to spin uncontrollably. The spinning cranking handle violently struck a crew member, fracturing their wrist. The incident occurred when the crew of a pusher tug were disconnecting lines from a cargo barge. The cargo barge ahead of the pusher tug was made fast with connecting lines that were attached to small manually operated coupling winches on the aft deck of the tug and passed forward to secure the barge.

- The tug's design limited visibility of the aft deck from the wheelhouse – no line of sight - and the Master and crew used handheld radios to communicate;
- The crew failed to follow the vessel's standard operating procedure by not removing the cranking handle.

Coupling winch and removable cranking handle

- Take a moment to undertake a dynamic risk assessment rather than rush to complete the task – **stop and think**;
- The Master could not safely undertake the simultaneous tasks of steering the pusher tug and trying to control the aft deck operations from a position of limited visibility – installing CCTV could help;
- “Task seen as routine” – it can be easy to overlook health and safety responsibilities while undertaking or routine duties. How can we make it easier to work safely, rather than easy to work unsafely?
- Toolbox talks can provide an opportunity to remind those involved of the correct process for the task, why it is important, and how to complete it safely.

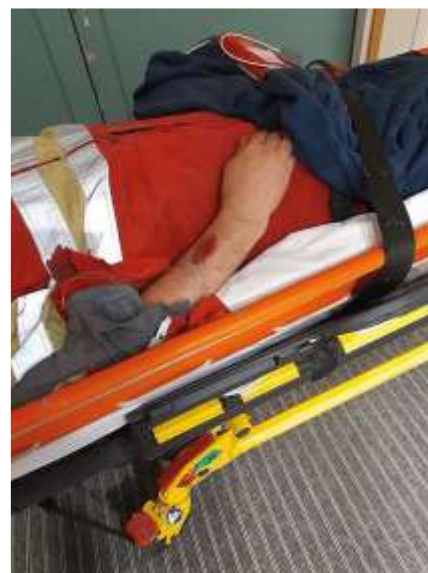
Injured person with fractured wrist

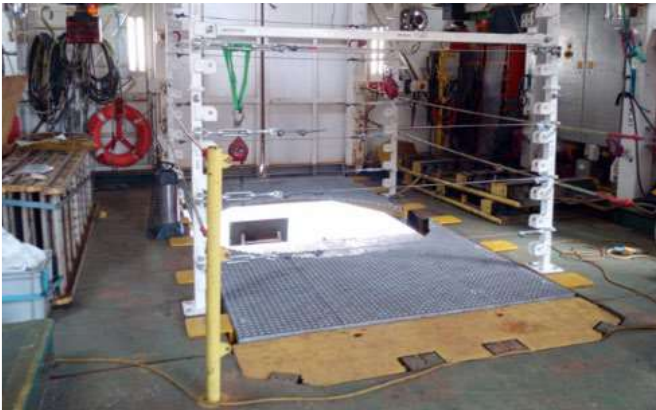
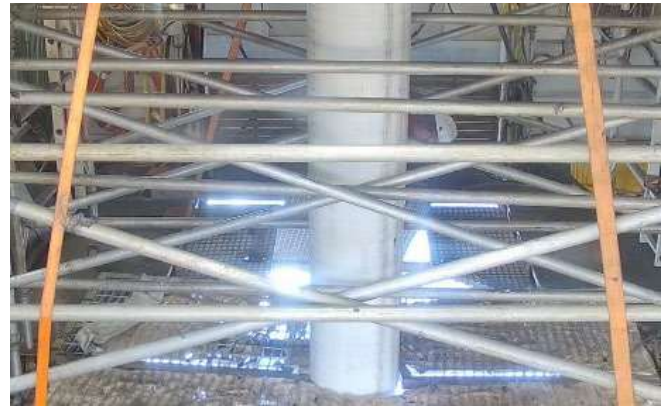
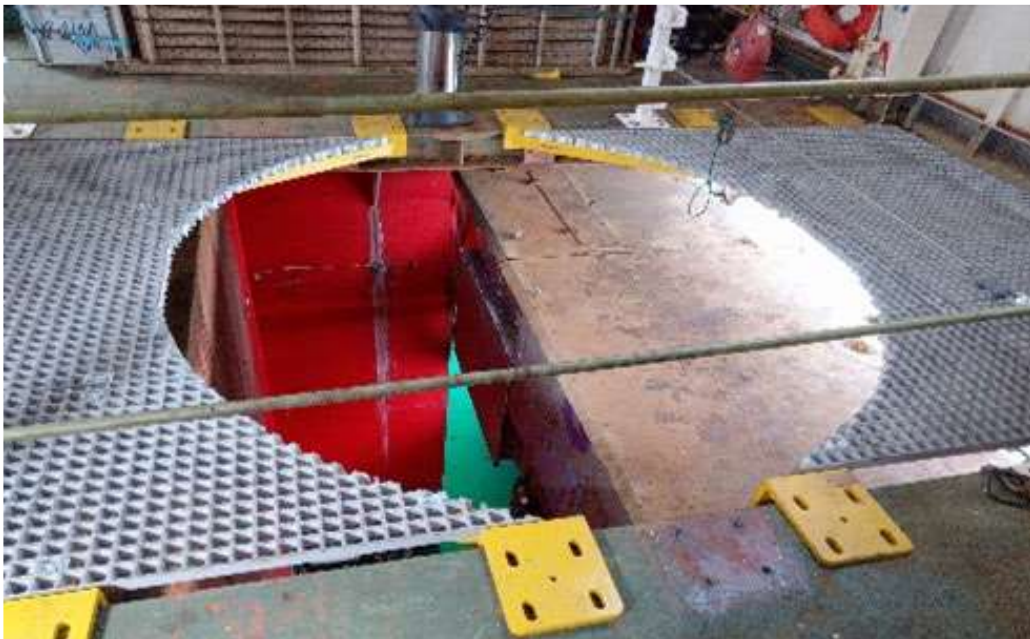
A section of Glass Reinforced Plastic (GRP) grating on a vessel dislodged and dropped to sea. The incident occurred when a welder was on the grating passing a welding hose connection to a level further up, during preparations for work activities. The welder arrested their fall on a support beam and recovered without assistance to a safe position. The failed grating section fell 5.5m to sea and was lost. The welder, who did not suffer any injuries, reported the near miss. Operations nearby were suspended to allow follow up investigation and for the worksite team to complete a full review and "Time Out for Safety".

- The securing clips provided, which should have held the gratings in place, were not spaced correctly nor fixed securely to the framework;
- Two of the securing clips were missed from the original installation design;
- No-one spotted that the grating section was installed with an overhang on one end. As the welder stepped on this area, the forces allowed for the grating to tip and fall to the sea.

- Changes to planned maintenance system for grating and fixings, and amendment of safety checklists for area;
- Added grating to future DROPS surveys, particularly on areas where work on split levels occurs, where the risk of serious personal injury may occur from falls and where potential for significant dropped objects exists;
- Future grating design should follow good practice guidance for load capacity, fastenings and the avoidance of overhangs that may create a cantilever effect;
- Changes to grating should be pre-approved by vessel Captain or Chief Engineer, temporary or permanent modifications should not be performed without approvals.
