1 Dropped lifting beam due to parted soft stop

2 Vessel collided with platform

3 Diver's umbilical trapped during a pipeline flooding operation

4 Stored energy - dislodged pin causes injury

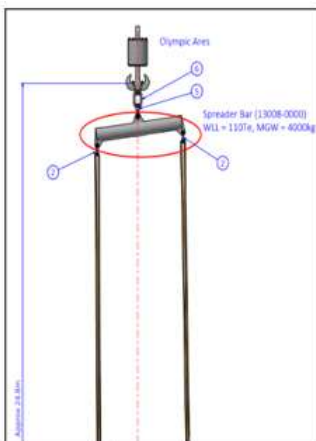
Pic 1: Initial Rigging setup

During lifting operations a lifting beam weighing 4 Te was dropped from 50cm. The incident occurred when the lifting beam was being prepared for relocation for sea fastening prior to transit. A 1 Te stop was doubled through the main lifting pad eye on the lifting beam for the relocation. When the crane started lifting the beam, the soft stop parted, and the beam fell 50cm to deck. The deck crew kept a safe distance from the lift; no-one was injured.

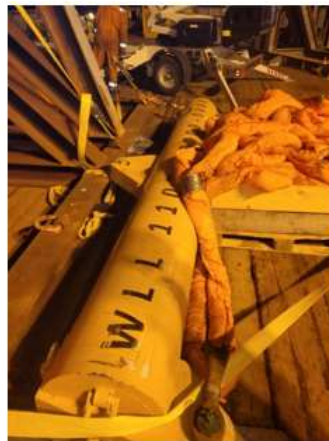
Pic 2: Lifting Beam

- The weight of the lifting beam was not checked before the relocation;
- An unidentified sharp edge on the pad eye in combination with an 1 Te soft stop (lifting a beam weighing 4 Te) caused the soft stop to part.

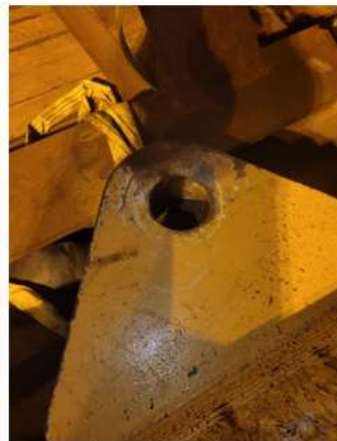
Pic 3: Pad eye

Our member considered that owing to the nature of the unidentified sharp edge on the pad eye, it is likely that even a higher rated soft stop would have also been severed in this operation.

- Never use soft stops against straight / sharp edges;
- Any straight or sharp edges or corners identified should be protected or covered or alternate lifting arrangements identified;

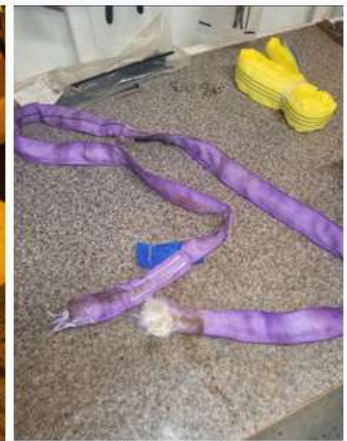
Pic 4: Parted Soft stop

Our member identified as the cause, a failure to properly assess and identify risk.

- Verify the weight of objects before the lift. Always verify that lifting equipment has the capacity to lift the load in hand;
- Be ready to STOP THE JOB if you are unsure about the safest method to be used.

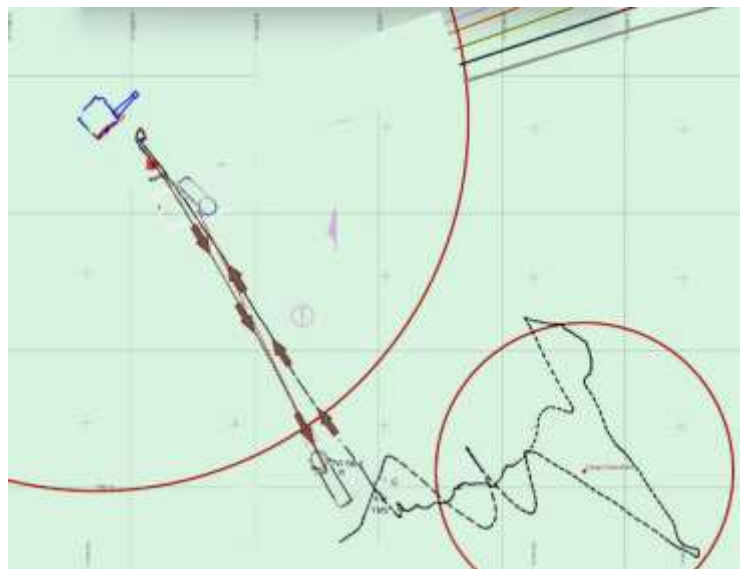
A vessel was waiting on weather when it collided with an unmanned and unlit platform. The vessel had been holding on DP at a fairly constant distance from the platform for about four hours from midnight, but thereafter, started to move towards the platform. The vessel was being driven using “joystick auto heading mode”. The vessel started moving forward and collided with the platform.

Vessel track and the 2 circles plotted on the survey screen.

- Failure to properly monitor the position and speed of the vessel;
- Lack of situational awareness; the vessel was being held approximately 750m from an offshore installation. It was in a blow off position but because of the wind direction, was pointing directly at the platform;
- The Master’s standing orders, night orders and safety management system were not fully followed;
- The second officer, who was officer of the watch (OOW) was engaged in non-watchkeeping duties and had not requested a seaman to assist with the watch keeping.

A contributory factor was that neither radar proximity nor ECDIS alarms were set.

- Updated and reviewed the safety management system to identify ambiguities in wording;
- A daily toolbox talk to be held for watchkeepers with a discussion of the DP mode being used;
- Prevented non-essential personnel from being on the bridge unless necessary;
- Enforced an absolute ban on non-watchkeeping duties unless proper watchkeeping cover is available.

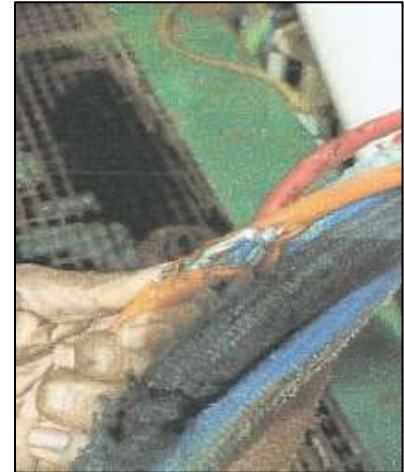
The pulling head of the newly laid line was in close proximity to another pipeline approximately 1.5m off seabed. Local arrangements consisted of a quarter turn valve and diffuser at the pulling head. Shortly after initiating the flooding, Diver 1 reported "All Stop" as the pipeline shifted horizontally by approximately 1.5m. Diver 1 umbilical became trapped between two pipelines resulting in a lost video signal, a restriction of breathing gas and only 1 m of umbilical available for manoeuvring.

Damaged umbilical

- The "as left" condition of the pipeline off the seabed and resting on top of other pipelines.
- The tidal current was pushing umbilicals against an elevated pipeline.
- Movement of the pipeline was due to a shift in weight as a consequence of flooding. When flooding started, the centre of gravity changed causing the pipeline to shift towards the diver;
- The divers' umbilicals were routed over and parallel to the pipes allowing portions to dip into a pinch point area.

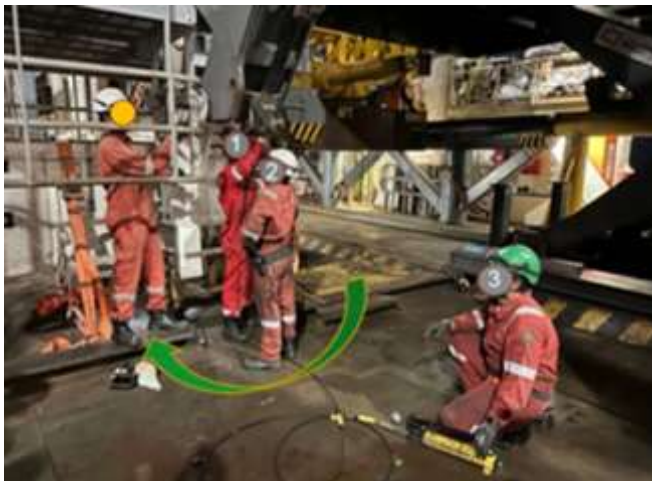
During disconnection of a structure, a securing pin became stuck and could not be removed by hand. A hydraulic jack was employed to eject the pin which resulted in the pin being released under load directly into someone’s face. A team of four persons were removing a structure. This involved the removal of four securing pins, each weighing around 10kg. The task has been done numerous times and was usually accomplished with a hammer and drift. On this occasion, one of the pins became stuck and could not be removed. The work team decided to use a hydraulic jack to force the pin out. Initially this did not work; one of the workers moved directly into the line of fire to obtain better sight of the restriction. The worker tapped on the adjacent plate with a hammer and the pin came loose and ejected with force, hitting the worker in the face. The pin hit the bridge of the person’s safety glasses causing a laceration to the forehead. They were treated onshore and returned to work soon after the incident.

Position of person hit by pin (yellow dot)

- The task risk assessment (TRA) for this task did not consider the use of a hydraulic jack for removal of the pin, nor did the toolbox talk (TBT) before starting work;
- A change was then made during the task (introduction of the jack), but the new risks were not thought through at all. Nobody in the work team thought to intervene and stop the job due to the change in method and equipment;
- During the operation of the jack, one person decided to switch positions to get a better view and to try and release the pin. That person got directly into the line of fire. There was significant stored energy now pushing behind the pin and that risk was not recognised.

- Stop and think – take the time to think things through;
- An engineering solution was proposed to remove the line of fire risk while removing these pins. A proposed design of cages or catchers on each pin was put forward, such that the pins can be controllably released into an area without potential for people to be harmed.

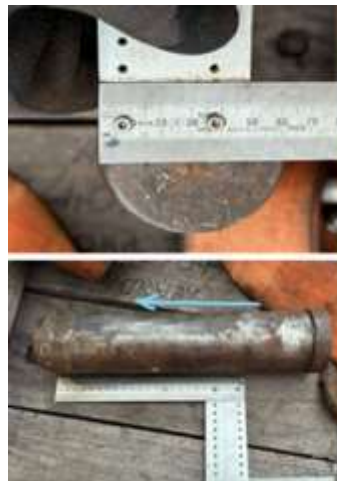
Size and weight of pin

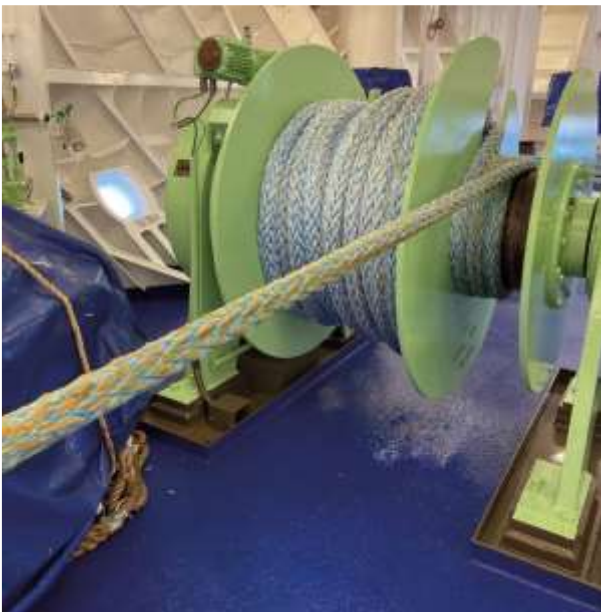
The messenger line suddenly snagged under the mooring rope and became wound onto the winch drum itself. Realising what had happened the injured person let go of the messenger line, but was unaware that it had formed a bight around their right leg. As the bight tightened, the injured person was pulled towards the winch drum and then dragged over it. The winch operator promptly stopped the winch. The injured person was disentangled from the messenger line and immediately taken ashore for medical treatment for a broken shin bone and other leg injuries.

Winch drum

- The long messenger line used to guide the mooring rope was able to reach the deck and wrap itself around the worker's leg, leading to the incident;
- The winch drum operator did not have clear "line of sight" to where the injured person was working.

- Exercise caution around moving machinery – maintain a safe distance;
- Avoid getting too close to rotating equipment and ensure that loose clothing or any objects that can become caught in it are kept clear;
- When operating equipment remotely, it is crucial to have clear visibility of the people and surroundings involved. Whilst remote control allows operators to move around the deck while operating machinery from a safe distance, such as outside snapback zones and clear of suspended loads, it is important to maintain a line of sight to monitor the working area effectively and to be able to communicate with colleagues to prevent incidents and respond promptly to any potential issues.

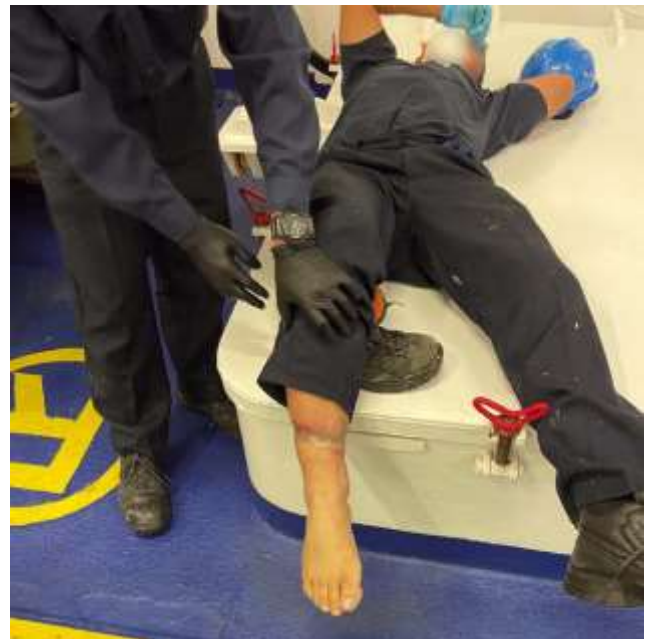
Injured person
