1 Swinging load after loss of position

2 Dropped welding fume extraction hood

3 Carriage of Methanol - Dangerous Goods - without proper certification

4 Personnel exposed to hydrogen sulphide during maintenance

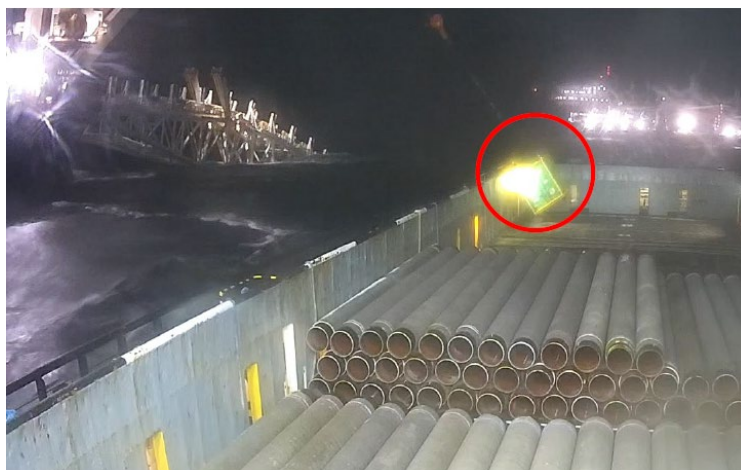
During backloading of an empty refrigerated container to a Pipe Supply Vessel (PSV), adverse weather conditions, combined with technical issues and the effect of high thrust wash, resulted in a loss of position of the PSV and an uncontrolled swinging load. There was no damage to equipment and no-one was harmed.

- Sudden gusts of wind of around 40 knots created high external forces, which resulted in an increased thruster wash towards the PSV, which caused the PSV to lose position;
- The PSV's azimuth thruster lost its running DP signal, contributing to the loss of position;
- The PSV was operating outside its Activity Specific Operation Guidelines (ASOG);
- The operational limits of PSVs operating alongside were not considered in the Activity Specific Operation Guidelines (ASOG);
- No-one stopped the job: the operation wasn't stopped despite alarms indicating the PSV was outside defined operational limits.

Container on deck

- Review any (project specific) ASOG to include vessel to vessel operations and the effect that thruster wash can have on vessels alongside;
- Review and update procedures for the lifting of cargo to/from PSVs to reflect the potential for loss of position;
- Ensure personnel responsible for DP operations review and consider the requirements of the ASOGs and document their review process;

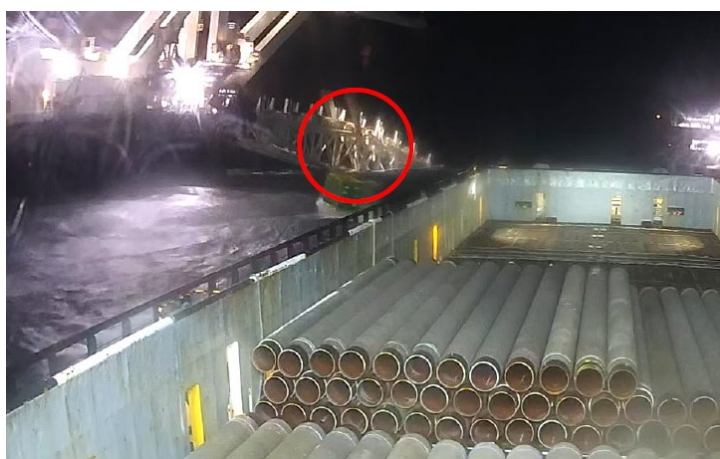
Container swinging

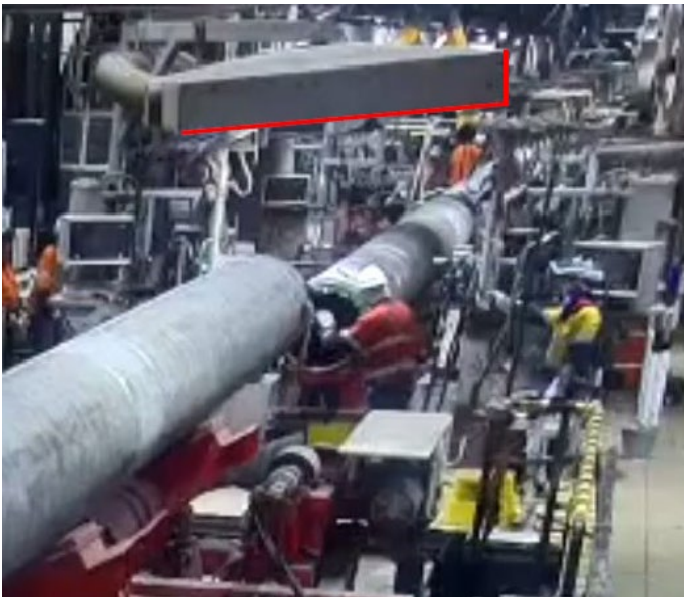
Extraction hood above firing line

- Secondary Securing Method: One M20 bolt running through the beam and the hood.
- The hood was not installed as per the drawings (due to the design being misunderstood), which meant that it was secured ONLY by the secondary securing method – a single M20 bolt running through the beam and the hood;

- A dynamic load was placed upon the single fixing point which allowed the hood to rotate and flex, causing increased stress on the bolt, triggering this to crack and shear, resulting in the hood dropping;

- The hood had not been added to the vessel DROPS register and so had not been included in the annual DROPS surveys, nor inspected, since installation.

- Ensure that in-house modifications are always conducted in accordance with local regulatory requirements, existing company procedures, and that a Management of Change process is followed if modifications are made;

- Have a through inspection of the vessel or worksite looking for potential dropped objects and plan to remove them where applicable;
- Look particularly for any unidentified modifications and ensure DROPS registers are updated as required.

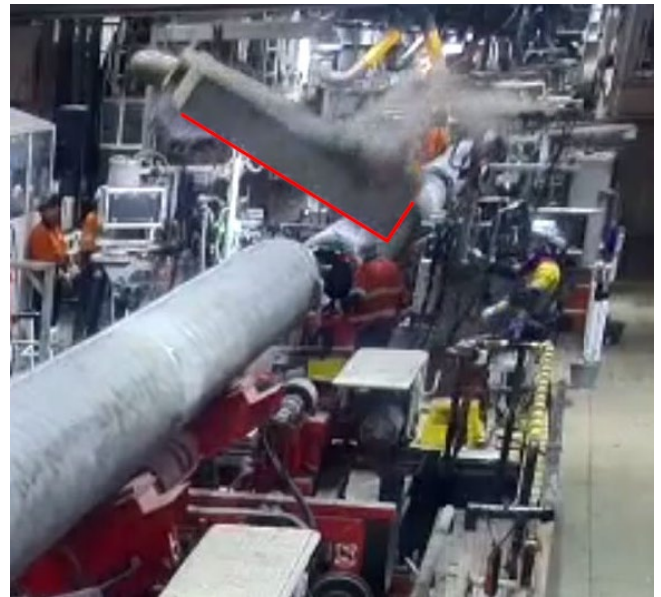
During pipelay activities onboard a vessel, a welding fume extraction hood (which weighed 215kg) fell onto a work station below. A crew member working in the welding station was struck from behind by the extraction hood causing them to fall to the ground. If the person had been struck in a different manner by the extraction hood, this could have resulted in a fatal injury.

Extraction hood falling towards person beneath

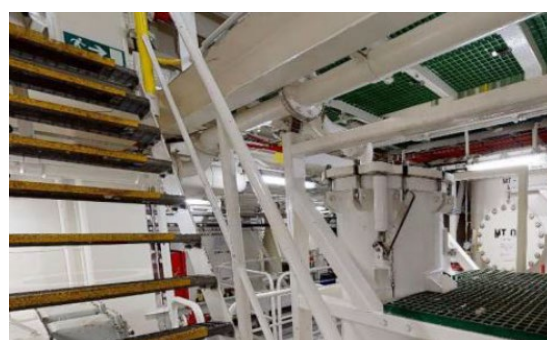
- There was an unexpected pressure release when the vent valve was opened on acid filter unit;
- The "All Stop" did not work as intended – there was further uncontrolled action without appropriate consultation and assessment, and this led to exposure to H₂S.
 - The subcontractor returned to work area after All Stop had been called.

- The system's pressure gauges had been broken for a long time and not fixed or replaced;
- Despite system being flushed and inspected after last project use, low lying water/chemical residue in the system allowed H₂S to form;

Acid filter unit in WTS room

- Be aware of any potential sources of H₂S at your worksite, specifically when working with chemical, sewage or seawater systems;
- Ensure that all personnel who might be involved fully understand the dangers of Hydrogen Sulphide;
- Clearly mark any areas that have been identified as a potential source of H₂S with warning signs;

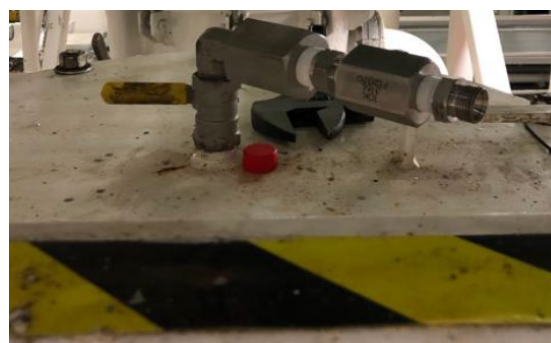
Subcontractor personnel were exposed to a high concentration of Hydrogen sulphide (H₂S) for a short period during maintenance work in a vessel's Well Treatment System (WTS) room. The incident occurred during annual maintenance work being conducted on the system's acid filter units. When the upper vent valve on an acid filter unit was opened, the subcontractor supervisor noted a pressure release from the system and a strong smell. The valve was immediately closed, an "All Stop" called, the extraction fan unit turned on and the team exited the room (no alarms were activated).

Vent valve on top of unit

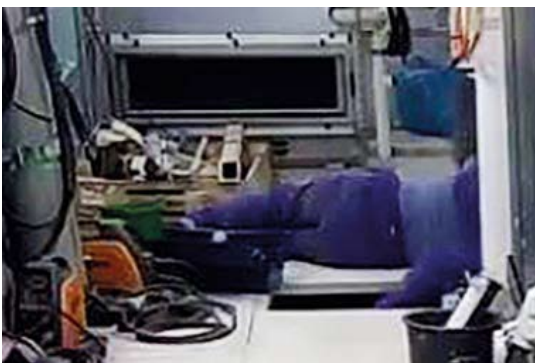
Contractor lying on deck to reach and disconnect mounts

At the same time, the vessel began its scheduled departure in rippled sea conditions with the wind gusting to 30kts. Shortly after leaving the berth the vessel rolled slightly and the compressor tilted from its suspended position, crushing the contractor.

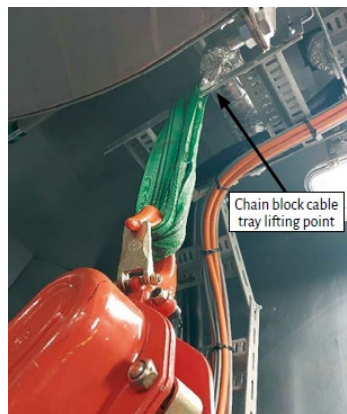
The cable tray lifting point

- Only one of two 980kg working load limit deckhead fixed rings had been used, along with lifting attachment points to a cable tray and a pipe bracket.
- Additionally, the chain blocks used for lifting the aft end of the compressor were hooked on to the chains of other chain blocks.
- The steel bars did not have any spreader arrangements and the wide forklift truck 'lifting slots' allowed movement of the bars.
- The workers
 - Were working under a suspended load;
 - Failed to assess or consider the risks involved of the load shifting when the vessel started moving;
 - Using wholly unsuitable strong points from which to lift a load.

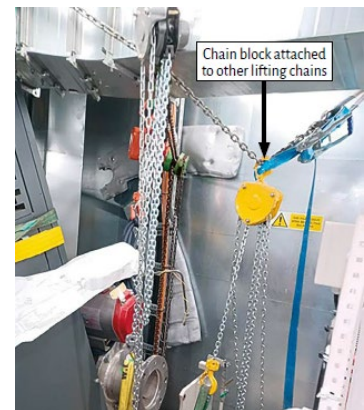
The lifting arrangements

Given the complicated lifting arrangement, and the weight of the compressor, this lift should have been subject to the development of a thorough lifting plan that included input from the vessel's senior officers and shore-based technical staff. This would likely have identified the correct lifting method and equipment, as well as appropriate timing for the lift in respect to the vessel's departure from port and the environmental conditions. Working in isolation, including as part of a team, can incur serious consequences.

- Lifting operations should be properly planned by a competent person under appropriate supervision and carried out in a safe manner – failure to do this nearly resulted in a fatality;
- Ensure you are familiar with the regulatory requirements and any relevant codes of practice or guidance before undertaking any lifting operations.
