List of DP Events

1 Know your vessel capabilities and when to stop!

2 Duty/not duty, which is the question?

3 You've got the ASOG, so now you've got to follow it

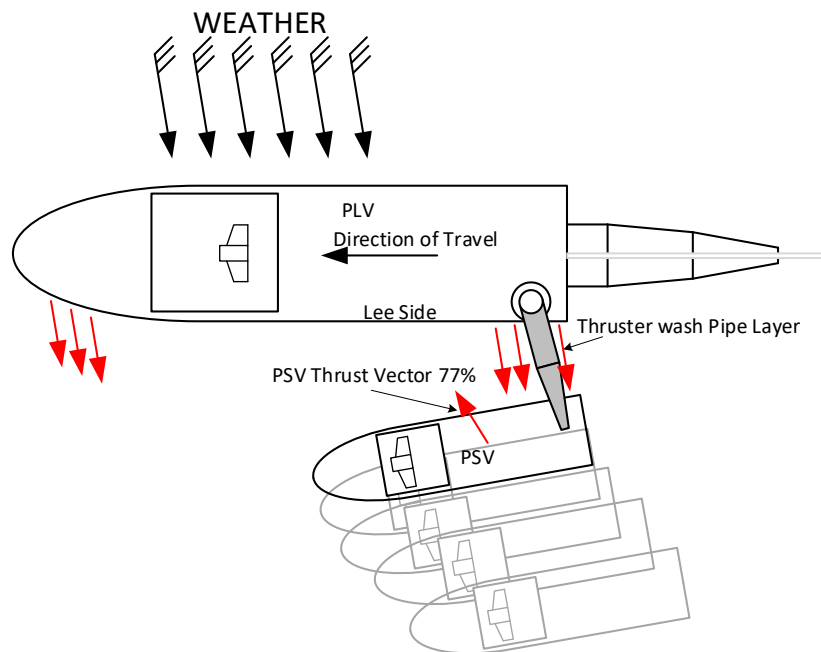
Figure 1 – Force off

A further 15 minutes later, the supply vessel suffered a loss of one thruster, and due to the vessel operating outside of the DP equipment class 2 station keeping capabilities, was forced off position by the high thrust wash of the pipelay vessel.

The Master of the supply vessel immediately informed the pipelay vessel Bridge however there was not enough time to disconnect the load on the hook and a container was dragged from the deck of the supply vessel and into the water, as the supply vessel was forced off position. Fortunately, there was no damage to equipment, and no-one was harmed.

- ◆ Sudden gusts of wind of around 40 knots created an increased wind load on the pipe layer, causing an increased thruster wash towards the PSV which caused the PSV to lose position.
- ◆ The failure of the PSV's azimuth thruster contributed to the loss of position.
- ◆ The operational limits of PSVs operating alongside other vessels were not considered in the Activity Specific Operating Guidelines (ASOG).
- ◆ No-one stopped the job: the operation was not stopped despite alarms indicating the PSV was outside defined operational limits.

The PSV was clearly operating outside of the vessel's environmental capabilities and there was no ASOG written for ship to ship cargo operations. The ASOG set out the operational, environmental and equipment performance limits necessary for safe Dynamic Positioning (DP) operations while carrying out a specific activity. Reference IMCA M220 *Guidance on operational planning*.

With clear operating procedures in place the Master or DPOs have the confidence to stand up and say “No, stop the job” when their vessel reaches the operating limits.

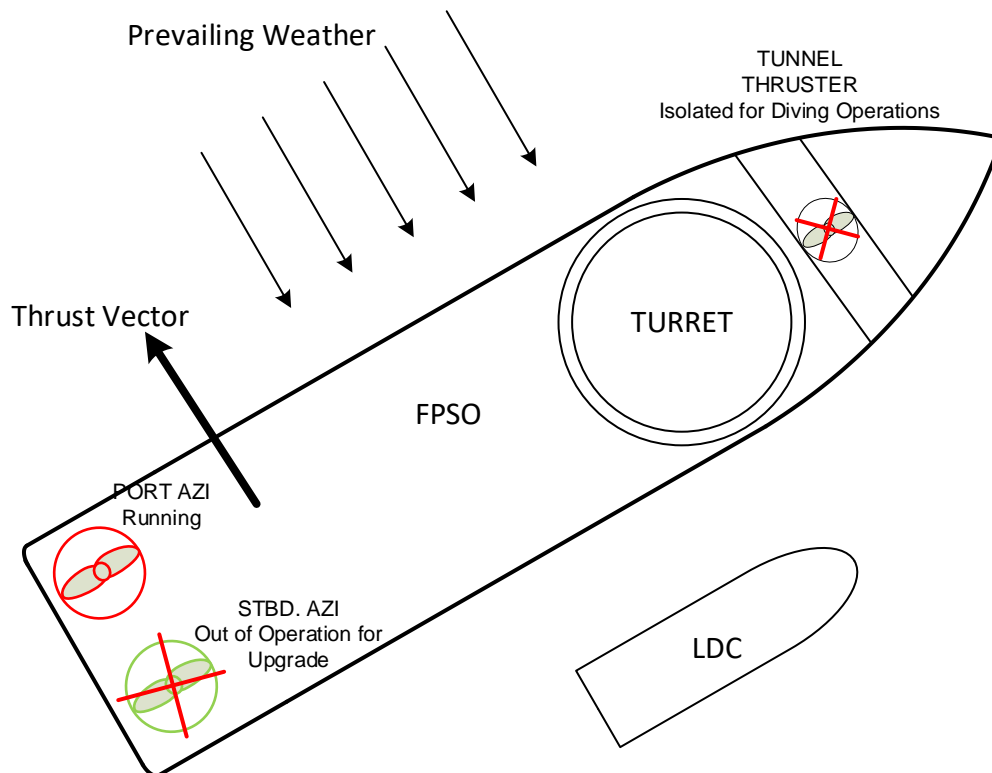
Figure 2 – Setup prior to loss

The engineer went down to the local controls of the port azimuth thruster, the steering pump that was due to be greased was running and set up as the duty pump, so the engineer switched the control over to place pump 1 as lead steering pump. As he switched the duty pump over pump 2 stopped and pump 1 started, as per the logic; however, the pressure dropped after stopping the running steering pump and the low-pressure alarm did not clear within the time limit set in the logic. The system shut down running pump 1 as a protective measure, leaving the port azimuth thruster with no steering. Pump 2 did not auto-start.

With no steering control of the port azimuth thruster, and no other thrusters operational, the heading of the FPSO could not be maintained.

- ◆ The quick response of the CCR to notify the LDC meant for a swift recovery of the divers to the craft with no incident; however, at the time of the event the CCR were not actually aware of whether the divers were in the water or onboard the LDC.
- ◆ The CCR did not relay the entire severity of the incident. No alarm was raised onboard the vessel.
- ◆ Due to the routine nature of the planned maintenance, insufficient risk assessment had been conducted. There was no consideration for if a failure were to occur and how this would affect the heading control.
- ◆ A thorough risk assessment of the diving operations had not been considered, including emergency preparedness.

No redundancy was in place on the FPSO during critical operations.

Prior to diving operations, a thorough risk assessment and clear toolbox talk should be undertaken with all parties and all shifts involved. Maintenance on critical equipment must be risk assessed to ensure whether safe to proceed. If in doubt, wait!

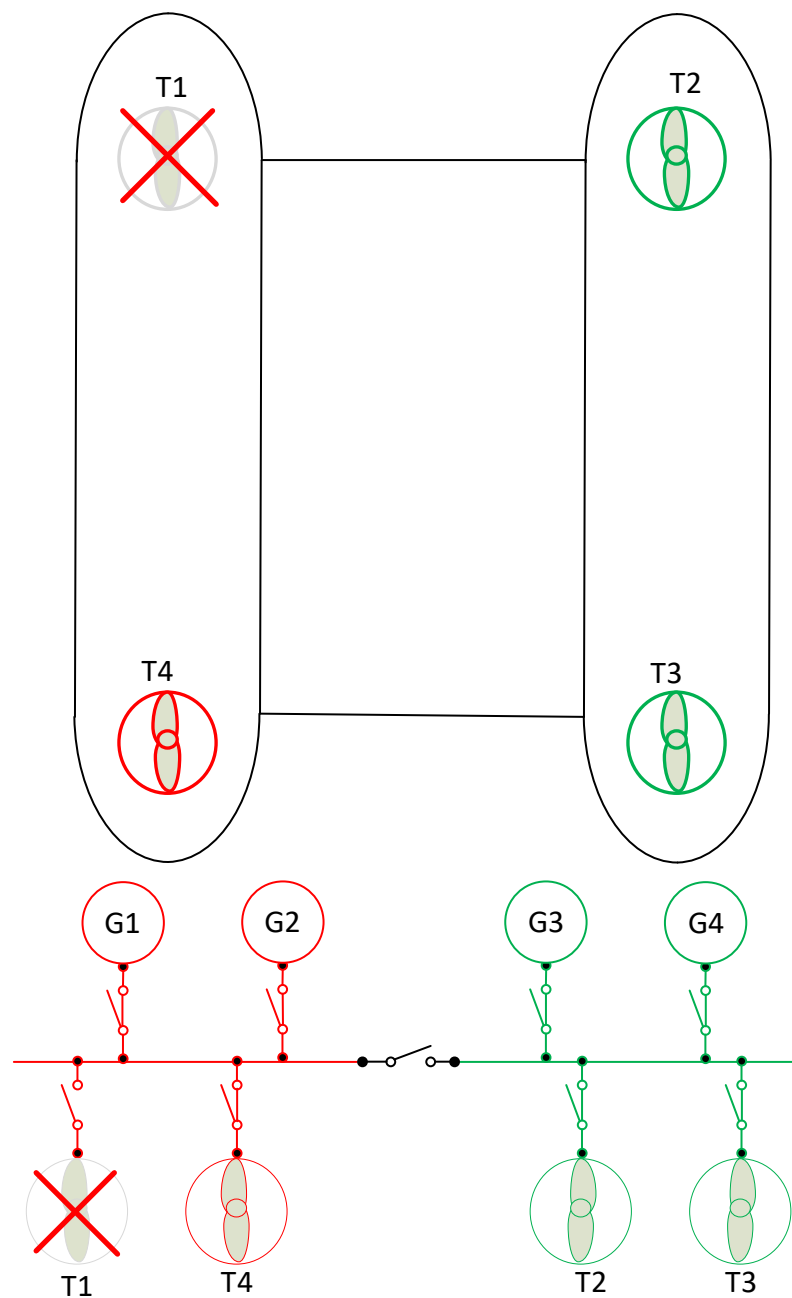
Figure 3 – Simplified power & thruster allocation

There had been reports of noise and heavy vibrations coming from a sea water cooling pump, allocated to Thruster No.1, therefore the engineers requested the DPOs to deselect and stop Thruster No.1 from the DP system, so investigations could be carried out. The DPOs agreed to the request, reducing the available thruster capacity on the portside to 50%.

Approximately half an hour later, a blackout on the starboard power system resulted in the loss of Thruster Nos. 2 and 3.

- ◆ The failure of Thruster 1 sea water cooling pump was due to shaft bearing damage.
- ◆ Blackout of the starboard power system was due to the malfunction of a running diesel generator control module; this produced an incorrect signal to the AVR and consequently affected both connected diesel generators.
- ◆ ASOG had not been adhered to during operation inside 500m zone. Any loss/failures of any DP related equipment should trigger yellow status and all parties should be informed.

When the DPOs shut down Thruster No.1 this caused the vessel to lose required redundancy. The vessel continued to operate alongside the asset, without relaying the reduced status to all parties and was actually operating outside of its post worst case failure DP capability. It was no longer single fault tolerant and therefore not DP Class 2 compliant.

The Master should have ceased operations and exited the 500m zone, in accordance with the approved ASOG.

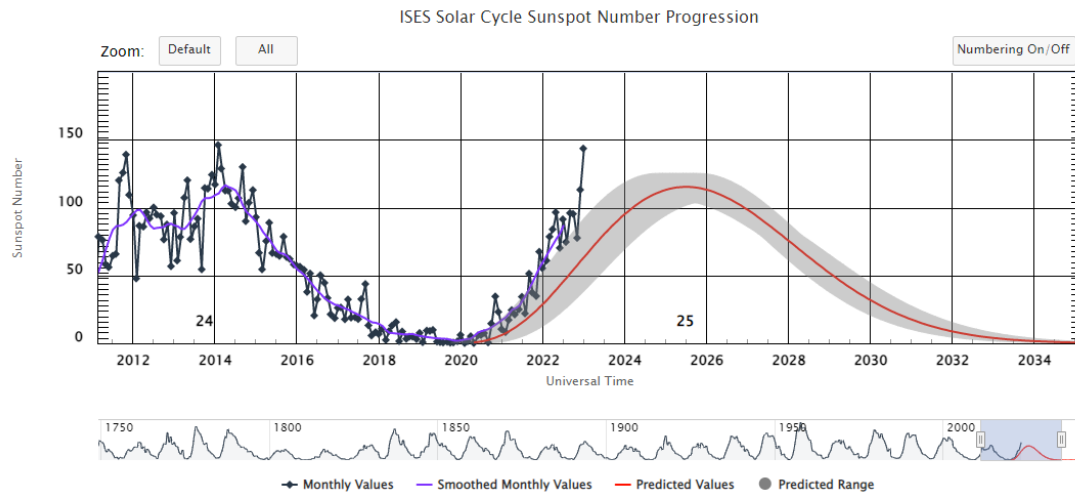
Figure 4 – Predicted Sunspot Activity

Following the most recent DP incident, the OEM of GNSS 1 & 2 were contacted and solar interference was again confirmed as the problem for the dropouts and that many other vessels operating in the same area were also experiencing technical problems.

We are currently in the 25th solar cycle and are approaching its peak, which is expected to occur between 2025 and 2028, this is when the interference to our technologies will be at their highest.

Follow the manufacturers' advice on updates of hardware, firmware or software that are designed to aid through these increased solar activity periods.
