1 ROV dropped to seabed

2 UK HSE: Service lifts on offshore and onshore wind turbines

3 Dropped halogen lamp caused small fire

4 MAIB: Man overboard – unguarded opening

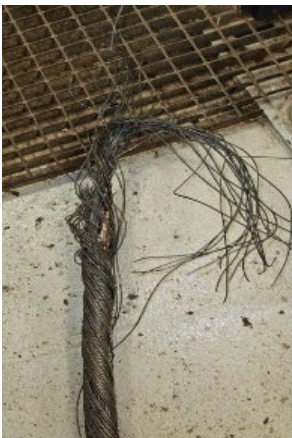
During recovery of an ROV system, the ROV TMS (Tether Management System) experienced a problem latching to the LARS (Launch and Recovery System). The umbilical was damaged directly above the Docking Bullet on the TMS, and was then sheared by the A-Frame docking head latch mechanism. The ROV then dropped into the sea and subsequently landed on the seafloor in a safe zone.

Umbilical Winch End

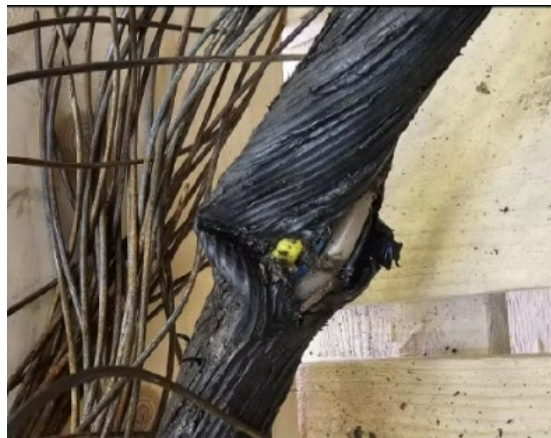
Umbilical Breaking Point

- An excessive amount of cold and dirty grease was in the latch mechanism which resulted in a slower than expected latching motion;
- The operator of the LARS system could not see the mechanical locked position indicator before releasing the umbilical tension, which resulted in a failed latch attempt. After repeated attempts to dock and lock, the umbilical separated with the result that the ROV fell into the sea and dropped to the seafloor.

- The latch mechanism was not cleaned and lubricated to OEM specifications;
- The LARS procedure specific to the installation was not followed;
- Supervision did not verify the correct maintenance plan nor the LARS procedure before work started.

- The latch design can damage an umbilical if it functions improperly and operates incorrectly;
- The company took the following actions
 - Restored latch functionality to normal by cleaning and lubricating, then verifying, the components function per OEM specifications;
 - Reiterated that crew should follow the LARS procedure for the specific ROV system onboard;
 - Ensured that supervisors verify that the correct maintenance plan and LARS procedure is available and is used for the specific ROV system onboard.

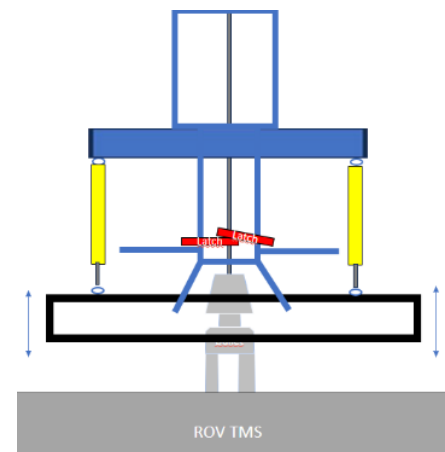
Sketch of Latches in Abnormal Position

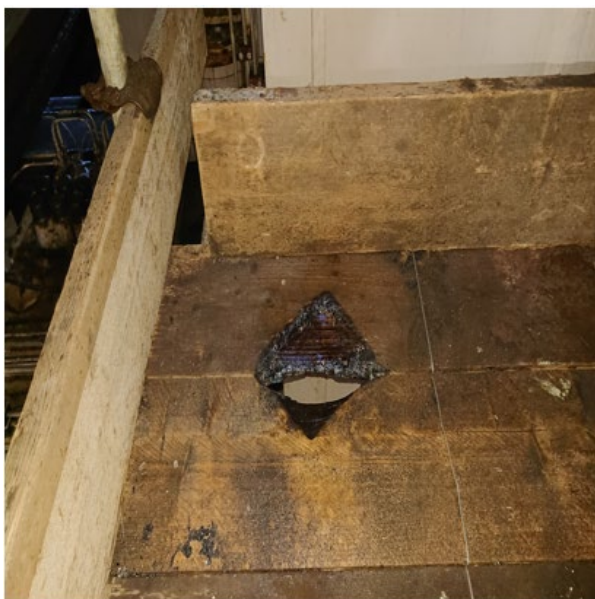
During painting work taking place on a vessel during the hours of darkness, a halogen lamp fell from a scaffolding where the work was taking place, causing a small fire in a scaffold board below. Motormen and deck mechanics promptly responded, adhering to the appropriate emergency protocols, and the fire was extinguished easily. There were no injuries, but the lamp was destroyed and the scaffold board damaged.

Damaged scaffold board

- Was this lamp fit for the job? Consider the use of LED lamps;
- Shut down all equipment before taking a break, or ensure a watch is kept over running equipment;
- Ensure installed equipment is stable and safe before starting work, and also after returning from a break;
- Remain aware of weather conditions and what is going on around you when working.

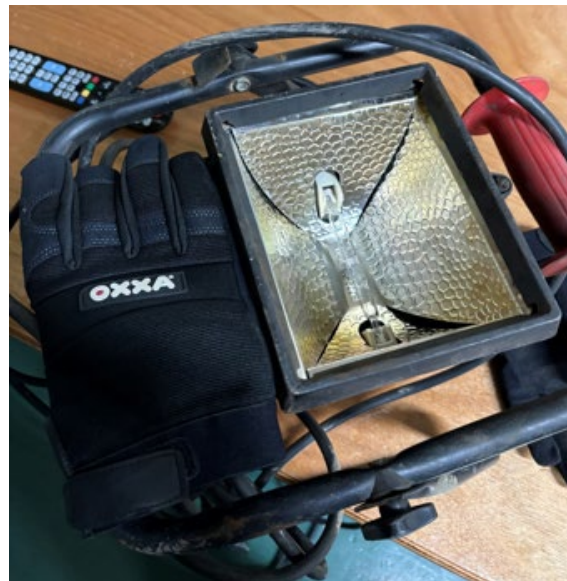
Halogen lamp that fell

- Our member’s root cause analysis discerned that the lamp was blown over by gusts of wind. It was placed in an open environment, exposing it to the weather conditions;
- There was a lack of proper supervision of the halogen lamp during the breaktime absence.

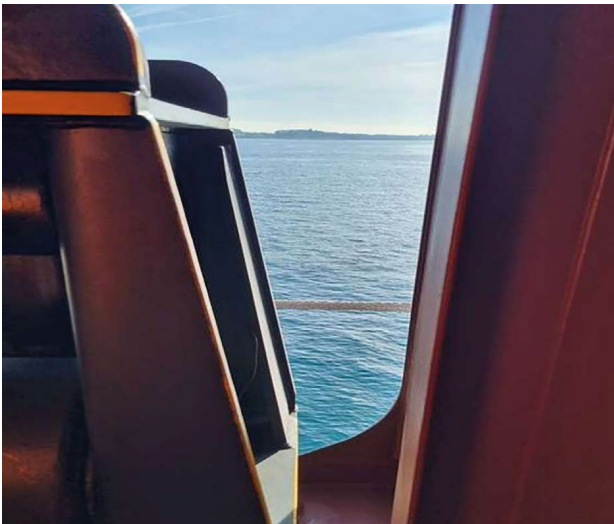
The unguarded opening at the time of the incident

- The opening was unguarded – there was nothing to stop anyone falling through it. Whilst with hindsight, after someone fell through it, it was obvious, the unguarded opening was not spotted when the vessel was designed nor during daily operations or previous surveys and audits;
- The action of swinging a heaving line to pass it around the structural pillar had been performed many times without incident, but on this occasion the momentum of swinging the line caused the crew member to overbalance and fall.

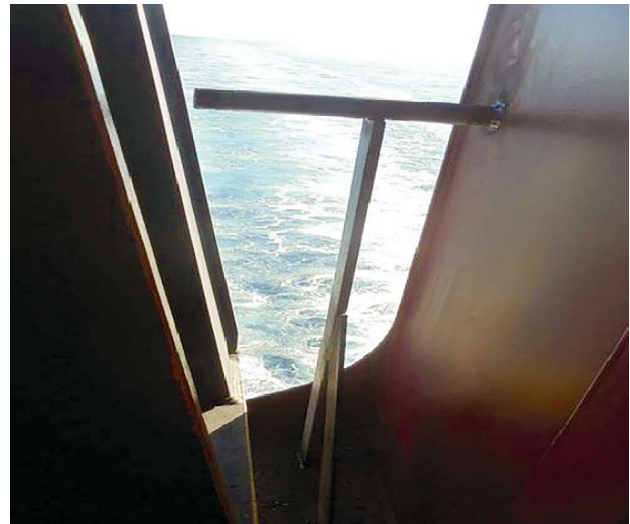
The guarded opening following remedial action

- The company required each vessel to undertake an immediate mooring area hazard assessment to prevent similar incidents in the future;
- The company took immediate action to guard the opening – there was swift remedial action to fabricate and install a railing and support to mitigate the risk.

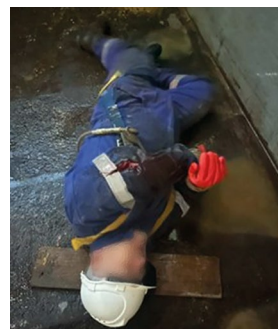
A crew person was working on a bulkhead locking bolt at the forward end of a hold on a cargo vessel and slipped and fell to the bottom of the hold, resulting in an open fracture to the upper arm. The incident occurred after dark in rainy conditions. Wearing a safety harness with a lanyard and safety hook, the crew person used the recessed footholds in the side of the cargo hold to climb about 2.5m to access one of the bulkhead locking bolts, and attached the safety hook. The crew person was unable to reach the locking bolt and, using one hand to hold on, disconnected the safety hook and attempted to move it to another position. But instead, they slipped from the foothold and their hand slipped from the single handhold before the safety hook could be attached to a securing point, causing the fall.

Injured person
