1 Loss of pressure to diver's primary air supply

2 Equipment fell on someone's leg causing injury

3 Electric shock after water ingress to switch

4 Emergency musters and drills

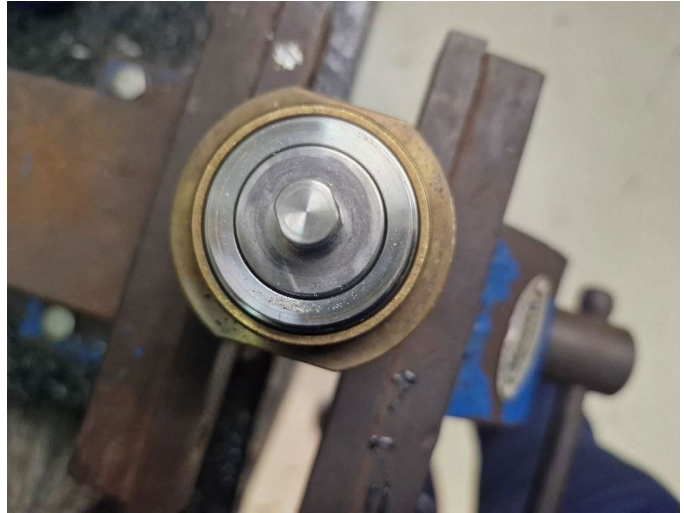
A diver working underwater experienced a pressure drop from the primary HP supply regulator. The diver was recovered safely, and tests were subsequently carried out on the surface, and the same pressure loss was observed. The regulator was removed from the panel, stripped, and inspected. During the removal of the sensing assembly, old/dry lubricant was observed on the bottom end. The sensing assembly was checked by moving the shaft up and down simulating what would occur within the regulator during use. Friction between the shaft and the sealing face was evident, as it would not move as freely during the up and down movements through the sealing face due to the dry lubricant.

The internal lubricating grease had dried and was no longer providing lubrication, rather it acted to restrict the movement of the machined parts.

Regulator Body Removed

- Action taken:
 - Increased planned maintenance schedule frequency for checks, test and cleaning of seal kits, sensors and panel regulators to every 6 months;
 - Tested and cleaned all other regulators on the panel and gas racks flow tested and cleaned, and changed planned maintenance schedule to every 6 months;
 - Keep careful records of lubricant identification and batch number;
 - Ordered newly updated sensors and more seal kits with new and more sensitive sensors;
 - Liaise regularly with manufacturer for any information on new types or upgrades that may be available.

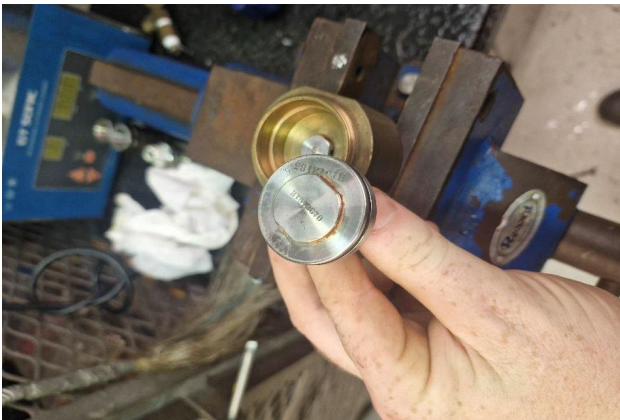
Top of Sensing Element/Diaphragm

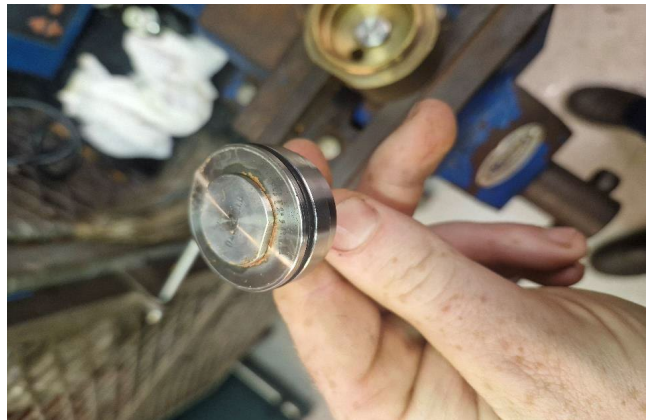
Bottom end of Sensing Element/Diaphragm

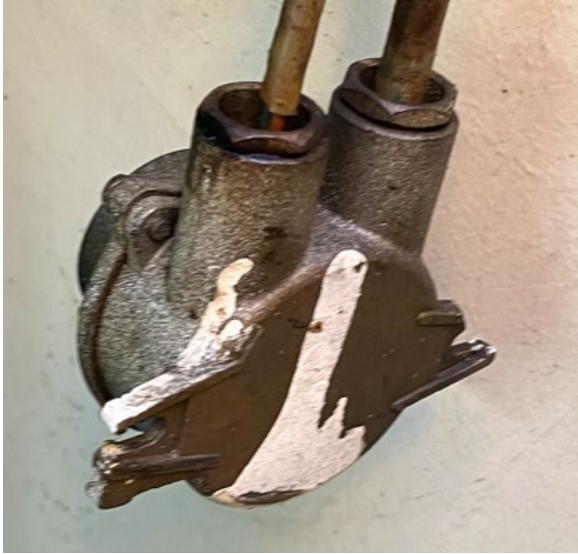
A shore representative visiting the vessel experienced an electric shock after touching an electrical switch in the steering room. Stop the Work authority was exercised; the electrical switch was immediately isolated and subsequently removed for investigation.

- The switch had been removed from the wall, but not re-installed, during maintenance;
- There had subsequently been engine room washing following major repairs, and the water ingress arose at that time;

Appearance of electrical switch to visitor

- Ensure maintenance work is fully completed before returning equipment or systems to service;
- Arrange appropriate isolation and protection of electrical connections and switches during any washing or cleaning of an area;
- Ensure all parts of the vessel electrical systems and equipment are regularly inspected and tested by a Competent Person and the results recorded in the Planned Maintenance System.

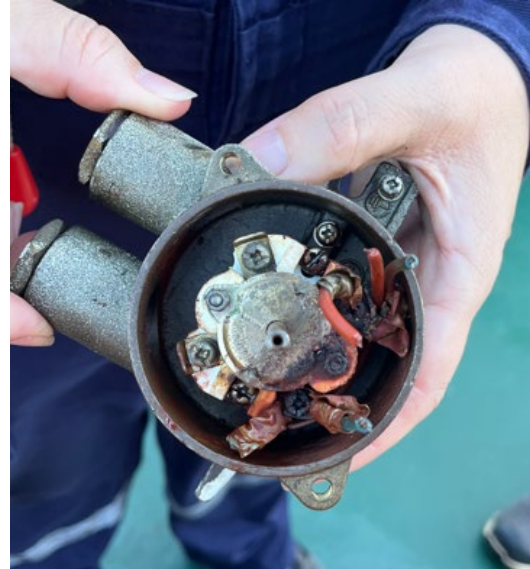
- The switch had been unprotected and remained live, not isolated, during the engine room washing.

Electrical switch showing clear sign of water ingress

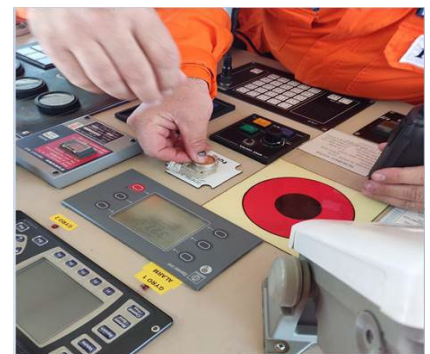
During an emergency drill, it was found that the General Emergency alarm on the bridge was delayed whilst being activated.

Further investigation revealed that dedicated Emergency button was stuck, and it failed to perform its function in a timely way during the drill.

- Check: could your emergency alarm buttons be stuck or seized? When was the last time anyone actually pressed the fire alarm button?

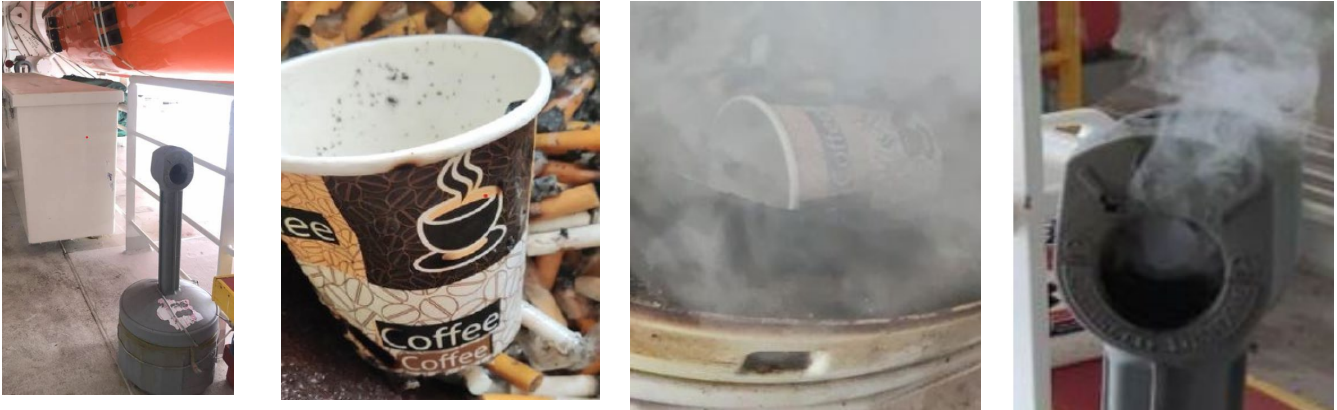
A fire alarm was set off on the port side muster station where there was a smoking area. An AB and the 2nd Mate were sent to investigate what was going on. On arrival at the muster station there was dense smoke coming from the ashtray stand. The ashtray was opened, and a smouldering paper cup was found, along with recently discarded cigarette butts.

The smoker had, instead of bringing the cup to the dedicated waste bin which is just 10 metres away, just opened the standing ashtray and dumped the paper cup together with the still burning cigarette butt and closed it. This action caused smouldering and a small fire and could have developed into a much more serious situation.

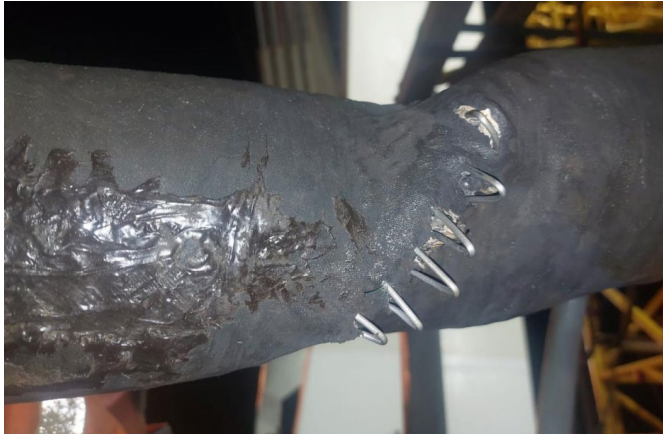
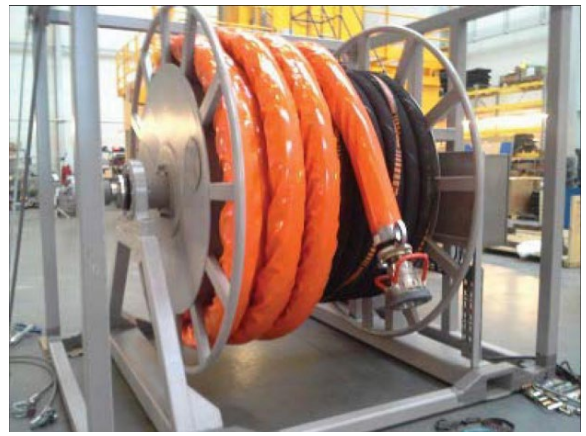
During offshore bunkering operations, the bunker hose was damaged when it was stretched. A vessel passed the bunker hose to the supply vessel using the crane. The crew of the supply vessel received the bunker hose and tied it off. The crew then noticed possible damage to the bunker hose. The hose was returned and upon inspection it was seen that the outer layer of the bunker hose was damaged. Bunkering was cancelled. The potential further consequences were a possible spill to the environment and delay in operations.

- Both vessels experienced moderate pitching and rolling due to sea conditions;
- The bunker hose was tied off to the supply vessel aft bollard while still connected to the crane on our members' vessel;
- Due to both vessels moving in different directions, and the crane being unable to keep up with lowering or raising the hose in these conditions, the hose was stretched and damaged.

- Reviewed risk assessment for this task to identify risk of tying off bunker hose whilst still connected to the crane;
- Ensure that that standing orders for bridge communications include any special conditions between vessels – including not to tie off the bunker hose when connected to the vessel crane, if this can be avoided.
