IMCA Safety Flashes summarise key safety matters and incidents, allowing lessons to be more easily learnt for the benefit of all. The effectiveness of the IMCA Safety Flash system depends on members sharing information and so avoiding repeat incidents. Please consider adding safetyreports@imca-int.com to your internal distribution list for safety alerts or manually submitting information on incidents you consider may be relevant. All information is anonymised or sanitised, as appropriate.

1 Side scuttle (porthole) knocked out by wave impact

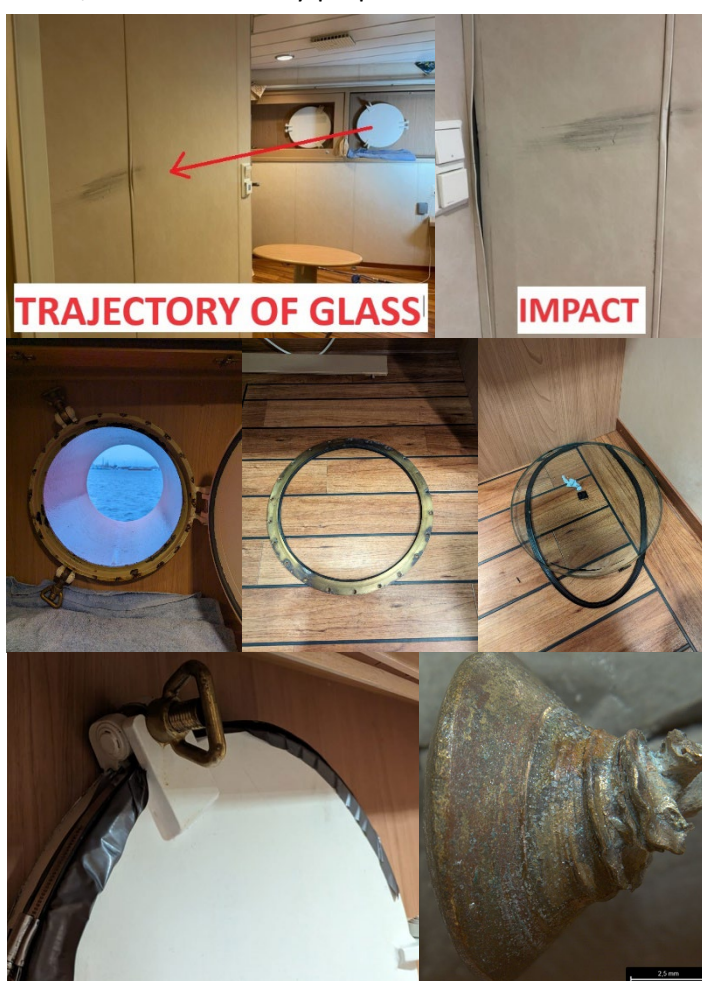
While a platform supply vessel was on passage through heavy seas, a large wave hit the vessel and a side scuttle (porthole) in one of the cabins broke loose from its frame, and was violently propelled across the cabin. A crew member sleeping in the cabin at the time was awakened by the impact and ingress of cold water. Personal effects were destroyed and significant repairs were required to the cabin and the scuttle.

Our member notes that under slightly different circumstances the incident could easily have been a fatality, had someone been in the line of fire of the glass pane, frame, and screw heads. The weight of the glass pane was over 6kg and it was projected over 3m by the pressure of air and water.

- The vessel was hit by what was considered to be an extra large wave. Conditions at the time Beaufort gale force 8 from the south, seas 2.5m-4m. The vessel was steaming 138° at about 6 knots. Our member noted *“wind direction, wind wave direction and swell direction being almost 90 degrees apart, it is not unlikely that a joining of wave energy might have formed hitting the vessel at a worst-case angle to starboard bow and scuttle.”*
- With water and air pushing into recess and pipe of the scuttle, all 22 screws sheared simultaneously, and the pressure built up sent the glass, glass retainer ring and screw heads across the cabin;
- When glass and glass retainer ring broke loose, there was nothing for the deadlight to seal against and duct tape had to be used for temporary weatherproofing;

- There had been previous maintenance of some scuttles following slight leakage, but nothing on record for the one that failed in this incident. It is however possible that at some point, someone with good intentions has taken upon themselves to tighten up the screws if observing minor leaks or drops. With specified max torque for brass screws per maker advice being 4N, there is not much force needed before the screws become overtightened.

Following detailed metallurgical investigation of failed screws/bolts, it was felt that the cause the incident was that the 22 screws holding the glass and glass frame did not have adequate strength to withstand the force of the wave that hit the way it did. The screws provided were poorly manufactured and had been overtightened during installation or during service life.

- Checked all other scuttle glass holder screws;
- Overhauled all scuttles during next dry dock which was scheduled a few months after the incident;
- Detailed discussions with metallurgists relating to metal screws;
- Discussions with both the supplier of the scuttle and the original designer of the vessel;
- Amended procedure for required use of cabin deadlights in heavy weather;
- Added signage to discourage overtightening screws of the glass retainer ring.

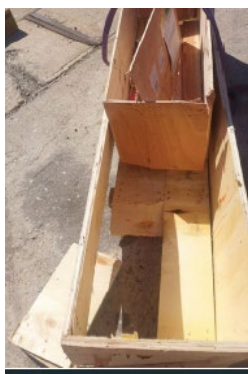
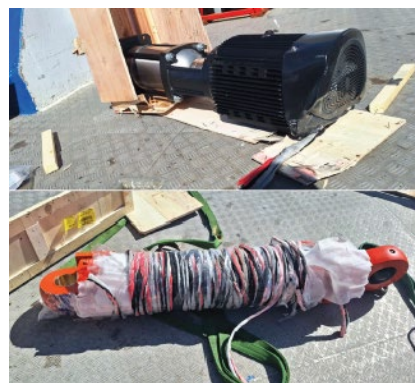
Condition of the cargo box before and after the incident

Pump and hydraulic ram dropped

- The cargo was not prepared properly: the wooden box in which the hydraulic ram was stored did not contain any support or cargo securing structure; the hydraulic ram was loose and could slide around the box due to inertia and the lack of support;
- The two boxes were placed onto the pallet but were not secured by any means as strapping or shrink-wrapped to the pallet. This allowed the boxes to move more freely around the pallet surface and change the balance and centre of gravity of the load;
- The pallet was loaded with two wooden boxes, one with the ram that weighted 365 kgs and the other box contained a pump weighed 93 kgs, so the pallet was unbalanced;
- There were several gusts of wind during the operation that could have swayed the load during lifting.

- Only trained and certified vessel crew should be involved in lifting operations;
- Cargo delivered to the vessel should be visually inspected by competent personnel to assess their condition before lifting. Any doubts as to their integrity should be reported to the vessel master and client as required, and the cargo rejected until safety is confirmed;
- Wooden pallets are not designed to be lifted. Pallets do not have a safe working load and slings can cause the pallet to fail regardless of the type;
- Cargo should be properly secured and that securing should be assessed by competent personnel before the lift starts;
- Check the weather, particularly the wind, before and during lifting operations.

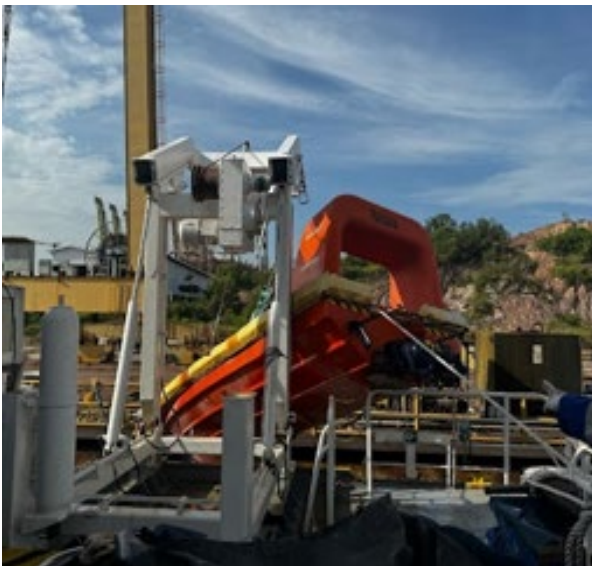
FRC close to dropping

- In the initial stages of the launch the FRC was still lashed down, causing the forward part of the FRC to collide with a railing while the stern became stuck;

- Risk Assessment: Include comprehensive checks for mechanical and hydraulic systems before launching the FRC;
- Communication: Maintain clear and consistent communication channels between the officer in charge, engineers, and crew members;
- Procedures: Develop and implement detailed procedures for the launch and retrieval of the FRC, ensuring all crew members are trained and aware of their roles.

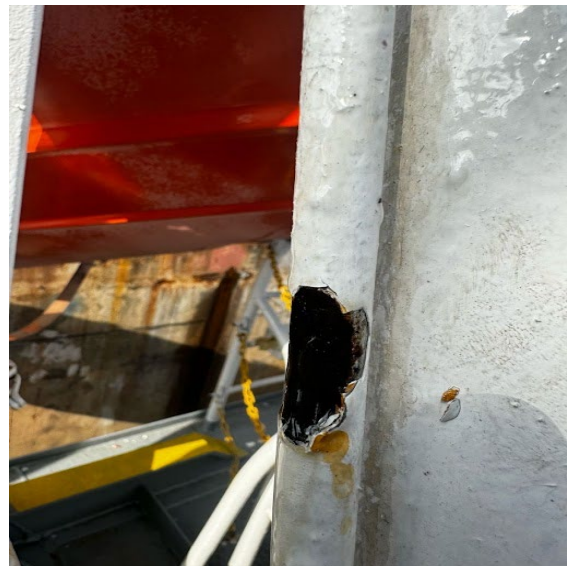
Hole in hydraulic pipe

- The hydraulic pipe burst due to abnormal pressure conditions;
- There was a lack of clear procedures and communication during the launch process;
 - In particular, insufficient pre-launch checks and communication.

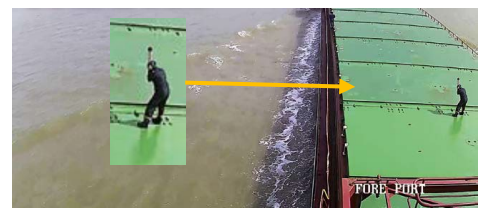
Crew on a cargo vessel were preparing to open a cargo hold hatch cover, which was sealed by several wedges. The usual technique for releasing the wedges was to use a sledgehammer. A crew member quickly approached the wedge and, without taking time to prepare, swung the sledgehammer. The sledgehammer hit the wedge, but instead of coming out, the wedge remained lodged in place and shattered, sending debris flying towards the crew member. A small fragment of the securing wedge penetrated the crew member’s right leg, just below the knee. The crew member received first aid and was signed off work for three days to recover from their injury.

Crew member swinging the sledgehammer

Before using heavy tools, be aware of what could happen if things go wrong. In this case, swinging the hammer away from the body might have reduced the risk of being struck either by flying debris or the hammer itself if the wedge was missed.
