IMCA Safety Flashes summarise key safety matters and incidents, allowing lessons to be more easily learnt for the benefit of all. The effectiveness of the IMCA Safety Flash system depends on members sharing information and so avoiding repeat incidents. Please consider adding safetyreports@imca-int.com to your internal distribution list for safety alerts or manually submitting information on incidents you consider may be relevant. All information is anonymised or sanitised, as appropriate.

1 Lifeboat air cylinder explosion on an empty installation

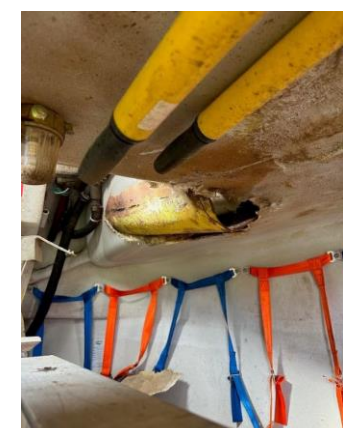
The affected lifeboat was removed and taken ashore for further inspection. One of the bottles had exploded with a good portion of it propelling upward through the centreline seating structure and embedded itself into the overhead of the lifeboat. One bottle fell to the sea through the hole created in the hull of the boat and one bottle remained intact.

- The bottles in this boat were purchased new in 2018;
- Further inspection after the lifeboat was brought onshore revealed significant corrosion over the length of the bottles in the area where they were in contact with the bottom of the boat.
- Each of the three bottles was placed in a form fitting “saddle” built into the bottom structure of the lifeboat instead of being raised slightly above the deck in a cradle. The two brackets holding the bottles from above were made of stainless steel and there was no insulating material between this bracket and the steel bottles. It appears the installation and location of the bottles was subject to retaining moisture, especially between the bottle and the saddle. It could be that the corrosion was further exacerbated by galvanic action between the steel bottles and the uninsulated stainless-steel bracket.

- Bleed down pressurised systems when no longer needed;
- Ensure pressurised air bottles are fully and adequately inspected during weekly/monthly maintenance and annual servicing;
- Look closely at the way in which pressurised air bottles are stored – could there be moisture traps? Is there a way to avoid that?
- Ensure pressurised air bottles in lifeboats are raised above the deck to provide better ventilation around the bottle;
- Ensure any device holding pressurised air bottles in place is a similar material or suitably insulated between materials that are dissimilar – be aware of the risk of galvanic corrosion.

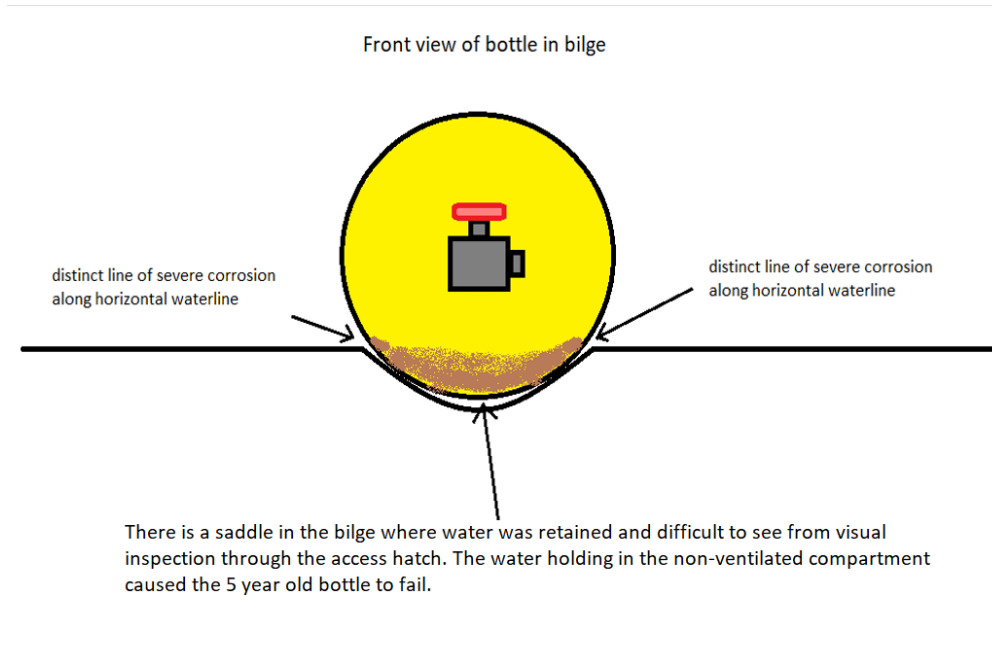
- This particular installation provided a very restricted access to these air bottles, so this greatly limited the ability to adequately inspect the bottles during regular weekly/monthly maintenance and annual servicing:
 - The access ports only allowed a view of the top (valve end) of the bottle.
 - The saddles in which the bottles rested completely obscured the section of the bottles inside the saddle.
 - The bracket holding the bottles in place was of a different material and was in direct contact with the bottle (not insulated).

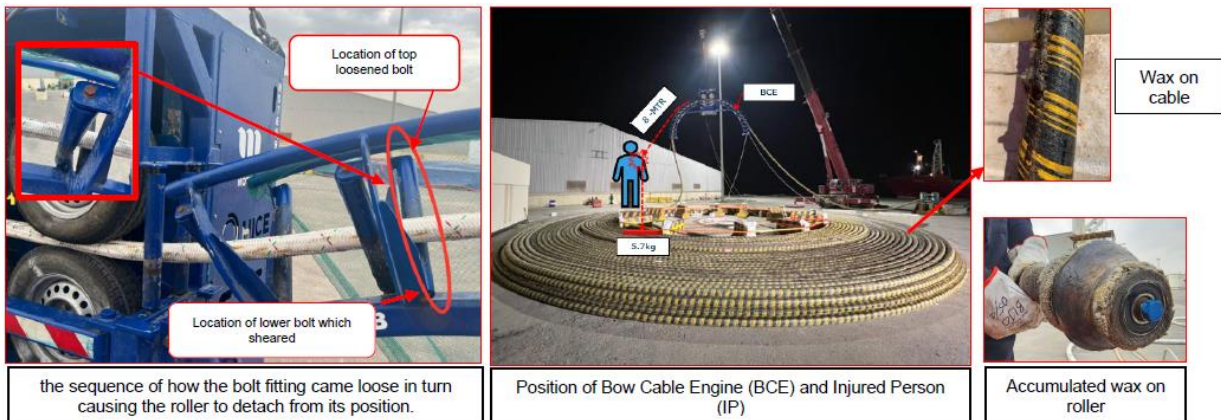
A roller weighing 5.7kg fell 8m and hit someone on the shoulder. This high potential incident occurred during alongside when a 69kV electrical cable was being trans-spooled ashore from a third party vessel. A connection bolt failed, allowing the roller to fall from a suspended Bow Cable Engine (BCE). On disconnection it dropped, first striking and being deflected by the BCE,

before hitting the right shoulder of one of the subcontractor’s workers. The worker was underneath and close to the BCE as their task was to guide the cable as part of coiling it for storage. Work was stopped and the person injured was taken transported to external medical facility for assessment and X-rays. The X-rays revealed no breaks and the person injured was fortunately able to return to work.

- The injured person was working under a suspended load;
- The company had a Safe Use of Work Equipment assessment process, which was not applied;
- Existing risk assessments were inadequate. Additional measures to prevent dropped objects, such as secondary retention or cargo nets on the BCE, were not taken into account;

- Ensure effective application of the Management of Change (MoC) process to assess and manage the identified changes including identification and assessment of risks;
- **Be curious** - keep questioning all aspects of what may go wrong. Take the time to go through all potential risks to consider and implement adequate mitigation controls;
- Everyone should feel able to **stop the job**, ask questions, assess, and only then, act.
- Guard against becoming **complacent** by continually asking the question “*what if ...?*”
- Remember the wax that no-one had taken into account? Ensure better communications with relevant parties to ensure everyone involved understands what is being delivered before it arrives.

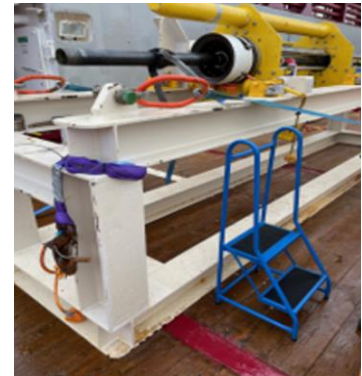
Step ladder/hop-up

While the worker was on the 2-step ladder/hop up, the vessel hit a wave and pitched, and this caused the worker to lose balance and fall. The step ladder/hop up went to the right and the person fell to the left struck their ribs on the frame of the tool and then fell to deck. In pain, the worker went to see the vessel medic, who after assessing the situation, transferred the worker ashore for further assessment and treatment. The diagnosis was a fractured rib. The worker was unable to return to work and went on sick leave.

- The ladder/hop up was not secured to a fixed point as required in procedures;
- The hazard/risk of using the two-step ladder had been identified in the risk assessment, but the mitigating actions were not satisfactory. The equipment was not robust enough.

- Even falls from low heights can result in serious injuries;
- Could the work have been done when the sea was calmer?
- Ensure such equipment is properly secured before use;
- An engineered solution was to be prepared, for a fabricated access point on the tool frame, to negate the use of a temporary step ladder.
