1 Near miss: lift bag released unintentionally from crane hook

2 Nitrogen cylinder ruptured

3 Offshore platform decommissioning near miss

4 NTSB: Fire on vessel - stray electrical current during welding

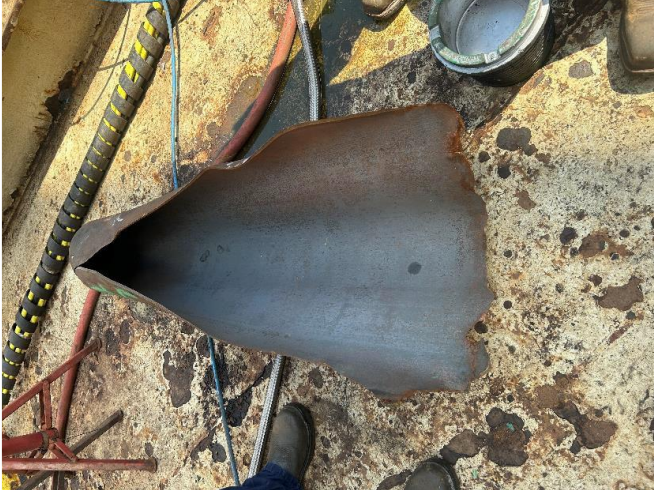
Part of ruptured bottle

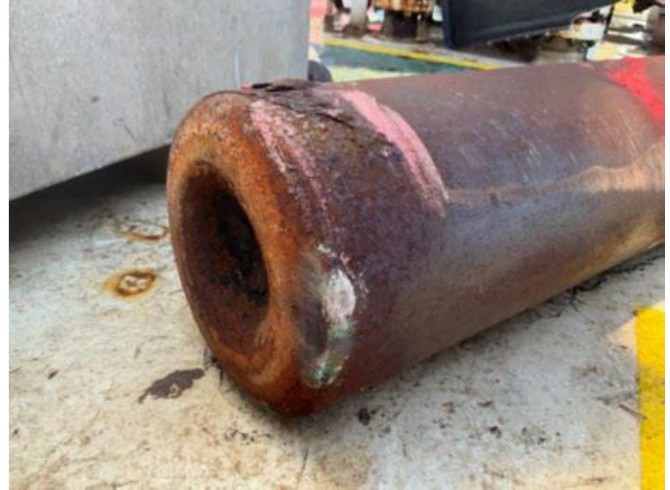
Base of bottle showing corrosion

The base of the cylinder that ruptured was heavily corroded. Other cylinders in the quad had evidence of similar but less severe corrosion.

The cylinders were 9 years into their 10-year hydrotest cycle, and had been visually inspected by the supplier in accordance with applicable industry guidance, when they were refilled some three months before the incident, before being loaded out to the rig. However, the severe corrosion that caused the rupture was not spotted during this inspection;

- Are the cylinders on your facility or vessel certified and in good condition?
- Are you able to see the condition of all cylinders in every rack?
- Are all cylinders located on a free draining base to minimise corrosion?
- Do you know what level of visual inspection of cylinders/quads is provided by your supplier?
- Are all cylinders on your facility stored and located in accordance with the relevant industry regulations?

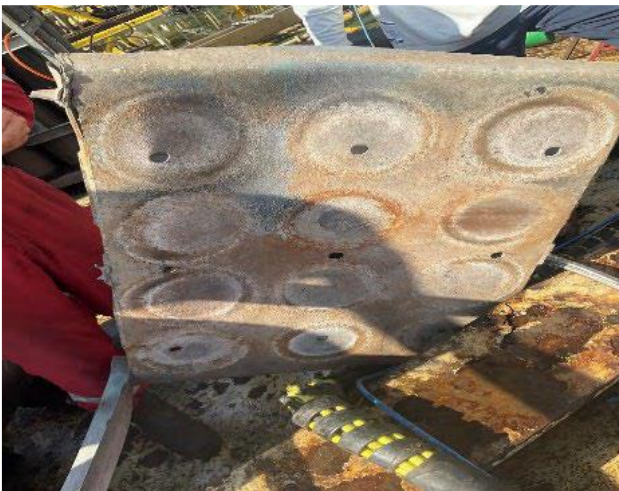
Difficult to access middle cylinder

The cylinder that ruptured was located in the middle of the quad and therefore not easy to properly inspect without disassembly of the quad.

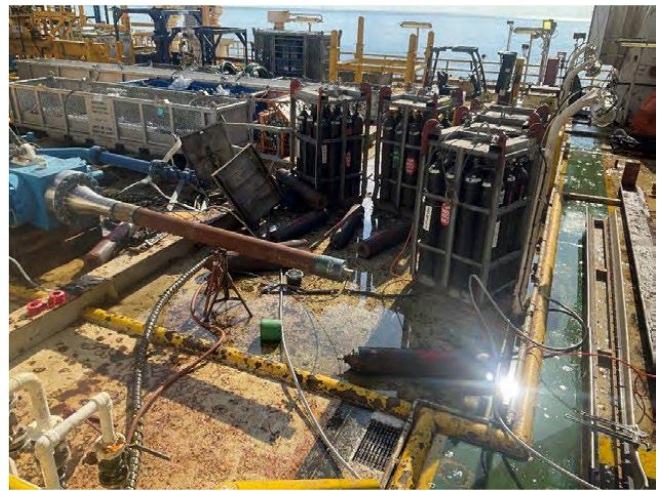
Where the rupture occurred

Calculations showed that the fatal blast zone for a single cylinder of this size pressurised to 2,400psi would be around 1.5 metres. The severity of the blast caused the rack to be destroyed and the other cylinders to be propelled across the deck.

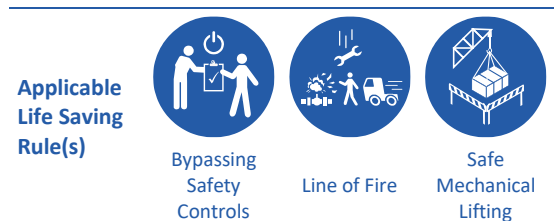
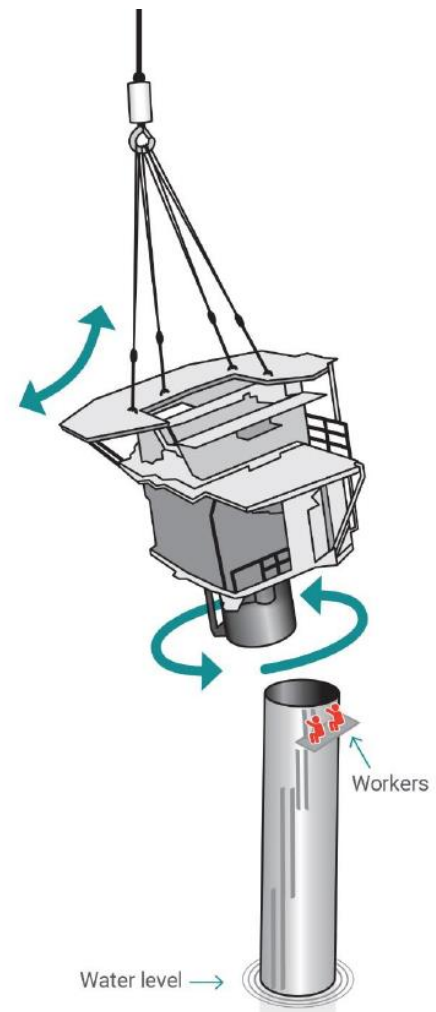
- Dynamic forces that could be applied to a rigged load while a crane was in auto-tensioning mode were inadequately understood or considered when developing the lift plan;
- The requirement for pre-load tension was not subject to adequate technical assessment;
- The platform rotated on separation; the engineering assessment did not identify the turning motion induced by pre-load tension;
- An over-reliance of previously successful methodologies rather than the analysis of their suitability to the specific tasks of this activity.

- A technical assessment of lift plans to identify and consider all forces acting on a load, including forces which may be unintentionally applied due to automatic settings and crane modes;
- Use of castellated cut designs where a possibility of rotation (turning moment) of the load exists;
- Consider and assess the whole of life design, including commissioning and decommissioning procedures;
- Ensure workers are not under suspended loads.

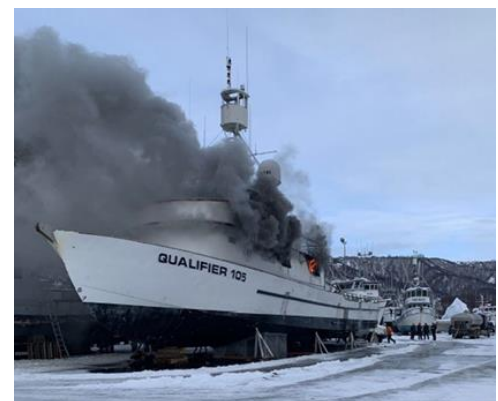
Qualifier 105 on fire in the boatyard

The fire watch and one welder each saw a small flame on two different bunks in a cabin. Those small flames were likely caused by ignition of combustible materials—including carpet, wood framing, and plastic sheeting—in the ceiling of the cabin and in the overhead bulkheads. This is dealt with in some detail in the report linked above.

The NTSB determined that the probable cause of the fire was an undetermined electrical source that ignited a stateroom ceiling. Contributing to the extent of the fire damage was the substantial use of combustible materials composing the stateroom ceilings and bulkheads throughout the vessel's accommodation spaces.

- Take precautions against stray welding current: Stray welding current is a fault condition in which current goes through unintended conductors and back to the return terminal of a welding machine; it can cause fires by overheating wires. To avoid potential fires caused from stray welding current, maintenance personnel, owners, and operators should follow industry practice to place the work clamp (the return current clamp) of the welding machine as close as possible to the point of welding.

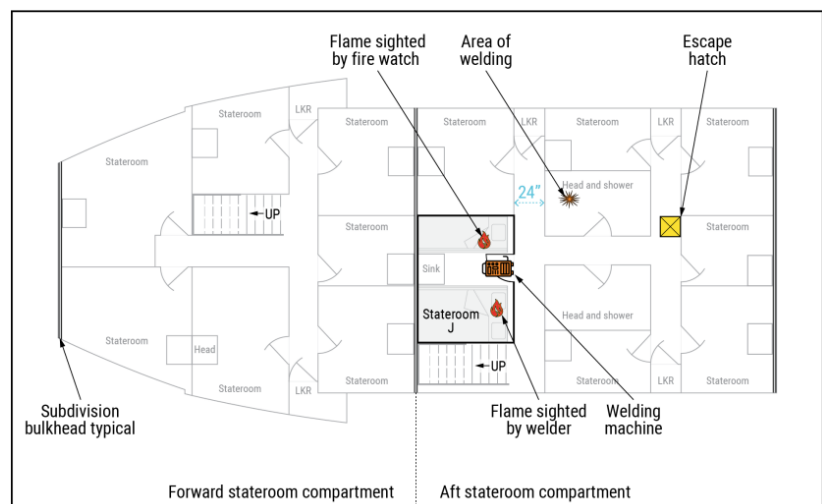
On board the *Qualifier 105*, the welding machine work clamp (the return current clamp) was connected to an aluminium cross member below the deck in this cabin, about 3m from the point of welding. The return current had to travel through the vessel's aluminium structure and/or conducting wires from the spool gun's electrode back to the work clamp. The aluminium structure would have served as a conductor, and the resulting

current in the structure may have found its way into the vessel's electrical system. An electrical wire in the overhead of the cabin could have served as an unintended conductor and become overheated and eventually led to a fire.

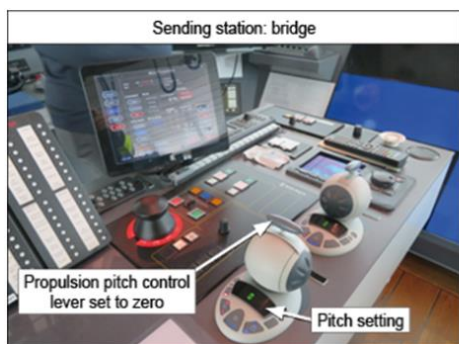
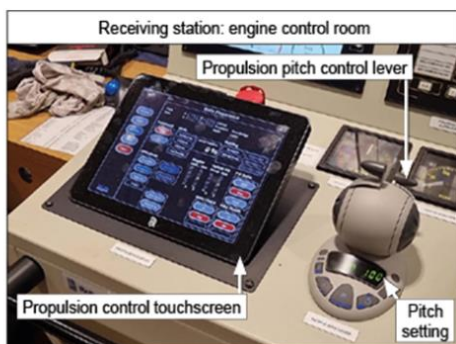
The status of Kirkella's control system at handover of control

- The pitch levers for *Kirkella's* propulsion control system were not synchronised between the bridge and engine control room when control was transferred. The propulsion control system was not fitted with interlocks to prevent this from happening – these were not required;
- *Kirkella's* engineer had not checked that the engine room pitch lever was matched to the bridge pitch setting when control was passed from the bridge to the engine room;
- There was no procedure for control changeover.

- The interlocks, which were optional, could be retrofitted by the engine manufacturer;
- Robust shipboard practices are essential to maintain propulsion control during handover, regardless of whether system interlocks are fitted. Documented procedures should contain a requirement for the operator of the sending station and the receiving station to check that propulsion systems pitch settings are synchronised at the time of transfer.
- To reduce the risk of propulsion thrust being applied inadvertently while alongside the MAIB suggests that it is advisable to declutch engines before transfer of control.

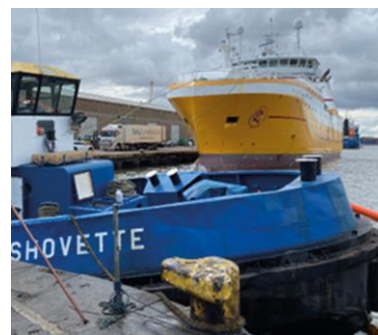
Fishing vessel *Kirkella* lost control of its propulsion system while berthing, and collided with the harbour tug *Shovette* in the port of Hull, UK. *Kirkella's* bulbous bow breached *Shovette's* hull and starboard fuel tank during the collision, causing the tug to partially sink and resulting in approximately 7,000 litres of marine diesel oil spilling into the dock. *Kirkella* was not damaged. There were no injuries.

Kirkella and Shovette
