IMCA Safety Flashes summarise key safety matters and incidents, allowing lessons to be more easily learnt for the benefit of all. The effectiveness of the IMCA Safety Flash system depends on members sharing information and so avoiding repeat incidents. Please consider adding [safetyreports@imca-int.com](mailto:safetyreports@imca-int.com) to your internal distribution list for safety alerts or manually submitting information on incidents you consider may be relevant. All information is anonymised or sanitised, as appropriate.

## 1 Man overboard during motion compensated gangway transfer

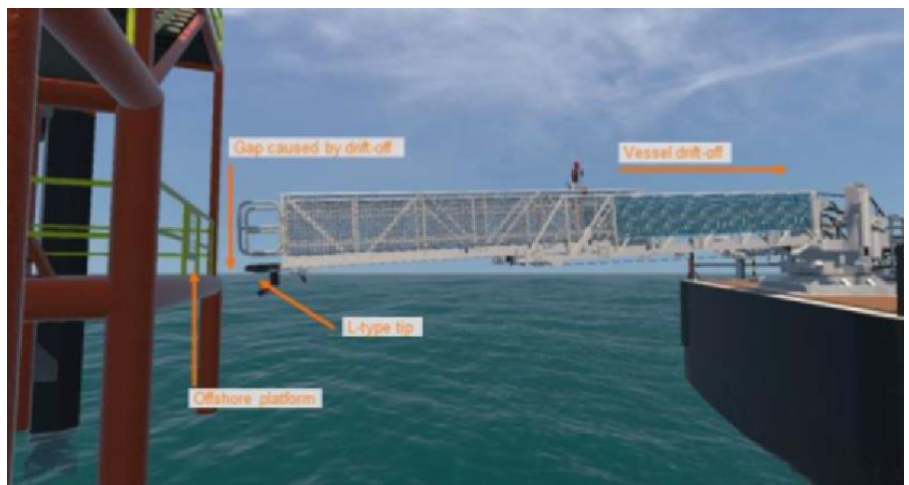
An offshore worker fell overboard from a height of one metre while transferring from a platform to a vessel (non-DP) via a motion compensated gangway. The incident occurred as the vessel drifted off from the platform, resulting in the gangway disconnecting from the platform and creating a gap between the gangway and the platform, through which the worker fell overboard. The worker was able to hold onto the platform's boat landing and was safely recovered back to the platform. After a medical examination, the worker was declared fit to return to work.

- After stepping on to the gangway tip and holding the handrails, the worker heard a warning sound and simultaneously heard the voice from the platform's boat landing officer, which caused him to take a step backward. By the time the worker had stepped back, the vessel had drifted off, resulting in the disconnection of the gangway from the platform. He lost balance and fell overboard through the gap.
- The worker's life-jacket (personal flotation device) did not inflate when he fell into the water. However, he was able to hold on to the platform's boat landing.

- The vessel (not a DP vessel) operating on manual station keeping, as per normal mode of operation, could not keep station and fully drifted off from the platform;
- After the vessel drifted off, the worker stepped back from the tip instead of stopping and holding onto the railing.

- Ensure you have a clear understanding of the emergency procedures for the gangway before crossing;

- Other workers transferring should not interfere with the ongoing operation;
- Vessel crew and gangway operator should be well prepared on how to prevent/manage drift off situations through familiarisation of procedures and assessments;
- Ensure that life-jackets and Personal Flotation Devices are checked regularly as fit for purpose;
- Safety induction video should cover all relevant emergency scenarios – the safety induction video was updated.

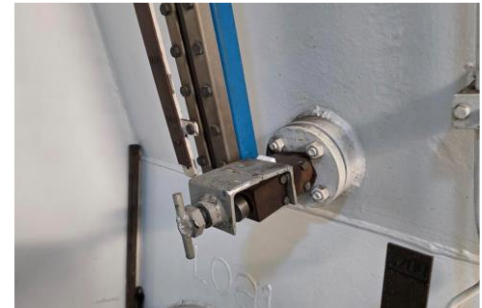
During a client inspection, the sight glass on a vessel main engine lubricating oil storage tank was found to have been fitted with an unauthorised and homemade 'clamp'. An unauthorised 'clamp' was installed on the storage tank without any consideration for the potential consequences. This clamp kept the self-closing valve open at all times, contravening mandatory regulations, company standards and exposing the crew, the vessel and the environment to a significant fire, safety and environmental risk.

- The modification was made to save time during a routine task, without due consideration to the potential consequences and hazards;
- No onboard routine inspections, safety walk-rounds, observations or interventions had raised a concern regarding the modification.

*Showing a home-made clamp which ought not have been there*

- Thorough search to ensure no such other or similar devices are installed;
- Reminded people of their responsibility to maintain a safe workplace and to raise concerns where any safety devices may have been modified;
- Ensured all personnel are aware that tampering with any valves, alarms, safety devices or other approved measures intended to maintain the safety of the crew, vessel or the environment are unacceptable and will lead to disciplinary measures;
- Daily routines and planned maintenance tasks ought be carried out as per instructions or procedures – there ought be no deviations from the instructions or modifications are made to equipment without the proper approvals or a Management of Change process;
- Ensure that all onboard routines, inspections and walk-rounds consider the integrity of safety devices and highlight any concerns.

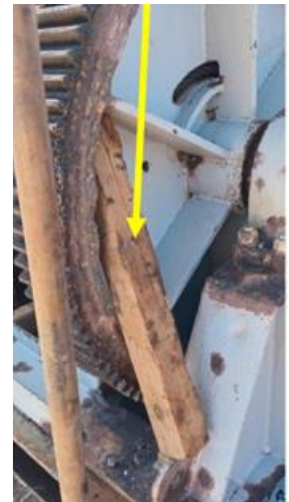
Wooden beam

the wooden beam to secure the winch drum, the drum rotated back, trapping the his little finger between the beam and the winch base. This resulted in a broken finger.

- One person was trying to do a job that had already been established needed more than one person to do it safely;
- An improvised securing device was used (wooden beam), and this was seen as the most suitable and easy solution to secure the drum;
- Due to the general painting permit that was used for this job, there was no additional risk assessment covering the specifics of painting a winch that might potentially rotate;
- No further assessment was performed on how to properly secure the winch when the drum was in free rotation.

- Stop the job when it cannot be performed safely;
- Don't attempt to perform a two-person job alone; wait for assistance, even when this takes extra time;
- Ensure that a safe and designed-for-purpose securing methods are used, even when this takes more time to prepare;
- Do not use "general" permits and always assess the risks associated with changes introduced to an existing piece of equipment.

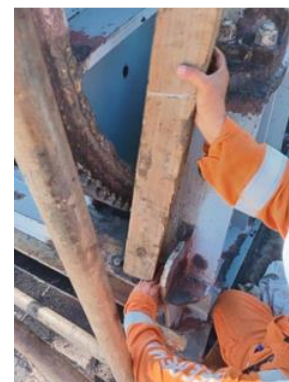
Position of hand at the time of the injury (re-enactment)

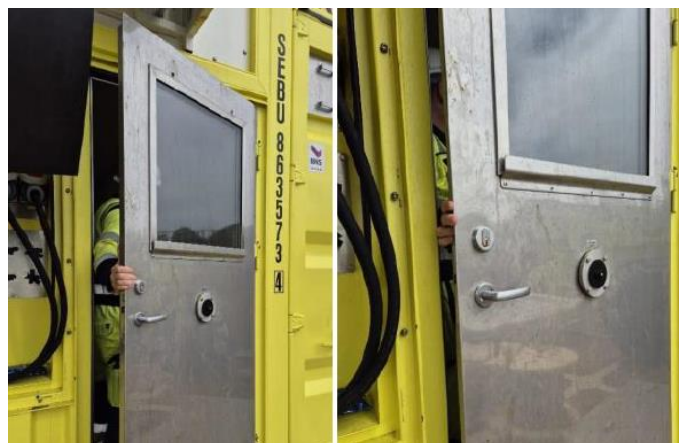
The worker was entering a workshop container located on deck. They opened the door with their right hand and stepped inside holding the door with their right hand to close it behind him. As the door closed, the wind and the movement of the vessel combined to cause the door to close more quickly than anticipated. The injured person's right index finger got caught between the door edge and the door frame, causing a laceration to the right index finger.

- Safety by design: work areas should be designed safely to avoid injuries. Doors inside and outside the accommodation are potential pinch points and this should be addressed in planning;

- Avoid complacency and maintain awareness of the surrounding conditions – take extra care when the vessel is moving during rough weather.
