## 1 Main Crane failure during load test

## 2 AC vent unit cover dislodged and fell 1.7m

### 3 Dropped sheave and clump weight

#### 4 UK HSE: Incident during rig decommissioning leads to fatality

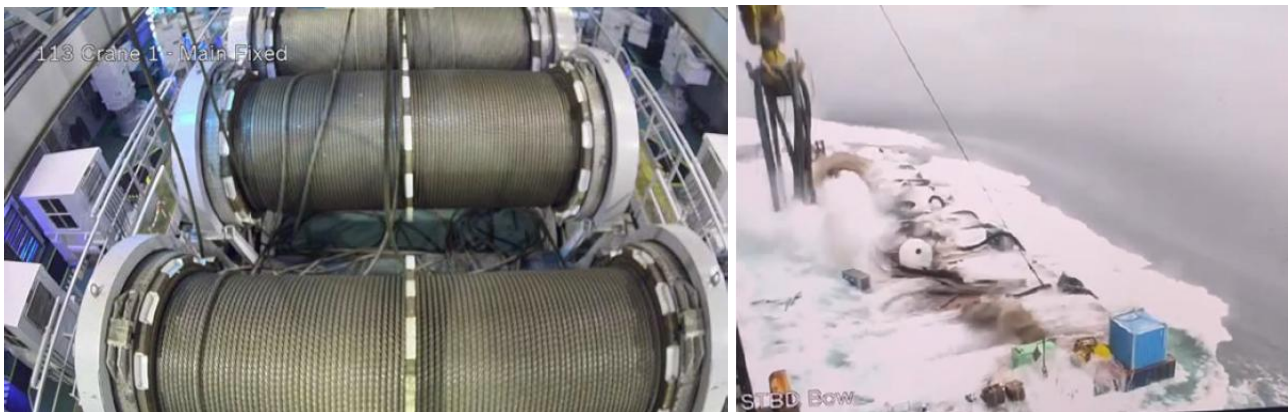
While performing the overload load test at maximum load plus 10% on a heavy lifting offshore crane, a major failure occurred. At maximum load, the crane main block wires broke and the testing load (two cargo barges) fell, along with the main block, into the water. As a result of the loss of load, the vessel listed to approximately 9 degrees. There were no injuries.

- Mechanical failure on the clutches of certain of the main hook double drums. Since the main hook wires were reeled on four drums, when the load at the hook reached maximum (barges completely out of water) the clutches of two drums, #3 & #4 (starboard side of the hook) slipped on the transmission disk and the drum lost torque, while the other two drums, #5 & #6 (port side of the hook) were still pulling. This generated an unbalanced load on the main hook, beyond any normal compensation system, with concentration of stress on the port side half of the block assembly where the load ultimately exceeded the wire Maximum Breaking Load with consequent breaking of wires and the total loss of the load.

- Clutch pad failure. The recently installed clutch pads lost their holding properties at maximum crane load. During the investigation it was found that the failure of the clutch pads was linked to the lack of proper burnishing of new pads.

- Perform burnishing of clutch pads as per manufacture's procedure;
- Implement a clutch torque test to verify the holding torque of the pads as per new manufacture's procedure;
- Include in the planned maintenance systems the pads burnishing procedure and torque test with the frequency recommended by the manufacturer;
- Revision of crane FMEA, including review by competent persons.

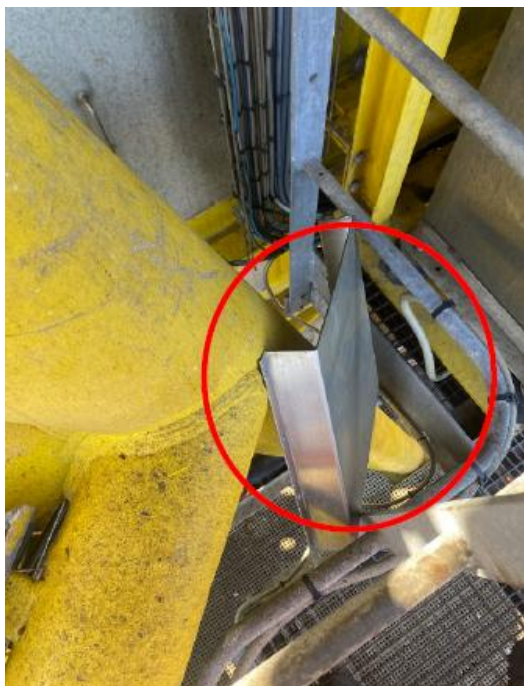
On a pipelay tower, the AC cover of a capstan electrical cabinet became detached and fell approximately 1.7 meters. The cover was found resting on a cable attached to the platform and diagonal tubular brace. There were no injuries. However, there was potential risk to individuals working nearby. Our member, based on information from the industry “[DROPS calculator](#)”, has treated the incident as it if were a Lost Time Injury (LTI).

*Cover in its final resting place*

- Inspect all similar cabinets / equipment and change out any incompatible fixings;
- Review existing dropped object checklists and/or work orders and update as required;
- Verify during routine dropped object inspections of equipment at height, that primary and secondary fixings and safety securing lanyards are all compatible;

- Update Planned Maintenance work orders where required.

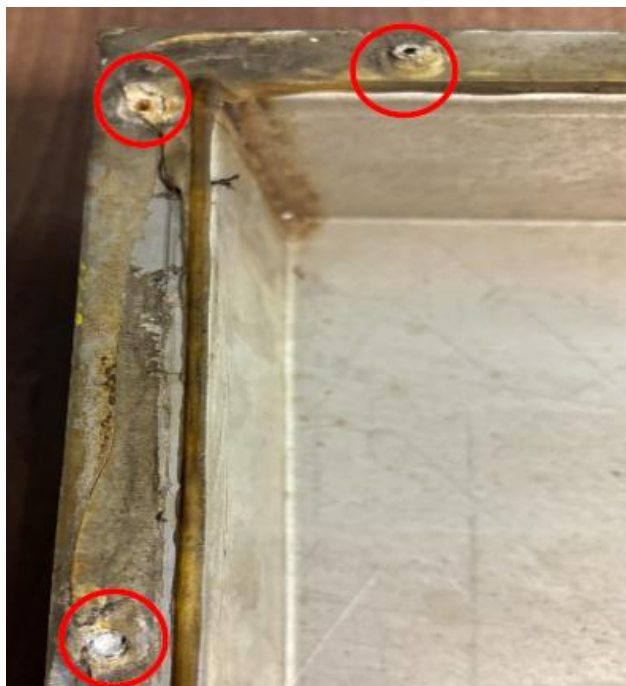
*Failed aluminium rivets*

Initial investigations detected a failure of the securing rivets caused by **galvanic corrosion**. When aluminium and stainless steel are combined in an assembly, electrons from the aluminium migrate into the stainless steel causing the aluminium to weaken and deteriorate at an accelerated rate.

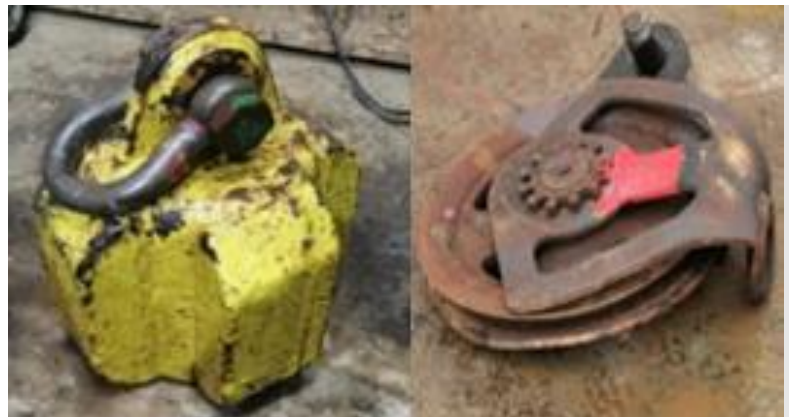
During the hoisting of the winch wire #5, the clump weight was pulled into the sheave, causing activation of the winch overload alarm. Although the crane operator promptly moved the joystick to the "0" position, it was too late. The clump weight had already been pulled into the sheave causing the sheave to break; both the sheave and the clump weight then dropped to deck. The sheave (204 kg) dropped from 64m and bounced, narrowly missing a forklift truck. Nearby crew found it necessary to take cover. The clump weight (approximately 700 kg) dropped onto the umbilical winch, resulting in a hydraulic oil spill on the main deck.

- The Crane Operator was performing simultaneous tasks requiring full concentration;
- Neither the Crane Operator nor the Rigger foreman had eyes on the tugger wire / clump weight;
- The tugger winches had no automatic alarm settings with automatic stops.

*Clump weight and sheave*

- Doing more than one thing at once – **DON'T!**
- When performing lifting operations, the banksman should always have eyes on the lift and make sure the area below the lift is clear of people;
- Be aware of the limitations of your equipment and **stop the job** when it cannot be performed safely.

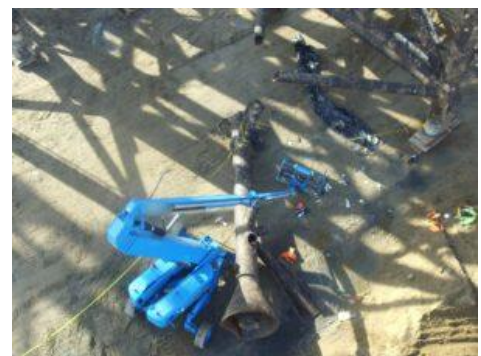
Two men were working as demolition operatives, also known as “Top Men”, undertaking the decommissioning and dismantlement of offshore structures which had been brought ashore. The two workers were removing an overhanging piece of metal pipework (known as a skirt pile), weighing in excess of 27 tonnes, from a gas rig jacket when it gave way. The pile struck the mobile elevating work platform (MEWP) containing the men, throwing them to the ground about 12 metres below.

*Where the workers fell*

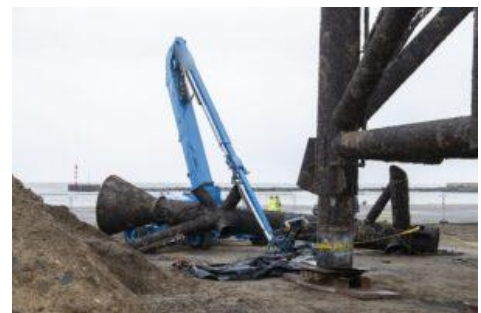
- Serious failings with the planning and the risk assessment which did not adequately cover the planned works;
- Shortcomings in supervision;
- The company did not risk assess the skirt pile being removed as it was considered low risk. As a result there was no cutting plan or safe system of work for the skirt pile.

*The skirt pile gave way and struck a mobile elevating work platform*
