List of DP Events

1 Thorough preparation is key

2 There – but not really there

3 Equipment Class 3, even if you operate as ‘Class 2

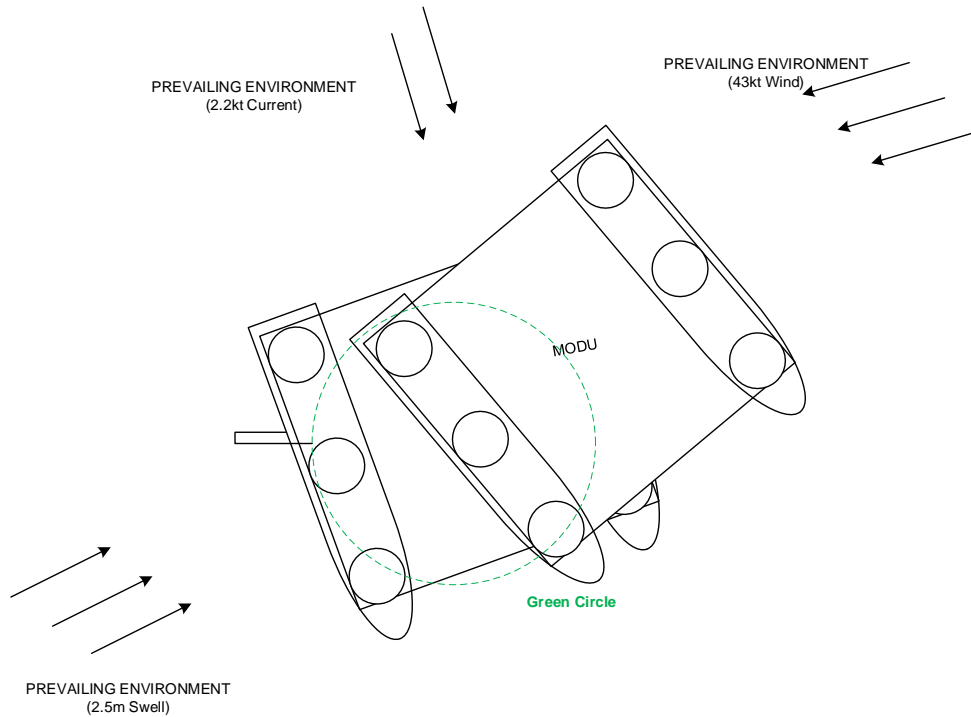
During the heading change, the rig was struck by a large wave, which resulted in an instant load spike and generator fault alarm on all running generators.

Auto starts were initiated for the three remaining stand-by engines, but before they could synchronise and connect, DG6 ramped to 100% and tripped on overload. The MODU blacked out, and the blackout recovery system was initiated.

Due to the standby generators already going through the start-up & synchronise process at the time of the blackout, the vessel was able to restore power within 12 seconds, the MODU recorded a 7m shift in position.

Figure 1 – Forced Out the Green Circle

- ◆ The DP system automatically switched temporarily to high precision control mode, as designed to when a position or heading change is made in Green Mode.
- ◆ The system was set to high gain.
- ◆ The large wave during the heading move forced the vessel out of the green area.
- ◆ The sudden power load increase initiated the auto-start system, as required.
- ◆ The system was set to Droop mode, and it was later identified that the droop curve limits were too tight to cater for the large load step changes of the generators.
- ◆ The power management system disconnected multiple generators when the first standby generator connected.

It was reported that following visits from the manufacturers of the DP and PMS systems, the software was upgraded, and extensive testing was carried out in both droop and isochronous modes, including scenarios of load step changes and blackout recovery.

The incident highlights the importance of performance testing of the power generation system and in all applicable load sharing modes (i.e. droop and isochronous). Testing during commissioning and DP trials, of the overall power and propulsion systems must include sufficient testing of generator load acceptance and rejection, blackout protection, DP & PMS thrust limitation, standby start of generators etc.

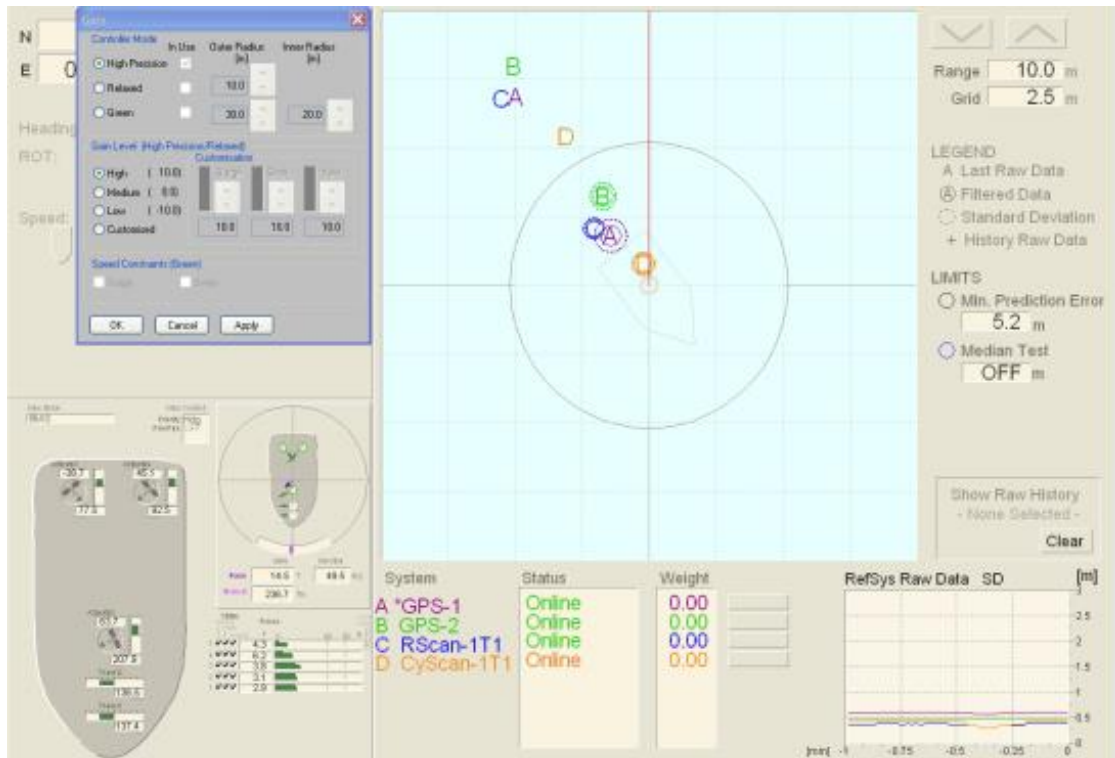
At 10:08, when the vessels position and heading deteriorated with around 2 meters and 2 degrees excursion, out-of-limit warnings were generated. Over the following couple of seconds, one by one, prediction error alarms for each of the reference systems were generated but not fully realised by the DPO.

The vessel commenced drifting aft and losing its heading due to the wind and waves. The DPO was monitoring the operator station and awaiting the thrusters to react and start thrusting to return to position; however, the vessel continued moving further away from position. On the operator station, the DPO reported that the reference systems were still appearing to be online, though the weighting was not clarified.

When the vessel's speed began increasing away from the asset, the DPO disengaged sway and surge to take control on DP joystick, at which point, a position dropout alarm was triggered due to no reference systems accepted into the system. The DPO manoeuvred the vessel away from the asset on the DP joystick and out of the 500m zone.

Figure 2 – Screenshot to show difference exceeding 5m

Following analysis of the event from the DP manufacturer, the cause was identified. The vessel was able to continue DP operations, with limitations, until the DP software could be upgraded to a higher version that had implemented improvements to handle the model error.

- ◆ Enter joystick mode to control the vessel and regain position.
- ◆ Re-calibrate all reference systems.
- ◆ Wait 30 seconds for position dropout to be reported, and the reference system will automatically calibrate.

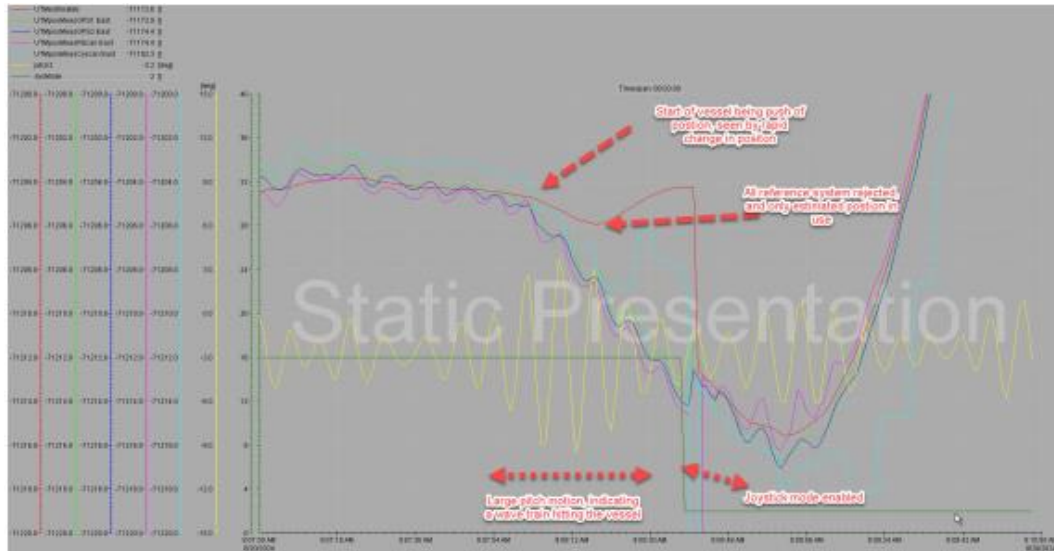
- ◆ Due to only one line of DP alarms being visible at a time on the operator station screen, the DPO did not visually see the reference prediction error alarms activated. When many alarms activate in a short period, the second DP operator station must be used to show the full alarm list.
- ◆ Multiple rapid alarms had been accepted, and the alarm drop-down had not been expanded to check entirely those activated. If they had, it would have been realised that the 'No reference system' alarm had been activated and that the system was using the estimated position only.
- ◆ From analysis of the DP system history, it was seen that the vessel was hit by a wave train. The wave train's effect is that the position reference systems' measure position is moving away from the estimated position.

Figure 3 – History Analysis

- ◆ The wave train hit the vessels, and this ‘unknown external force’ pushed the vessel rapidly out of position, causing deviation between the measured position (reference systems) and the estimated position (model position). The deviation exceeded the prediction error limits of 5m and caused all reference systems to be rejected.
- ◆ The DP software version onboard the vessel had a known weakness regarding position drop out of the DP reference systems during rapid movements caused by wave trains/ several waves in a row.

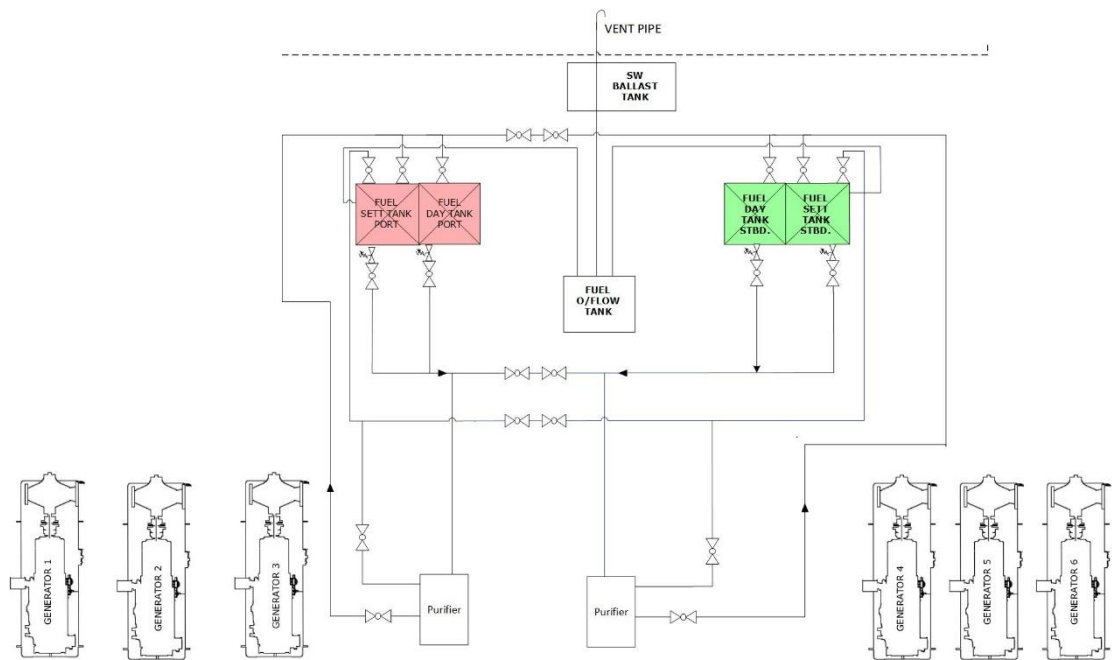
Figure 4 – Simplified Example Fuel System

The engineers discovered water in the fuel system, within the settling and service tanks on both port and starboard sides. and were required to drain the water from both systems. After two hours, the engines were finally restarted, and the vessel returned under control, having lost 2nm position.

- ◆ The water ingress to the FO overflow Tank was traced back to the FO overflow tank vent pipework.
- ◆ The FO overflow tank vent pipe was traced and found to pass through a water ballast tank, which at the time was full.

- ◆ Upon emptying the water ballast tank, the leaking stopped, and when the vent pipe was safely inspected, it was found with several holes from years of corrosion.

- ◆ The FO overflow tank was set up to the port and starboard settling tanks simultaneously.
- ◆ FO operation procedures were reviewed, and concluded that there was room for improvement in regard to the storage, transfer and treatment onboard.

- ◆ During the incident, both port and starboard FO purifiers were operating; however, no alarms were activated.
- ◆ An investigation of purifier settings revealed that the water monitoring function was inactive in a factory setting. The Purifier controller was still in default factory settings, which did not match the vessel's separator type onboard. The controller settings were updated per the manufacturer's instructions to match the actual purifiers onboard. All functions and alarms, including water content alarm, were verified.

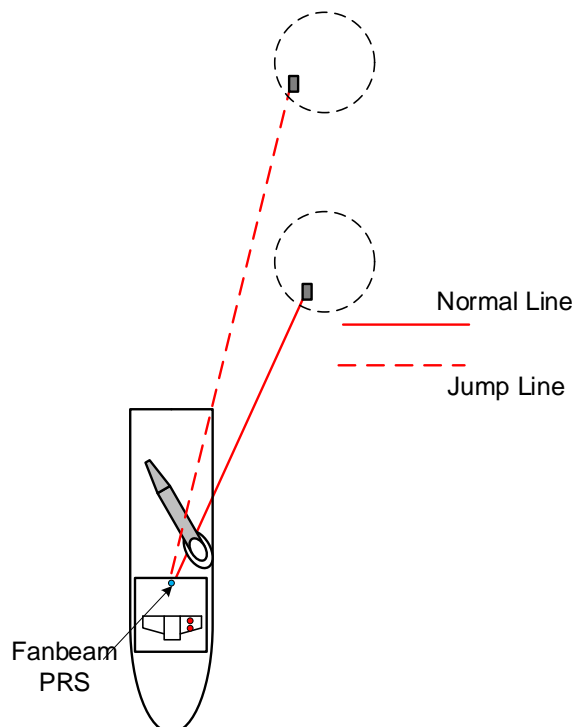
Figure 5 – Fanbeam Array

The DP system registered the drop in reference system, with appropriate alarms and held position on the two remaining reference systems. However, when the crane moved away from the path of the Fanbeam, the Fanbeam reacquired a connection, and a 4.5m move was experienced.

- ◆ Once the path was clear, the Fanbeam reacquired connection with a different reflector, which had a similar range, bearing and signal level as the original reflector.

- ◆ As the wrong reflector was acquired, the DP system repositioned the vessel according to the position of the secondary Fanbeam reflector.
- ◆ The vessel recreated the scenario, and the same outcome was experienced with each repeat. Without deselecting the Fanbeam from DP, after the signal loss, the Fanbeam reacquired the wrong reflector, and the vessel experienced a position move.

- ◆ During an alternative scenario, when the Fanbeam lost connection, the DPOs deselected the Fanbeam from the DP desk. Only when the Fanbeam became available and stable did they reselect the Fanbeam back into DP, and the position remained stable.

- ◆ Once the crane covers the line of sight between the Fanbeam and reflector and a prediction error is generated, the DPO should deselect it from DP.
