## 1 Diver exposed to unplanned release of production gas

## 2 Dropped object – wooden packing block

### 3 BSEE: person fell through open hatch

#### 4 NTSB: Fire on vessel – escaped exhaust gases

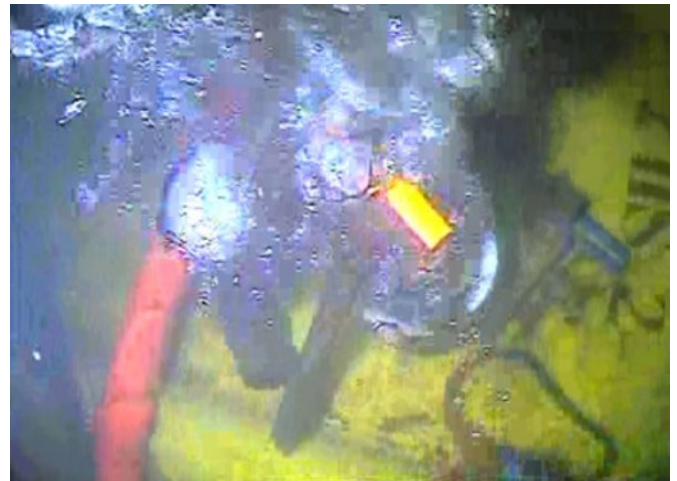
*Production gas bubbles coming out of the receptacle*

- The divers continued with dummy stab removal despite the gas bubble release without challenging the ‘as-found’ condition.

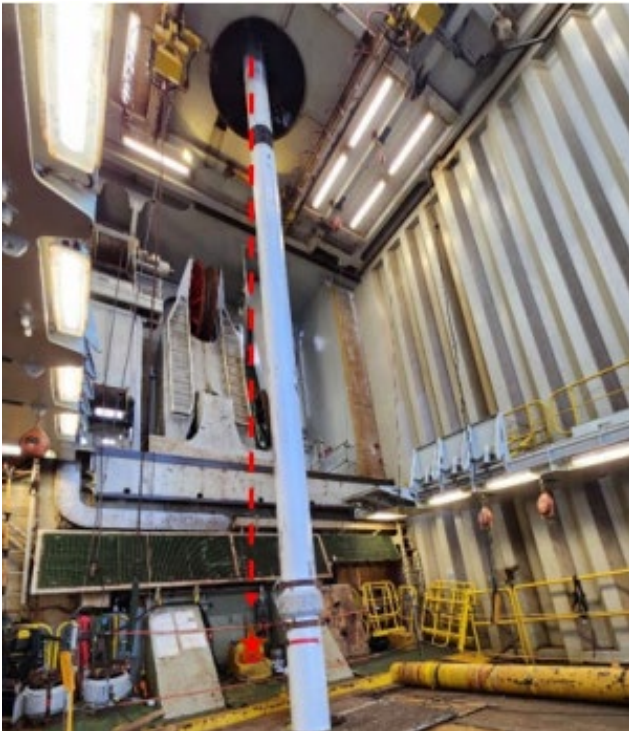
During pipelaying operations, a wooden packing block (approx. 1kg) became attached to the pipe whilst spooling off the reel. It crossed the main deck and entered the pipelay tower with the pipe, where it became detached and fell more than 10m through the lay system before landing on the workstation floor. There were no injuries.

*Workstation showing dropped impact point*

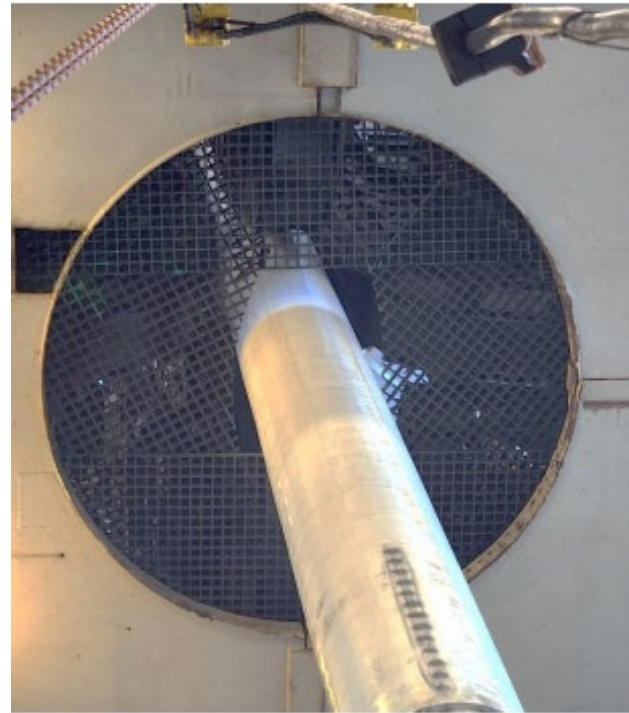
*Gap in the mesh platform that the block fell through*

- The dropped object (wooden packing block), used for crossover packing on the spooler reel, had compressed into the parent coating of the pipe. It was thought that this was the mechanism that has transported the block on the pipe and into the lay system;
- The DROPS barriers on the workstation were inadequate to prevent a wooden block getting through the gap around the annulus of the pipe. The drops barrier is also susceptible to movement from pipe deflection without retracting with the pipe, and this could potentially widen the gap around the pipe. The dropped object passed through this gap and landed on the workstation floor. Had the barrier been suitable to restrict the size of the smallest packing block the incident would have been prevented.

- Ensure all barriers are sufficient for the activities you are conducting;
- Ensure specific barriers (as in this case, around the pipe) are designed to minimise any gap to prevent the passing of potential dropped objects, whilst still allowing operations to proceed in a timely way;
- Ensure, so far as is possible, that there are no personnel in high risk/drops work areas;
- Be aware of risk normalisation and becoming accustomed to seeing unnecessarily dangerous situations in your workplace. Tolerating small defects or gaps in risk control can lead to major incidents;
- Consider new technologies available such as artificial intelligence using CCTV and alarms.

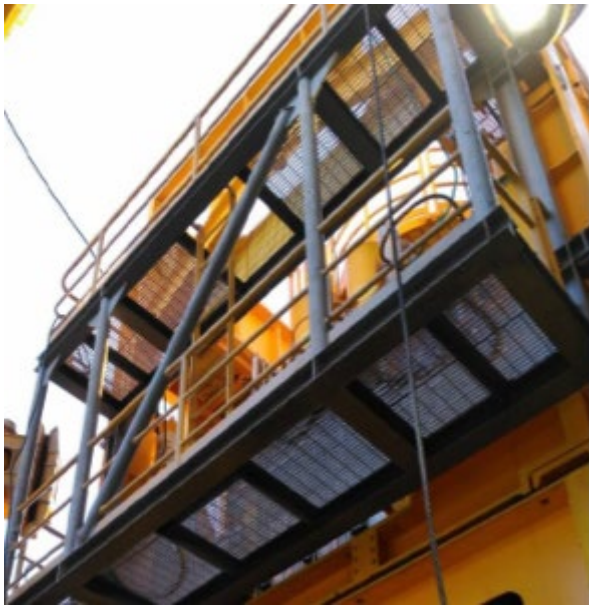
A worker on a blowout preventer platform fell through an open hatch cover that had been removed due to damage. The worker sustained injuries to his leg and knee.

*Area from which worker fell*

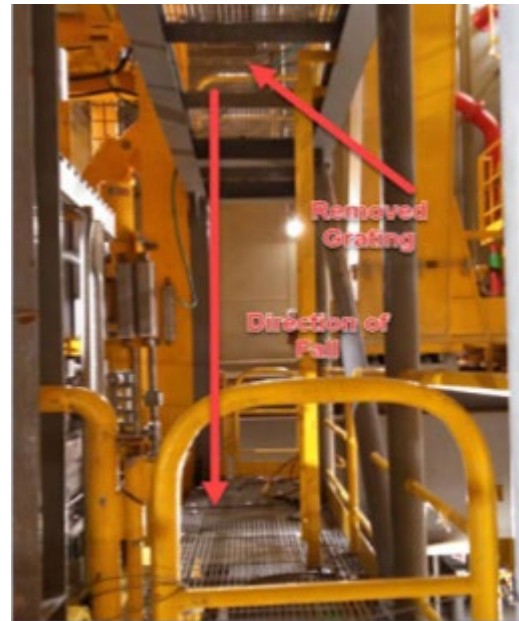
*Hatch cover removed*

Multiple factors contributed to the incident, including a lack of situational awareness for potential hazards, inadequate fall protection measures, and the failure to 1) properly secure the hatch covering the hole, 2) take corrective action after the cover was removed, and 3) alert other personnel to the hazard.

- Check your surroundings prior to starting work for any potential hazards;
- Identify and document hazards and then communicate these to all personnel;
- Ensure the proper fall protection is used when working at heights;
- Check temporary equipment and work platforms for hazards prior to use;
- Use a spotter to help identify and communicate any hazards when working at heights;
- Install barricades and “flag up” areas with questionable walking or working surfaces. Soft barricades (e.g., caution tape) may be temporarily used, but hard barricades should be installed;

- Ensure ladders that connect decks have safety gates that swing closed when not held open;
- Remind personnel to stay vigilant of their surroundings when working on or near elevated work platforms;
- Remind personnel to work at a pace that allows for continual reassessment of dynamically changing work environments;
- Follow approved procedures for the work being performed and outlined in the job safety analysis.

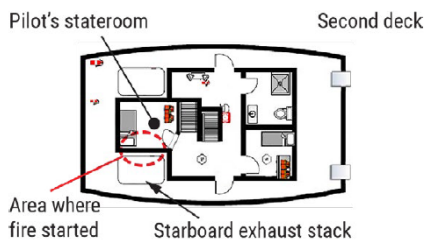
A fire had started behind panels in the pilot’s stateroom, which was located between the vessel’s two stacks, each containing engine exhaust mufflers and piping. Cracks in the welds on the upper section of the starboard muffler located inside the starboard stack—which may have been caused by a latent issue, such as a defect in the muffler during construction or the exhaust system design’s allowance for thermal expansion and contraction of exhaust piping above the muffler outlet—allowed the hot exhaust gases from the operating starboard engine to escape into the stack area and increase the temperature of the space and its bulkheads.

*Layout of part of the vessel. The dashed oval identifies where fire started.*

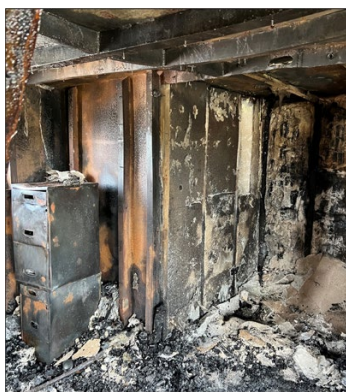
*Destroyed interior of vessel*

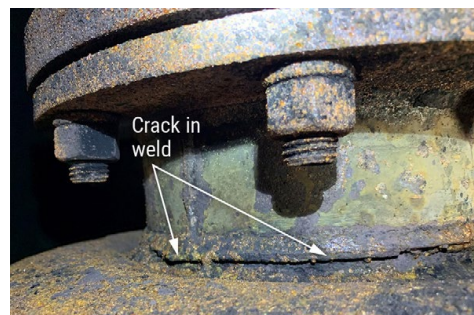
*Crack in weld below the upper (outlet) flange of the starboard muffler*

The NTSB’s investigation suggested that **undetected cracks** in the starboard muffler allowed exhaust gases from an operating engine to escape and ignite wooden structures affixed to the common bulkhead of an accommodation space. Contributing to the extent of the fire damage was the substantial use of combustible materials in the joinery, outfitting, and furnishings in the accommodation spaces.

- Remember that engine and other machinery exhaust systems generate tremendous amounts of heat. These systems often run through tight spaces that are difficult to access and inspect and are often located near materials or equipment that obstruct entry and direct observation;
- Consider inspection of welding and other potential weak points in such areas.

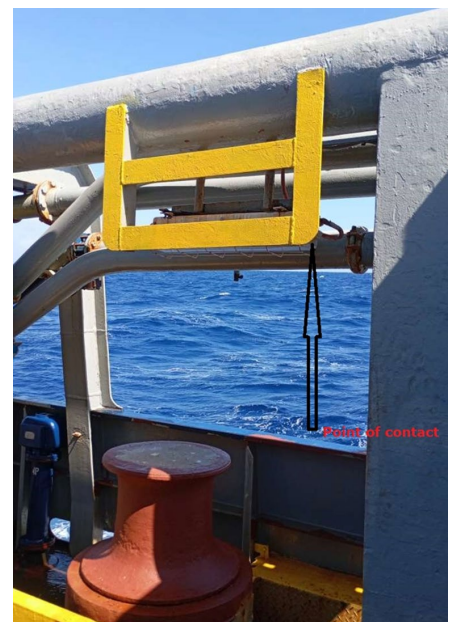
Deck light guard

- The crane operator did not notice the potential snagging point, so continued the operation;
- The deck crew did not recognize hazard and did not stop the activity;
- Owing to the colour it was painted, the deck light guard may have been difficult for the crane operator to see and identify as a potential snagging point.

The importance of the crane operator being able to see the job, and to have good communications with the deck crew, cannot be overstated.

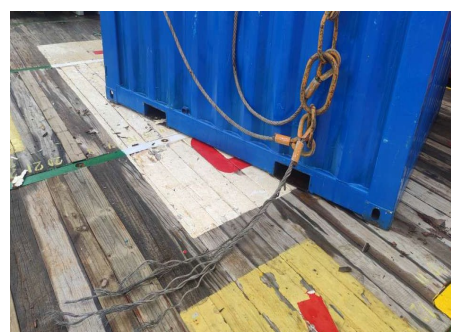
Damaged sling

On a vessel engaged in deck cargo operations offshore, a number of lifts had been successfully discharged and backloaded, which led to limited space on deck. The crane operator had landed a 3m cargo container on deck, and while he was trying to re-position the lift for easy disconnection by the deck crew, the corner of the container became snagged on the side of a deck light guard resulting in the parting of one of the slings. The container with broken slings was safely stowed on deck. There were no injuries, no damage and no environmental impact.
