IMCA DP Station Keeping Bulletin 03/20

DP Incident Caused by Human Factor

Lack of Operational Planning Leads to DP Incident

Loss of Gyro Input Causes Loss of Position

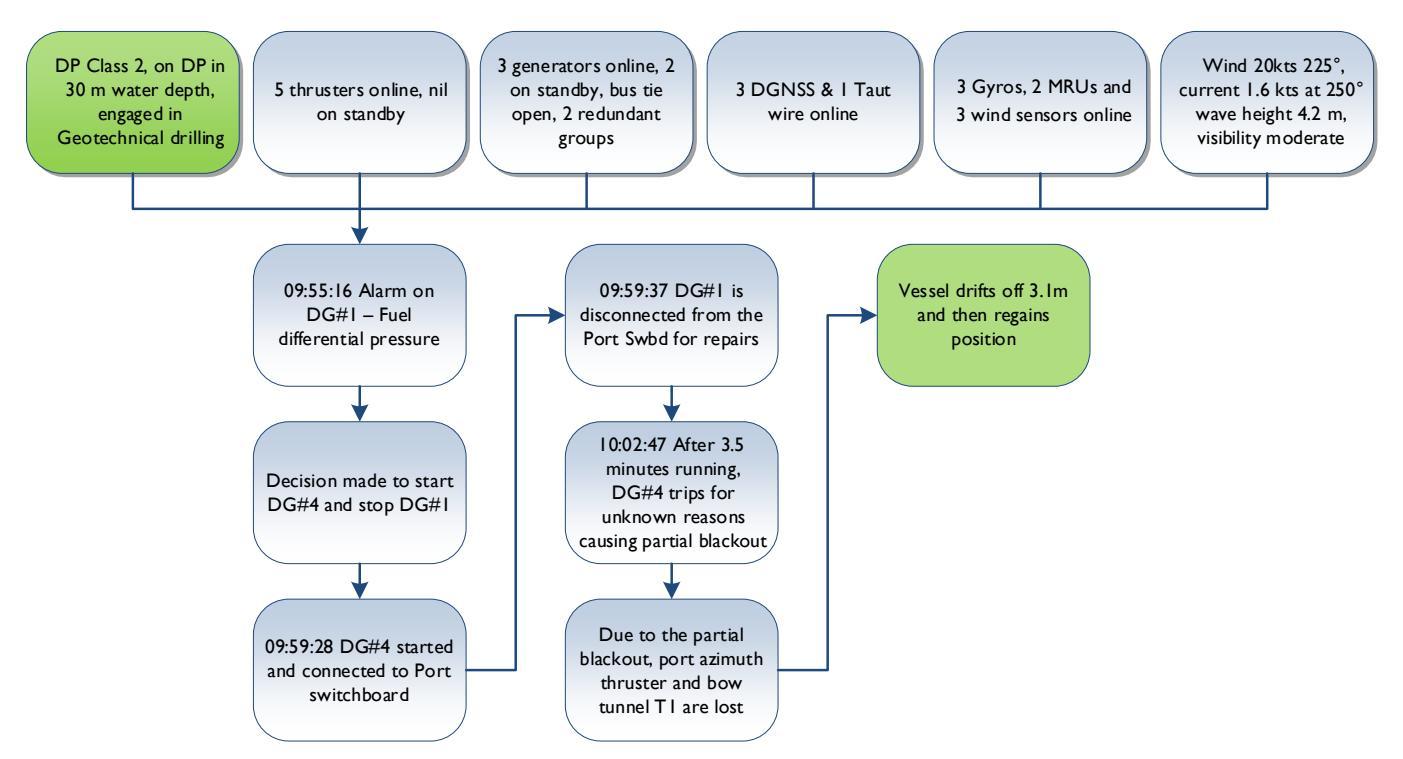
It is mentioned in the report that DG#4 tripped out for unknown reasons. Elsewhere in the report the cause of this incident is mentioned as complacency or lack of knowledge with DP redundancy concept.

- The set-up of the PRS was such that the DGNSS had the majority of the "PRS Weight" calculation in the DP controller, which is not recommendable.
- When a fuel filter differential pressure alarm is received, ensure that the correct procedures for filter changeover and filter replacement are carried out as soon as reasonably practicable. Always ensure that standby diesel generator is checked to ensure continuous service.
- The excursion was 3.1m but it should be noted that this is 10% of the water depth and could have been critical depending on the industrial mission.
- There is no mention of the DP watch circle in the report. It is particularly important that an Activity Specific Operating Guidance (ASOG) document is compiled and utilised for all DP operations, in accordance with IMO Circular 1580, chapter 4, see IMCA M 220 Operational Activity planning.

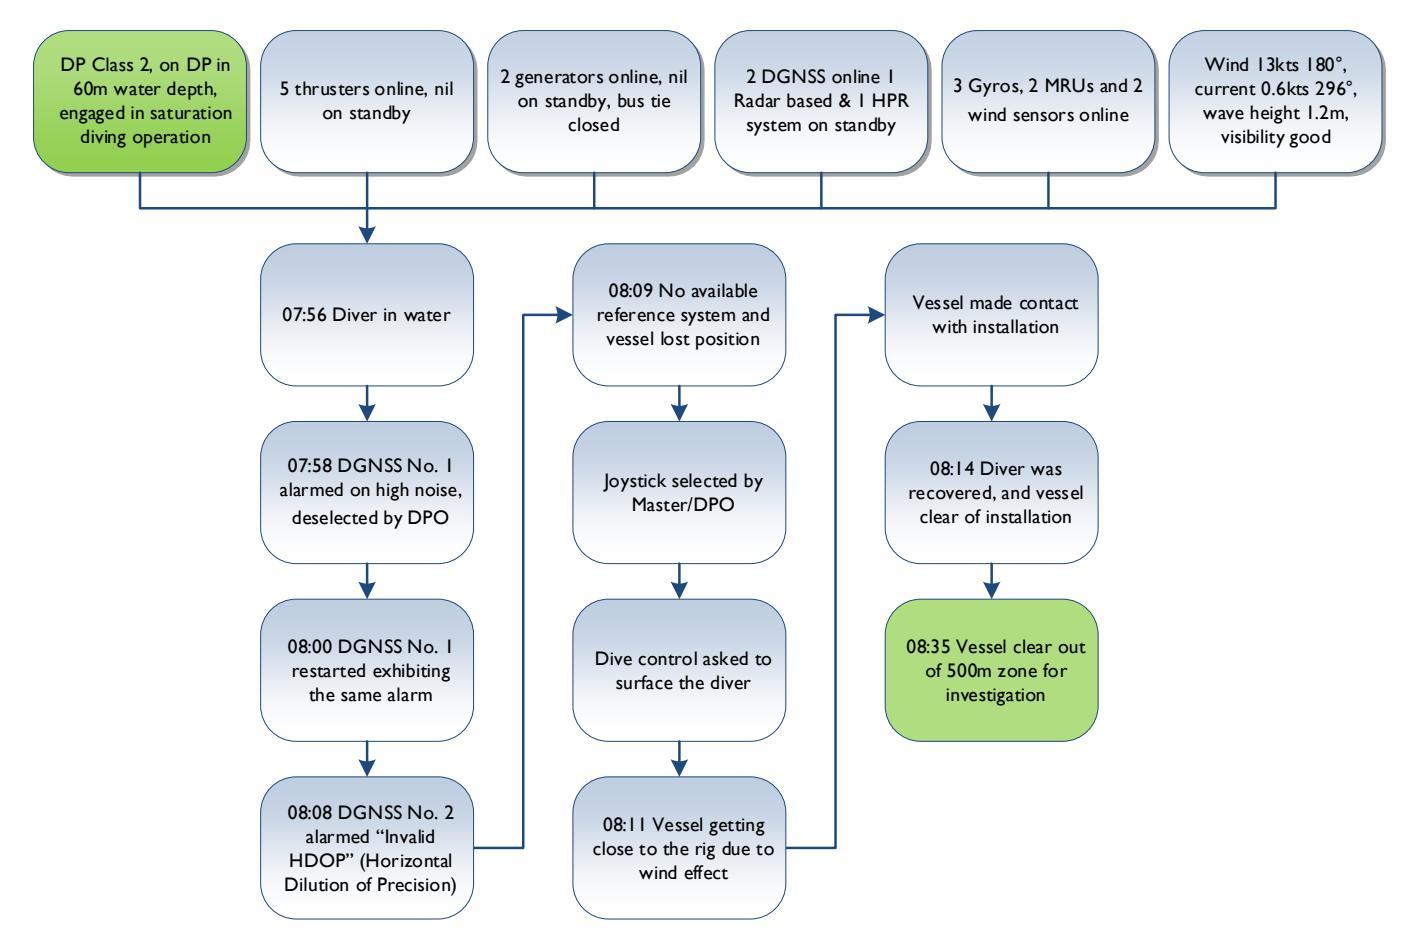
It was concluded that the loss of both DGNSS were due to huge superstructure of the installation interfering with satellite signals. This phenomenon is called reflection meaning DGNSS picks up reflected signals from the surroundings.

- The vessel was not being operated as a DP Equipment Class 2, as the requirement is at least three independent position reference systems should be installed and simultaneously available to the DP control system. Reference IMCA M 252 Guidance on Position Reference Systems and Sensors for DP Vessels.

- Loss of more than one DGNSS position reference system is a well-known issue due to external common cause failures, for example shielding of reference satellites and/or differential corrections.

- Operational planning and decision support tools, such as Activity Specific Operating Guidelines (ASOG), were clearly not in use or were inadequate. Reference IMCA M 220 Rev 1 provides Guidance on Operational Activity Planning.

- It appears that the DP Alert system was not used.
- It is mentioned in the report that at 08:09, master takes control of the vessel by the IJS. It is unclear from the report why the vessel then made contact with the installation. Reference IMCA M 117 The Training and experience of Key DP personnel.

- This event clearly demonstrates the benefit that can be gained from regular DP exercises and drills.
