1 LTI finger injury during mooring operations

Safety Flash

09-23 - April 2023

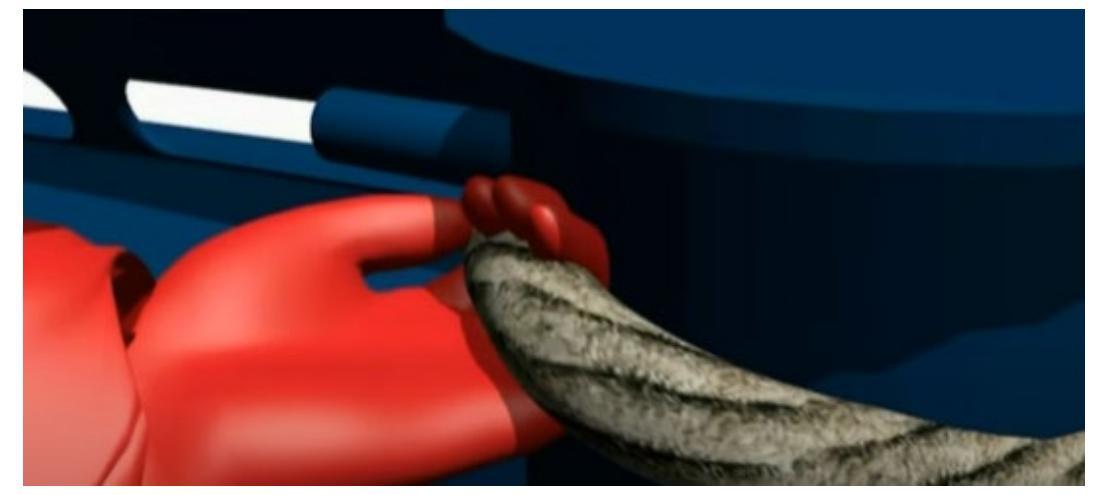
An AB got his left index finger trapped between a bitt and a mooring rope, resulting in a broken finger and 45 days off work. The incident occurred during un-mooring at the end of a ship-to-ship refuelling operation.

- There was no assessment of the PPE worn by the crew on this job; the impact gloves worn by the AB were in poor condition;
- There was a soft eye at the end of the mooring rope, but no small rope extension was used to remove the soft eye from the bitt;
- The crew on the other vessel did not allow sufficient slack on the mooring rope;
- There was no management oversight or monitoring of inexperienced or "short service" personnel.

- Ensure short service personnel (persons who are not yet experienced on any given worksite or vessel) are appropriately supervised;
- Our member started to use small rope extensions on the soft eyes so as to avoid exposing fingers and hands to risk;
- Ensure that sufficient slack is allowed when handling mooring ropes.

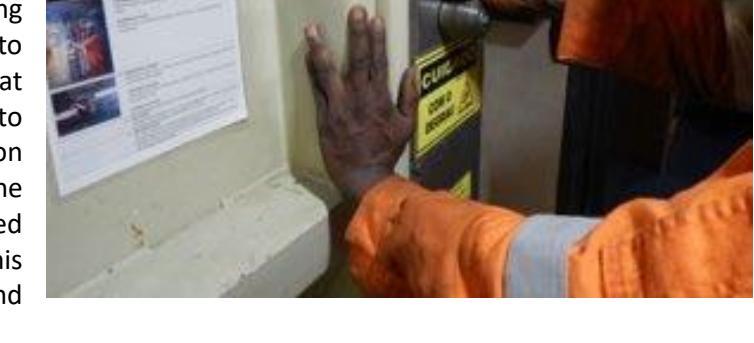
A fitter's left index finger was pinched between the moving door edge and door frame causing small abrasions to the index finger. The incident occurred during testing of the

watertight door following a visual alarm on the bridge which had indicated that a watertight door near one of the engine rooms was open. The Engine control room was contacted and requested to investigate the door status. A fitter was sent to check the door. Upon arrival he noted that the door was closed; however, the audible alarm was going off, indicating that the door was open. He began testing the door, which involved cycling it from closed to open. As he did so, his left hand was positioned flat on the moving door whilst his right hand was used to operate the hydraulic door lever. His focus was on the locating pin and sensor where he believed the fault to be, and he didn't realise his hand had moved into the line of fire. As he closed the door he got his finger caught between the moving door edge and door frame resulting in a minor injury.

Although the actual consequence of this case resulted in a minor injury the potential consequences of incorrect conduct with watertight doors could have resulted in a serious injury.

- The fitter's extreme focus on fault finding caused him to miss the important fact that his hand was in the line of fire;
- There were other distractions such as high noise levels from the machinery space, the door alarm, and flashing light which could have contributed to his lapse of concentration;
- Our member notes a non-contributing factor was the routine practice of leaving watertight doors in the open position whilst at sea. This could result in a detention by Port State Control or more importantly the risk to the integrity of the vessel when at sea.

• Controlling or modifying human behaviour is a difficult managerial challenge, which requires a commitment to safety, and the effective use of education, training, monitoring and enforcement.

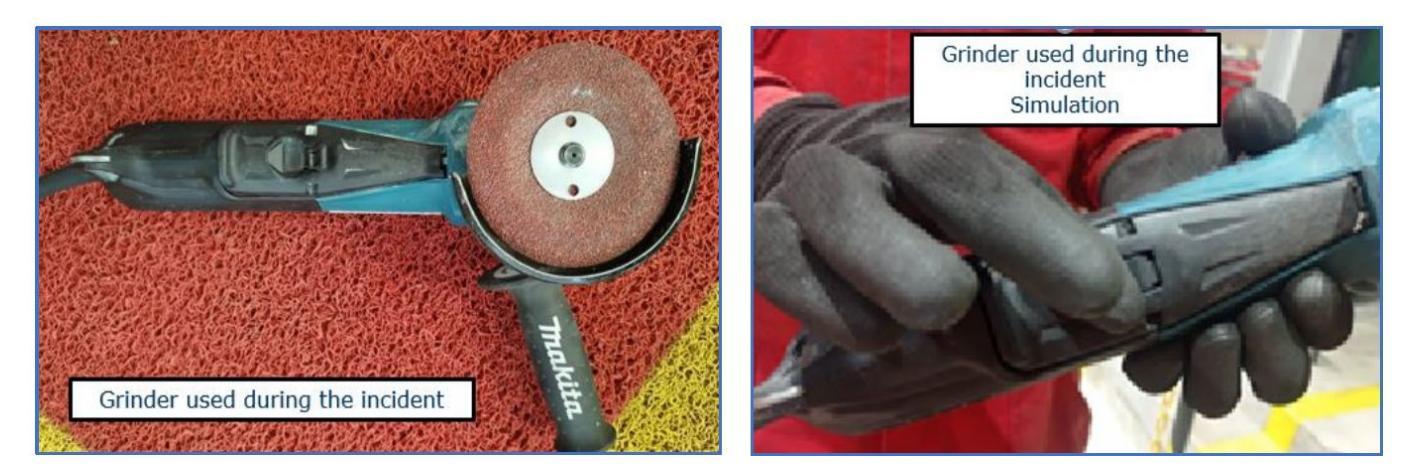
A subcontract worker received a 3cm laceration to the hand while using a portable grinder. The incident occurred during flowline fabrication work at a spool base. The portable grinder was turned off and hanging on the grinder stand (vertical support), with a flapping disk installed. The worker used his left hand to pick up the grinder to start preparation of

the parent coating in the workstation. As he grabbed the grinder, he inadvertently pressed the start trigger and the grinder started spinning. The grinder then slipped hitting his left hand, which resulted in a 3cm laceration between thumb and forefinger. He received first aid before being taken to hospital for further treatment – six stitches.

- The grinder used by the subcontractor had reduced safety features (i.e. a "deadman" switch only) when compared with company grinders at the same worksite (which were fitted with a "fast break deadman" switch);
- The wheel protection was not properly positioned, allowing the spinning disc to touch the workers' hand. This was not aligned with company "Abrasive wheels training" requirements;
- Although the worker was wearing the appropriate anti-cut gloves, their specifications were of a lower protection than those used by company crew.

- Ensure grinder wheel protection, and power tool guarding, is properly positioned before using the tool; during pre-work inspections; and during regular maintenance;
- Ensure subcontractors are clear on the requirements for PPE and hand tools should be the same for all;
- Before all operations remember the "7T's" take the time to think things through;
- Exercise stop work authority as and when appropriate.

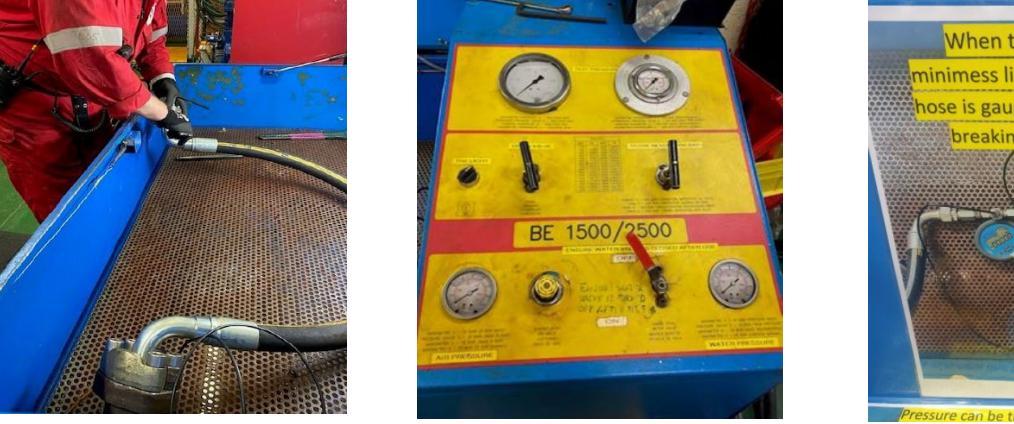
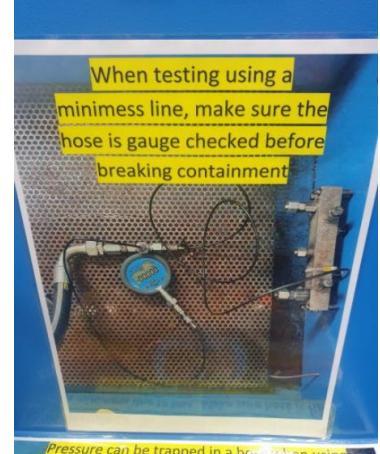
A technician was pressure testing hydraulic hoses in the hydraulic workshop using the water pressure test bed. He had previously tested two hoses earlier in his shift. On completion of pressure testing the third hose the technician opened the drain valve and witnessed the gauge go down to 0 bar. He then proceeded to remove the blanking flange

from the opposite end of the hose he was testing. When doing so a release of pressure occurred knocking his hand onto the wall of the test kit resulting in a laceration to the palm and a bruise to the back of his right hand.

- The technician assumed that as the reading on the gauge had dropped to zero, it would be safe to release the fitting. But the larger volume equated to a longer drain time;
- Pressure was trapped because the connection was mistakenly slackened too quickly after opening the drain valve. This resulted in the check valve in the hose to close and trap the remaining pressure in the hose. The hoses were "Minimess" hoses;
- Though the gauge on the control panel was reading zero it would have taken a few more seconds for the pressure to dissipate from the test hose due to the larger (3.75cm) diameter;
- Pressure was released when the technician started to remove the blanking flange.

- Create a routine duty for the testing of "Minimess" hoses and update the appropriate task risk assessment;
- WAIT a moment! Allow a delay of 10 seconds from when main pressure valve is opened, and always install a second gauge on the test hose after the "Minimess" to ensure the test hose has zero pressure;
- Post better instructions on the test rig reminding users of precautions when testing hose and to ensure pressure is drained from the test hose.

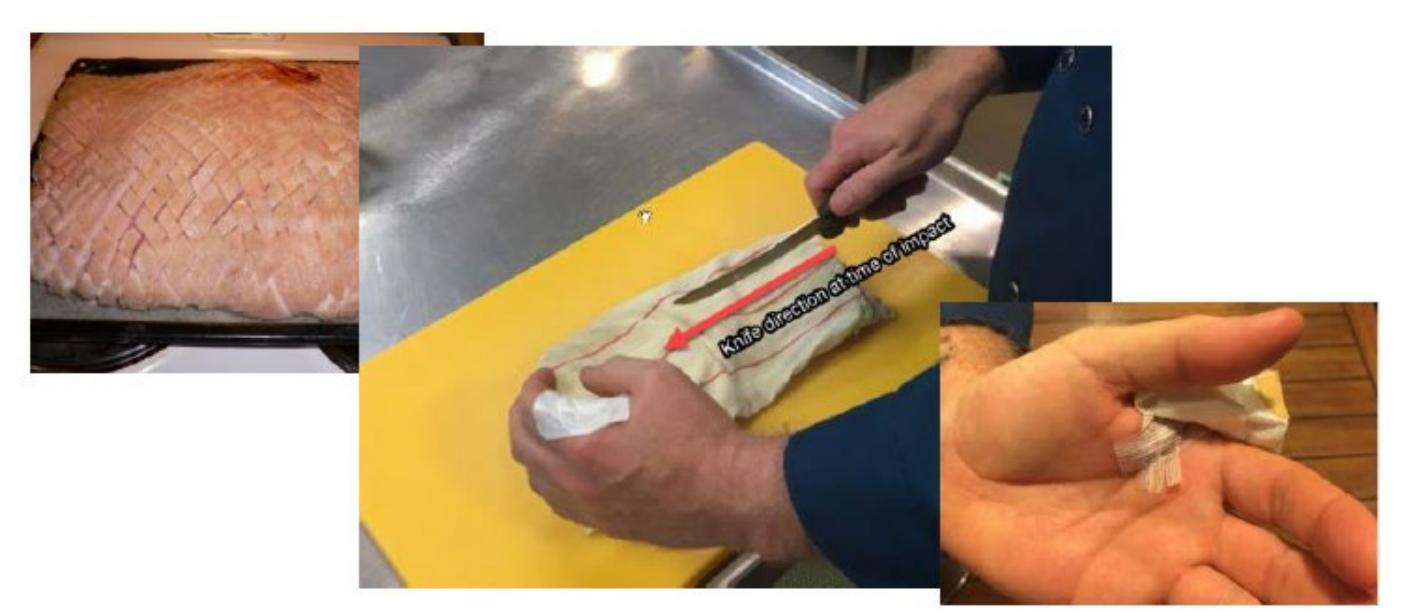
An experienced cook in the galley badly injured his hand when his knife slipped. The incident occurred in a vessel alongside at Christmas. The cook was preparing meat when his knife slipped and jabbed the top left part of the palm of his left hand, causing a serious laceration.

As a consequence the cook needed surgery to repair three damaged nerves.

- The cook used no PPE butcher's gloves;
- The meat was not at the ideal temperature for cutting with minimum force;
- Cutting was done by both pushing and pulling of the blade;
- The risk of the knife slipping was neither assessed nor mitigated.

- Cut away from the hands or the body;
- Use appropriate PPE in the galley;
- Did the injured person feel pressure to carry on ? A person working alone also has "Stop work authority";
- Experience is not necessarily a fail-proof barrier or mitigation against risk.
