IMCA Safety Flash 09/09

June 2009

I Poor Maintenance and Subsequent Failure of Welding Equipment

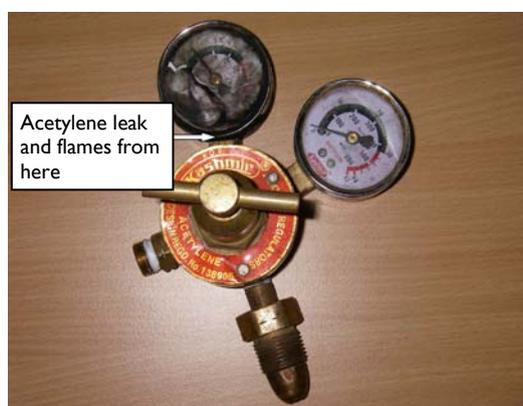
During a recent mobilisation on a member's vessel, sub-contractors were burning and welding sea fastenings on the main deck. Following a report that flames were coming from the contractors' acetylene tank regulator situated inside the holding gas quad, a small fire was extinguished at the regulator, which was then cooled and removed for inspection (see Figure 1). On examination it was found that thread tape was being used in all the connections on the contractors' equipment.

Figure 1 – Leaking regulator

The company would like to highlight the potential hazards of lack of control and maintenance of ship's and sub-contractors' welding equipment, as there have been a number of incidents involving welding equipment in a poor state of repair and being used whilst unfit for purpose onboard recently.

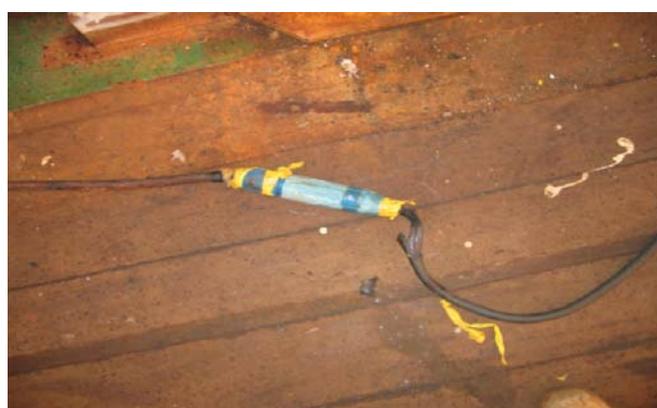
- ◆ A ship welding cable was found to be smouldering at a connection point;
- ◆ A midway cable connector was found arcing and smoking during deck welding operations;
- ◆ A nozzle head was found detached from an oxy-acetylene torch.

Figure 3 – Welding cable found to be smouldering

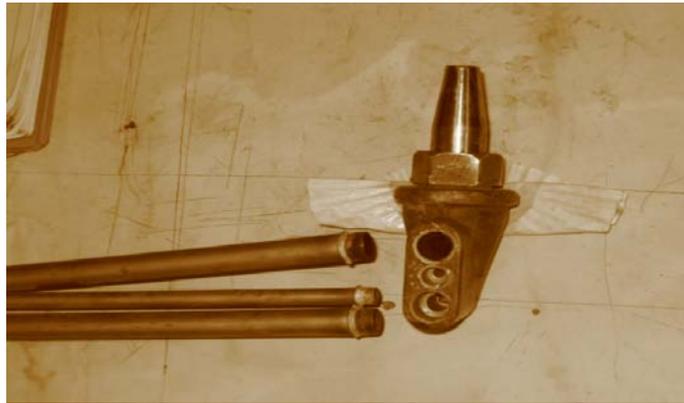
Figure 5 – Detached nozzle head

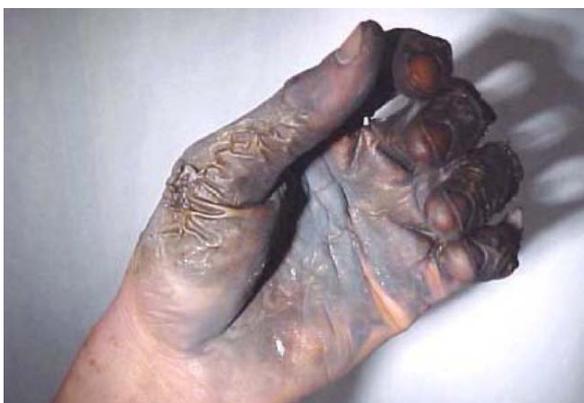
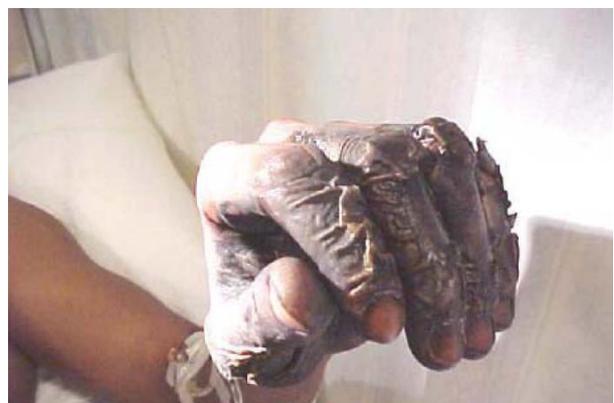
It highlights an incident involving a welder who was adjusting the pressure on an oxygen regulator. The welder had oil on his hand and there was an oxygen leak from the hose clamp. As a result the welder's hand was badly burnt. Oxygen under pressure and hydrocarbons (oil and grease) can react violently, resulting in explosions, fire and injury to personnel and damage to property. Never allow oil or grease or any organic matter to come into contact with oxygen under pressure.

Figures 7 and 8 – Welder's burnt hand following oxygen/hydrocarbon fire at leaky hose clamp
