IMCA Safety Flash 16/18

July 2018

1 Lost Time Injury (LTI): Ankle Injuries During Loading Operations

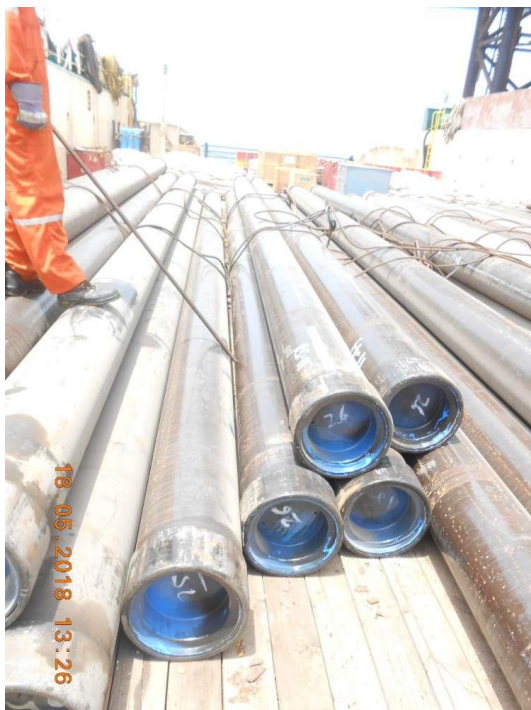
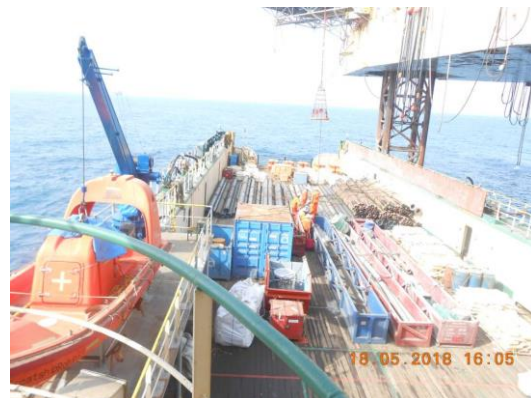
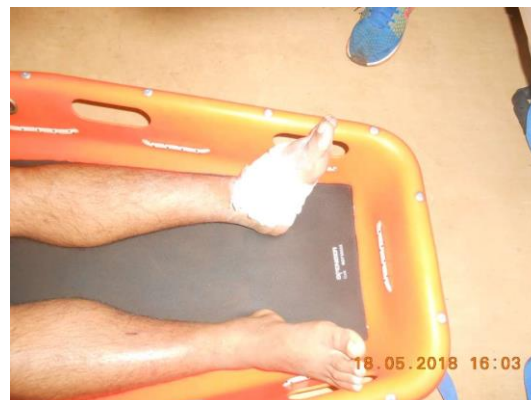
An experienced AB suffered serious ankle injuries during offloading operations. A vessel was delivering drill pipe casings to a jack-up rig when he was hit by the casing bundle being discharged. The casing involved in the incident was being lifted when it was observed that the Tag Line was entangled in the sling. The crane operator lowered the casing to around 1m above the vessel deck. The AB was instructed by the Duty Officer to untangle the tag line. Whilst he was doing this, the crane operator lowered the casing bundle without warning, causing it to swing towards the AB. He was struck by the casing bundle, lost balance and fell onto the adjacent casings lying on the deck. The movement of the crane did not stop, and the casing bundle was lowered further, coming to rest partly on the AB's legs and partly on other casings on the main deck.

- ◆ There was a lack of situational awareness/risk perception/risk awareness on the part of the crane operator of the rig;
- ◆ There was inadequate communication or transfer of information and intent from the rig crane operator to the vessel.

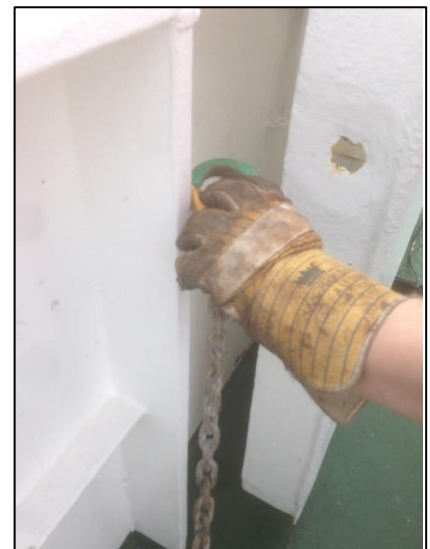
During cargo operations, a crewman got his finger stuck between the cargo and the lifting chain. The incident occurred when a vessel was discharging modules with a weight of 220 tonnes direct from the vessel to a trailer on the quay. One hook of a chain tackle which was connected to the cargo, fell off. The other hook was still connected to the trailer. When reconnecting the hook that fell off, a sudden movement of the module meant that one finger got stuck between the module and the chain. When the module swung back the crewmember was able to remove his hand. His finger was seriously damaged, and he had to be sent to hospital for X-ray and stitches. He came back onboard some hours later.

- ◆ There had been a change of plan, for which there had been insufficient management of change (MoC). The company has a technique for use in exposed harbours where swell is an issue. It was felt that there was

insufficient equipment available for that technique to be used safely, so the decision was made to land the cargo straight on the trailer, using chain tackles to reduce the horizontal motion;

- ◆ No job hazard analysis or toolbox talk took place for the alternative lifting technique; this is considered to be the cause of the incident.

- ◆ New technique was to be developed for landing cargo in a swell port, based on tools/equipment the company used in another product group (cross learning).

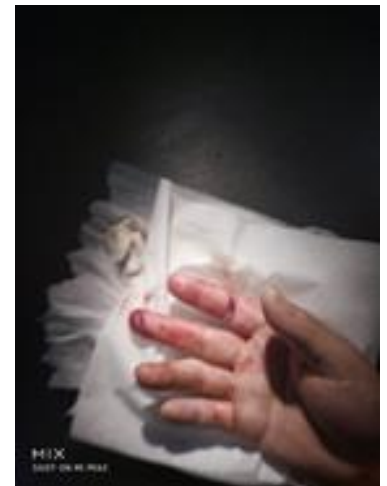
A crewman suffered a crushed finger during an operation to replace a winch wire on a large crane. Two crew members were installing a wire wedge into the eye of the wire in order to prevent the wire coming loose from the winch drum. They held the wedge in place by hand whilst other crew tightened the wire. Unfortunately, the wedge – which weighed 15kg – fell. The crew were unable to support the weight of it and one person had his right hand crushed between the wedge and the deck. He was taken to the on-board clinic immediately. The on-board doctor treated him for injuries to his forefinger and middle finger.

- ◆ There was no proper holding point on the wedge;
- ◆ Workers' gloves were contaminated by the wire grease during operation making them slippery;
- ◆ When the wedge fell, one person attempted to hold or stop its fall, but failed due to the 15kg weight;
- ◆ The operation was not conducted in the safest or easiest manner.

A better technique would have been to rotate the drum until the wire eye was upward. Then the wedge could be laid on the eye, and the wire tightened up until the wedge was suitably secured.
