IMCA Safety Flash 13/19

June 2019

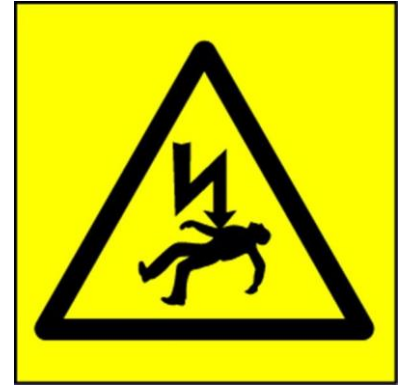
- ◆ Poor site housekeeping, specifically cable management;
- ◆ Incorrect ingress protection (IP) rating;
- ◆ Damaged tools and cables;
- ◆ Equipment used in inappropriate environmental conditions.

- ◆ Vessel energy sources, capacities and connections should be communicated between project teams and sub-contractors to ensure adequate time is given to review and plan works accordingly, with minimal deviations from the site controls and requirements;
- ◆ Task based risk assessments should consider the task, the site, the environment and the equipment, with operator/work party checks being essential for safe operations;
- ◆ Obtaining suitable 110 V AC, hydraulic, battery-operated or air driven hand tools and equipment should be considered where necessary.

Where 110V AC, pneumatic or battery operated equipment is unavailable either on the worksite or through the sub-contractor, 220V AC portable electrical hand tools can be considered, once risk assessed, in order to ensure the correct controls are in place (minimal use, RCD in circuit, isolating transformer, correct equipment ratings, environment, etc.), on a case by case basis or in line with specific regional electrical tooling procedures. Equipment supplied to site should always be fully operational and in serviceable condition and should be inspected by the end user before use.

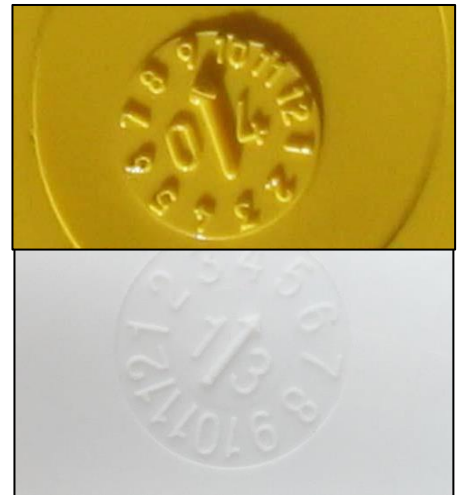
Safety helmets do not last forever and have a finite life span after which they should be disposed of. Helmets will have some form of embossed date stamp similar to that in the illustrations below. Members may wish to ensure looking into ethical and appropriate recycling of old or expired safety helmets, in particular, ensuring they are not used elsewhere after being thrown out.
