1 UK MAIB: Safety Digest – lessons from marine accident reports 1/2021

3 Leg injury when struck by rebounding hammer

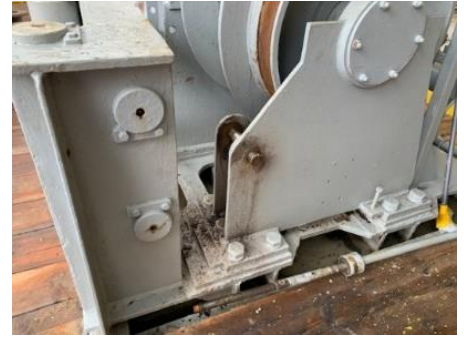
A crew member was struck on the right lower leg (the shin) by a rebounding hammer. The incident occurred when he was using the hammer to remove a stainless steel securing pin on the brake band drum of a tugger winch. He was using the hammer and other equipment to remove a stainless steel securing pin, which was positioned at knee height on the brake band drum. The pin was moving both ways a little, but required more lubrication. Spray lubricant was applied and was working through the pin mounts. The crew member was striking the pin out using the hammer; one blow missed the pin, rebounded back and struck his right lower leg, causing a small cut and bruising above the ankle.

- He was in the line of fire – his leg was so positioned as to be hit when the hammer rebounded;

- The arc / swing of the hammer onto the pin required precision to avoid striking to the side, which resulted in uncontrolled rebound of the hammer in an undesired direction.

- Immediate causes
 - He hit the pin in such a way as to cause the hammer to rebound in an uncontrolled direction;
 - His leg was in the way.
- Root Causes
 - Inadequate continuous risk assessment
 - The crew member did not identify the potential hammer miss-hit and rebound direction of the hammer during the activity;
 - The risk assessment did not identify the required body position to ensure it was not in the line of fire.
 - STOP Work Authority
 - No “Stop Work” and review the activity was undertaken during the tasks to evaluate the controls being implemented and the possible requirement to improve (by the individual or others).

- Deeper and more thorough consideration of what “Line of Fire” can mean – are you in **your own** line of fire?
- Check with your colleagues before starting – *is this safe, could I do this in a better way?*
- **STOP the job** if you think it is unsafe, and put the right controls in place to make sure no-one is harmed.

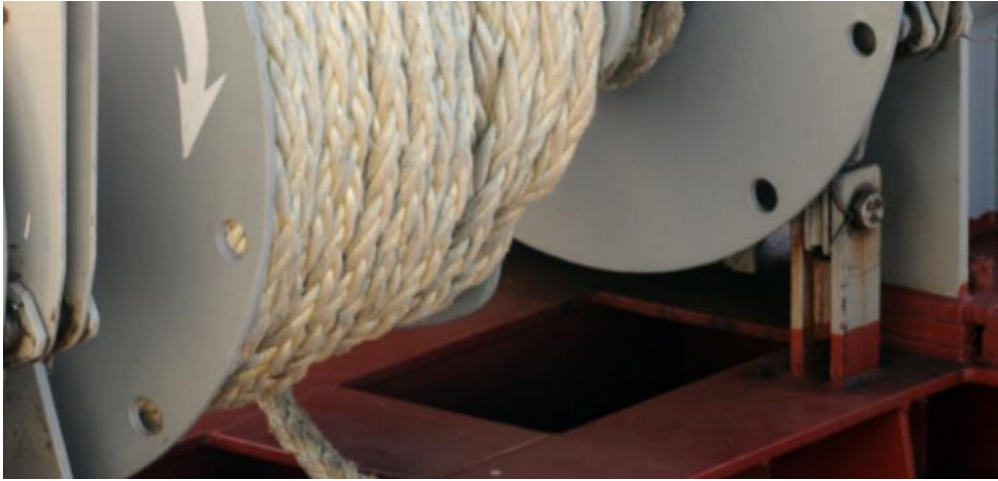
Line of Fire

During mooring operations, a member of the crew was caught between a mooring line and the fairlead as the mooring line paid out very fast, resulting in his leg being cut off. A first aid team from shoreside came onboard, and thirty minutes later an ambulance arrived and took him to hospital. He survived but is now disabled.

- The vessel had a risk assessment for the mooring operation, but this did not include the risk of the mooring line getting stuck in the propeller, as the mooring line should be floating in normal circumstances;
- In addition, the mooring line was partly around the bollard, with a bight and a right angle to the normal pull direction. This arrangement caused the snapback zone to cover the entire area between the bollard and railing. When the rope ran out rapidly and got caught in the propeller it snapped back to where the Third Officer was standing, even though he was not inside the normal snapback zone;
- This shows the importance of everybody involved in the operation being aware of the risks of potential snap-back zones. Mooring a vessel is a normal operation, but the **risks need to be re-evaluated every time**. (IMCA emphasis).

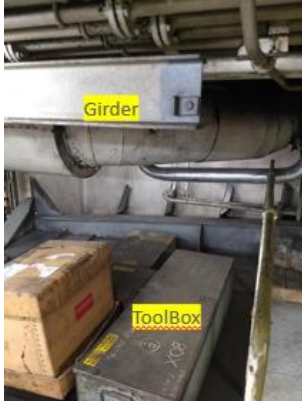
Around eight hours into their shift, a crew member was stowing tools and equipment in the port side aft engine room stowage, and as he bent down to open the lid of the toolbox, he hit the corner of a girder and gashed the top left-hand side of his scalp. He was attended to with first aid treatment to stop the bleeding, clean and dress

- The crew member was a very tall person in relation to the limited working space;
- The crew member was complacent and lacked situational awareness;
- He was not wearing proper PPE (a bump cap);
- There was no protective material on the girder, nor were there warning signs or hazard ID tapes on the girder;
- There was a lack of viable and safe stowage space in the Engine Room.

- Follow your company rules for PPE;
- Develop a higher level of situational awareness;
- Impact protection (high density foam) wrapped on the edge of the girder, also, safety warning signs, and hazard tapes to indicate line of fire.

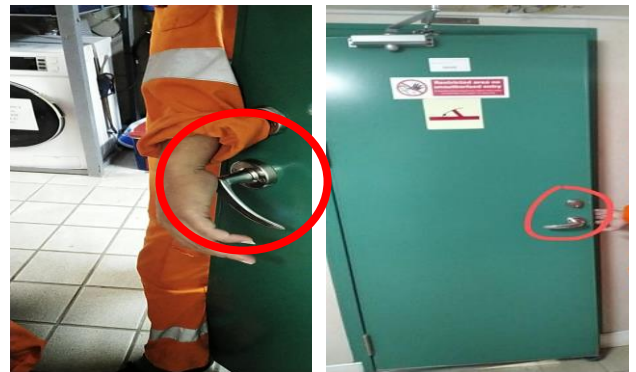
During a routine inspection of the air conditioning plant room, the engineer caught his sleeve on the latch of the AC room door and due to the lower pressure within the room, the door closed and slammed shut catching the tip of his finger. He was

*Crew Member Caught
Overalls On Door*

Door Closed On Finger

- He had his sleeves rolled up making snagging more likely;
- There was no indication that the AC room door would slam shut because the room was at a lower pressure than elsewhere;
- The spring loaded self-closing device on the door was set to slam the door shut due to the lower pressure in the AC room, as it would not close properly under any other setting.

- A sign was posted indicating that the door was a pinch point owing to its tendency to be pulled shut by the lower pressure in the AC room.
