IMCA Safety Flashes summarise key safety matters and incidents, allowing lessons to be more easily learnt for the benefit of all. The effectiveness of the IMCA Safety Flash system depends on Members sharing information and so avoiding repeat incidents. Please consider adding safetyreports@imca-int.com to your internal distribution list for safety alerts or manually submitting information on incidents you consider may be relevant. All information is anonymised or sanitised, as appropriate.

1 Damaged Electrical Cable

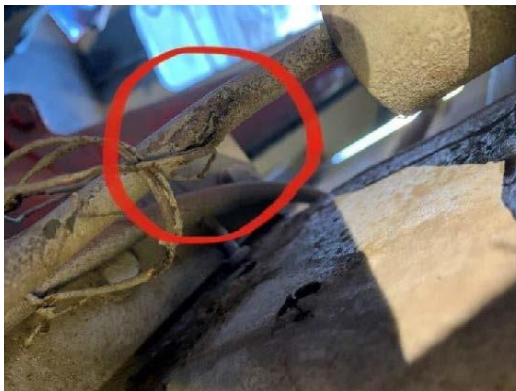
During a washdown of a vessel's cargo hold a crew member noticed arcing from around two electrical cables near the cargo hold light. Upon closer investigation he noticed a piece of tie wire connected to the cables was glowing red. The crew member immediately stopped hosing down and turned the water supply off and notified the ship's electrician.

Damaged cable

The outer insulation of the cabling was damaged. The cable insulation had deteriorated due to age and weathering, exposing the live wire. The location of the cable was such that it was not easily accessed for detailed visual inspection.

- Visual inspection of all electrical cables for early signs of aging and weathering, particularly in difficult to see areas.

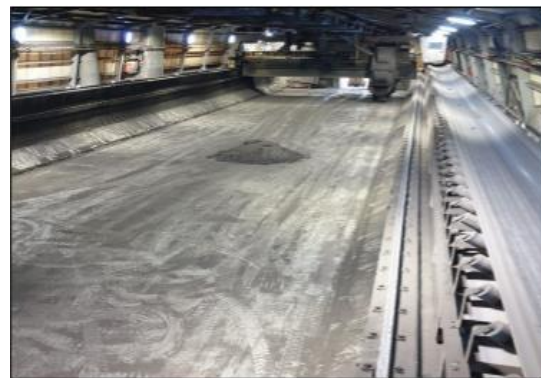
Cargo hold

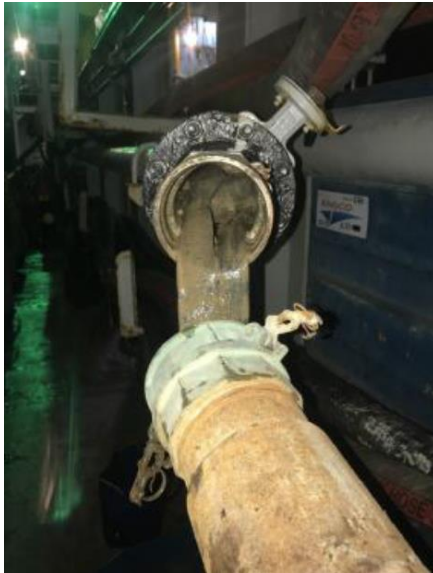
A vessel was engaged in routine operations receiving contaminated oil-based mud from a rig. Upon disconnecting the rig hose and vessel side coupling it was discovered that the inner rubber lining of the rig hose had peeled out and got caught at the junction of the connection.

Inner Rubber Lining of Rig Hose

Rig side hose inner lining parted from sheath and got caught between connections.

- Ensure that hoses are in good condition, properly certified, and in compliance with required standards, before use;
- Conduct a visual check on hoses before use;
- Remember that anyone can enact **stop work authority** if they see something unsafe.

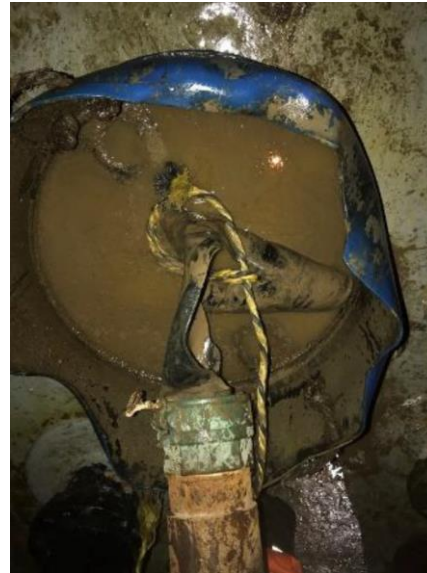
Rig hose

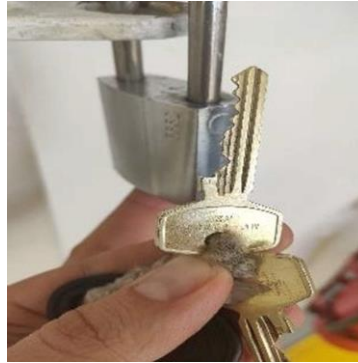
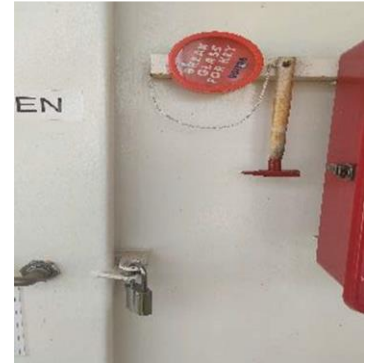
During a weekly inspection it was revealed that the key for the CO₂ fixed firefighting system compartment, which was stored in a break glass box adjacent to the entrance, did not fit the padlock – it was the wrong key. This could have led to unavailability of access to the CO₂ fire-fighting activation panel in the event of an emergency.

- Lack of awareness and non-compliance with both regulatory and company requirements.
- Lack of emergency preparedness

A new padlock and key were installed, with the key in the break glass box alongside.

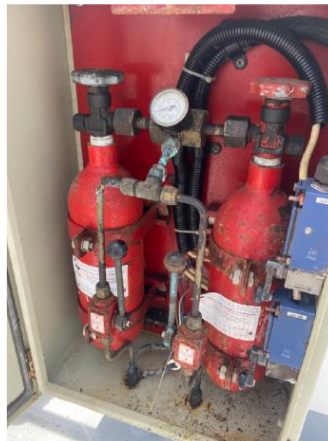
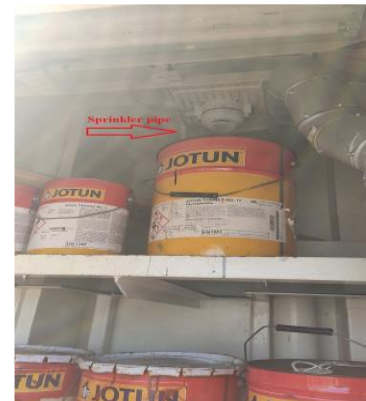
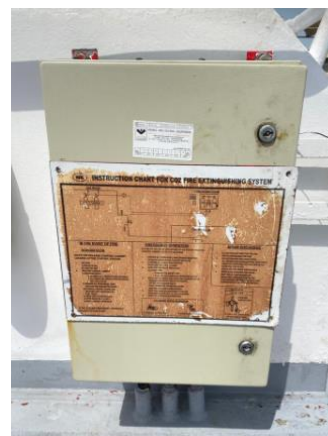
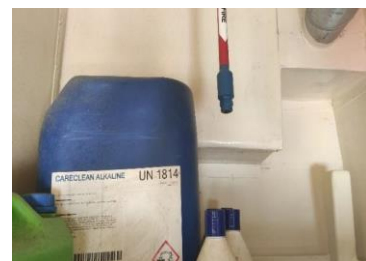
It was observed that the nozzles of the fire main piping system in the paint and chemical storage facilities were blocked by cans of paints and chemicals.

There had been no adequate visual inspection of the paint locker with respect to the fire fighting sprinklers, and as a consequence, the nozzles and sprinklers were obstructed.

During an inspection it was observed that components of the CO2 release station were corroded, and the CO2 release station instructions were faded and not clearly legible.

Members may wish to conduct a specific hazard-hunt or inspection of fire-fighting equipment inspection, particularly sprinklers and nozzles, and particularly in poorly lit or less-often visited spaces on the vessel.

Members may wish to check equipment such as this, that may be rarely or irregularly inspected, to ensure it is in workable and usable condition.
