1 Broken Chinese Finger

2 Incorrect operations result in failure of hoist

3 Man overboard from anchor handler tug

4 Don't ASSUME – verify and check

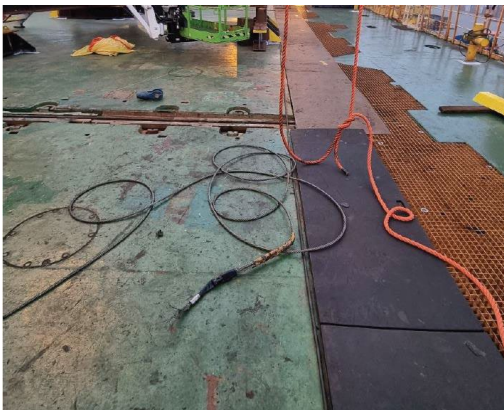
During a reeving operation of the forward crane auxiliary hoist, there was a failure of a “Chinese Finger” between the messenger wire and auxiliary hoist wire. About 6m before reaching the trolley sheave, the Chinese Finger broke, resulting in the auxiliary hoist wire falling down into the cargo hold. The messenger wire fell on the main deck below the crane trolley.

Broken messenger & auxiliary hoist wire

- The Chinese Finger parted due to direct contact between the sharp edge of the Auxiliary Hoist Wire and the Chinese Finger itself;
 - The Chinese Finger could not withstand the applied tension endured during the reeving works;
 - The point of contact between the Auxiliary hoist wire and Chinese Finger was too sharp resulting in a point load;
 - The Auxiliary hoist dead-end was not tapered and by this created a sharp edge at the extreme end of the wire;
- There was a lack of awareness of this aspect of the use of the Chinese Finger.

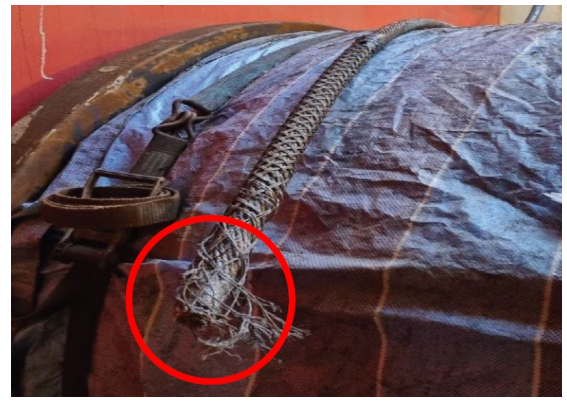
Close-up of broken Chinese Finger

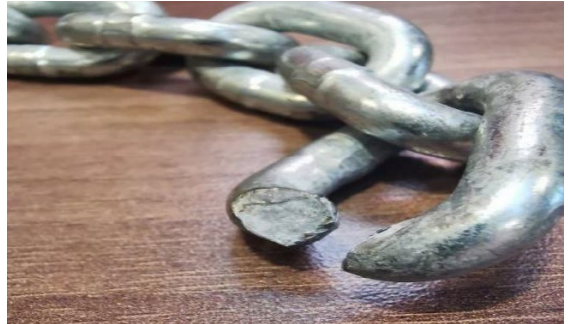
Findings indicated that at some point during the operation, the chain had entered the hoist in a twisted or knotted configuration and excessive force applied resulted in damage to the chain link which subsequently failed.

When using a chain hoist, consider checking the chain for twists as it enters the block. Continually monitor the chain to ensure no twisting occurs. Avoid pulling the hook into the body of the hoist.

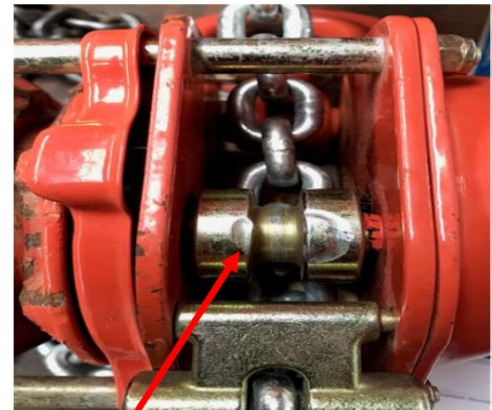
Sign of compression, indicating the chain link was twisted side on and snapped due to the change in dynamic loading placed on the chain link.

keep the load clear of the floor. This put additional load into the chain and block and left nowhere for any residual twist in the chain to go, causing the damage to the chain and its subsequent failure.

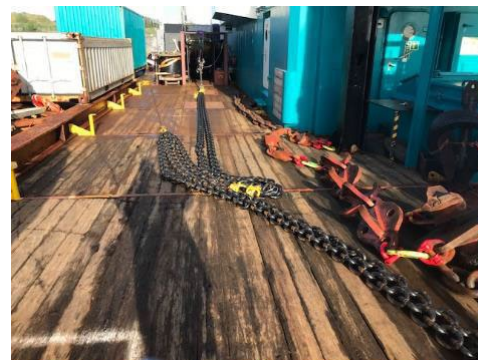
A sub-contracted anchor handling tug was performing grapnel run activities using a long chain as a grapnel. Whilst overboarding the chain, a crew member lost balance and fell overboard.

Vessel deck showing chain grapple

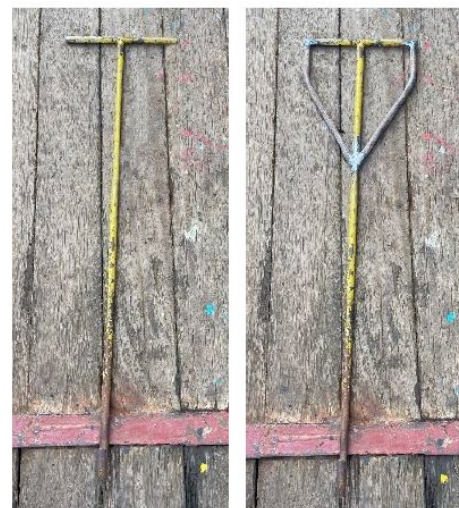
The first part of the chain was being over boarded using a hook with a T-bar across the top. When the chain started sliding overboard, the hook wasn't released quickly enough and at the same time the T-bar caught on the life jacket worn by the crew member, causing him to lose balance and stumble. This ultimately led to the crew member falling overboard.

Old and new design of hook

- After the incident the design of the hook was modified to prevent it from getting caught;
- Also, the overboarding process was changed to using the crane, eliminating the use of such a tool.

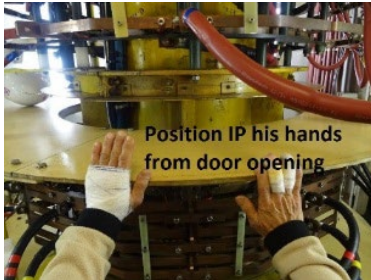
Electric shock: it was wrongly ASSUMED that a slip ring was isolated; it was not VERIFIED. Entry to the slip ring area was not required for the activity, that is why it was not isolated. This resulted in a person being electrocuted;

- Follow your company control of work processes – they are there to keep you safe;
- Do not start an activity until the control of work process, including all the necessary paperwork such as permits, JSAs, toolbox talks, etc, is complete. The paperwork is there to keep you safe;
- Inspect and VERIFY that all safeguards and precautions, as stipulated in the permits and JSAs, are in place before starting the activity – do not ASSUME they are in place;
- Don't be afraid to SPEAK UP and STOP THE JOB if you think that the control of work process is not being followed – DARE to CARE.

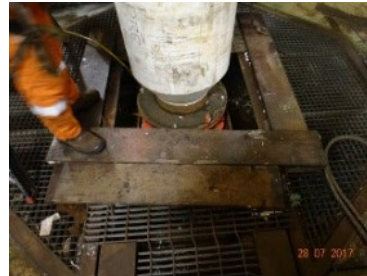
Dropped scaffold plank: it was wrongly ASSUMED that dropped object protection was removed. This resulted in a scaffold plank dropping 4m onto the coating station floor when the roller box, which the plank was resting on, was opened;

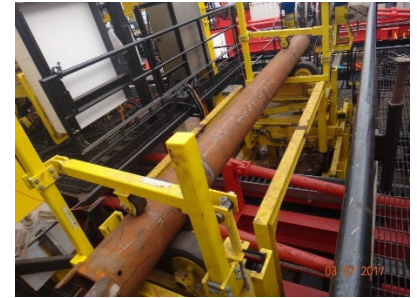
Worker went into area where equipment was moving: it was wrongly ASSUMED that the pipe assembly area was isolated; it was not VERIFIED. This resulted in a work party being exposed to moving machinery where they were working;

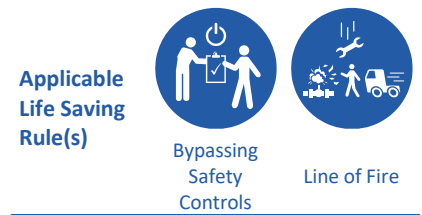
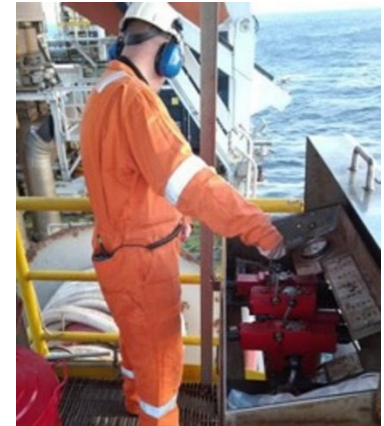
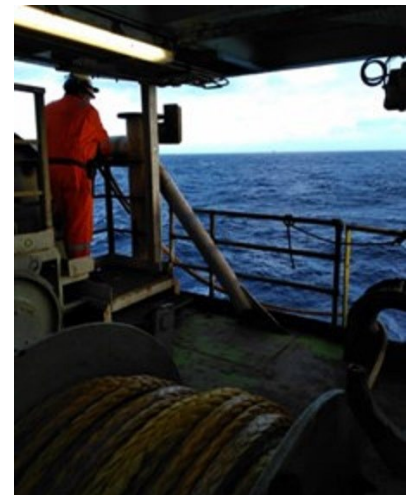
IOGP has published [Safety Alert #336](#) relating to a squeezed hand due to the unintentional activation of a winch. A crane operator stood by a control panel to operate the mooring winch. On the level below was an auxiliary winch connected to a rope that was hanging over the railing. By mistake, the crane operator activated the lever for the auxiliary winch, and a crewman on the level below saw the rope connected to the auxiliary winch move. He thought the rope was slipping over the railing and grabbed it. At the same time, the crane operator pulled further on the aux winch lever, which resulted in the crewman's hand being pulled in and squeezed between the railing and the structure.

- Poor design: the design of the workplace made it challenging for the crane operator to keep an eye on the control panel while operating the winch;
- The risk of unintentional operation of the winch was not identified, and the injured person's role in the work operation was not sufficiently described in the procedure;
- The injured person lacked part of the required training and did not know that the auxiliary winch could be operated from the control panel.

- Improve design of workplace to design out risks;
- Disconnect redundant levers;
- Ensure crew are properly trained and competent for the task at hand;
- Ensure the risk of unintentional driving of the winch is captured in risk assessment, toolbox talk etc.
