## 1 Serious injury during mooring operations: rope parted

## 2 Failure of slings during loading operations

#### 4 Damage to chain hoist subsea

## 5 Unsafe transportation and packing arrangements

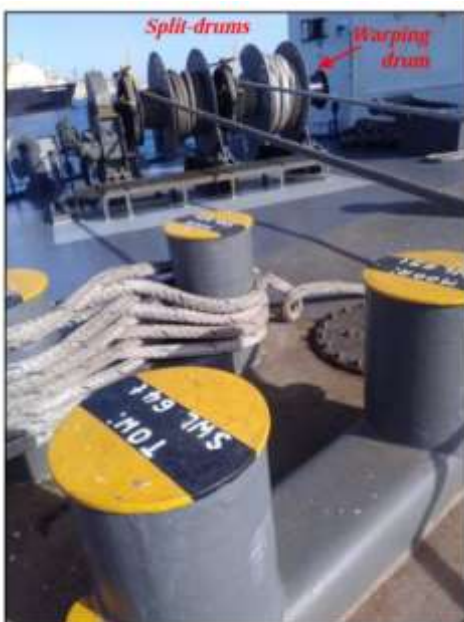
Figure 2: The aft, port side, twin split-drum mooring winch of *Mount Everest*

The Marine Safety Investigation Unit of Transport Malta has published [Safety Investigation Report 10/21](#) into a serious injury which occurred during the mooring of a chemical tanker of 23000 tonnes on Malta. At the aft mooring station, the mooring team noticed that one of the lines was tight, while the other was still slack. Whilst trying to equalize the tension on both lines, the taut line parted and struck the third officer. He suffered serious facial injuries and was transferred to a hospital ashore.

- A breaking test of the failed mooring rope, conducted after the accident, revealed that its strength had decreased by more than 50 % of its certified MBL;

- The rope’s external and internal fibres may have deteriorated due to abrasion / friction and / or chemical contamination;
- Stresses induced in the rope, due to internal friction and chaffing during this mooring operation, were contributory factors to this accident.
- The mooring configuration deployed for this operation was not supported by the vessel’s mooring design – it is likely that it would have been difficult to apply, considering the heights and distances between the mooring equipment on the poop deck;
- Crew members’ attention was shifted to another part of the mooring operation;
- There may have been a breakdown in communication during the discussion on the mooring configuration.

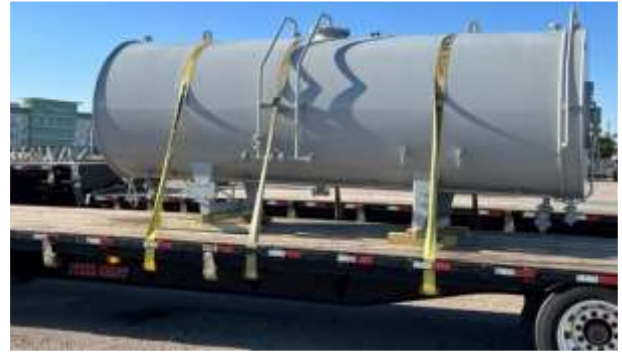
Personnel were loading out heavy plant at a land-based location when there was an incident involving failure of slings. A crew were lifting a large tank with a forklift using nylon slings and shackles from the lifting eyes at the top. The forklift carrying the tank to the trailer had to move over some rough ground and the tank was moving around and bouncing, so spotters were used on both sides. One sling failed and the tank dropped to the ground on that side. Then another sling failed, causing damage to both sides of the tank bottom, valves, and one leg was bent. There were no injuries.

- The slings broke due to the sharp edges not being protected there would have been high dynamic loads as the load shifted while being manoeuvred over rough ground.

- Ensure sharp corners and edges are protected before using soft slings – it is possible in this case that the edge of a fork was the sharp edge that cut the sling.
- A better practice would be to use a lifting attachment of some sort, or a crane – could the lift be done without soft slings?

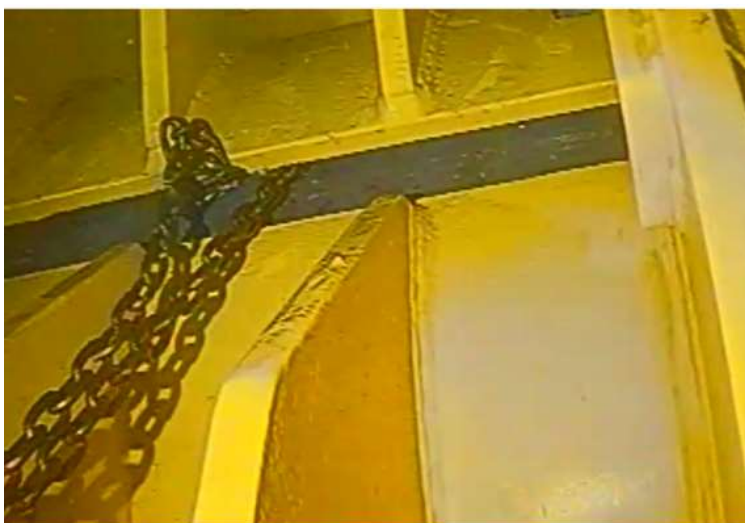
Whilst divers were lowering a large clamp for installation, the chain block used to centralise the clamp on the horizontal member became trapped in the hinge point on the clamp. The clamp was opened when it was noticed and damage to the chain link was observed. There was no damage to the clamp itself.

*Chain caught in the hinge side of clamp*

- Although initial checks of the worksite were performed, checks were not frequent enough during the task of lowering and closing the clamp;
- Whilst the procedure did include a safety note on awareness around pinch points, however, it did not specify any checks the hoist chain or loose items of rigging;
- There was no prompt for entanglement or snagging hazards included in the dive team procedures.

The root cause was found to be that the procedures did not identify and highlight entanglement or snagging hazards.

- Caused heightened awareness around snagging hazards when operating chain lever hoists;
- Reviewed procedures to include a prompt for the use of chain / lever hoists identifying the risk of entrapment of chains.

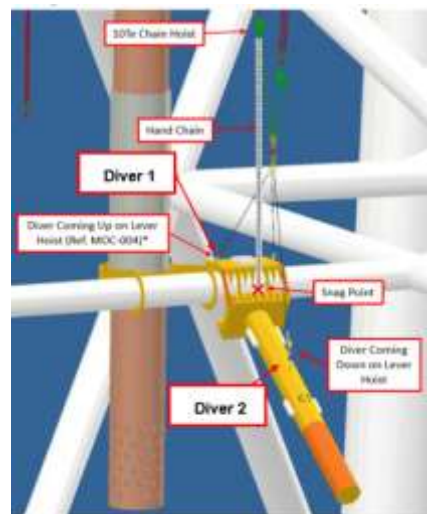
*Layout of clamp from procedure*

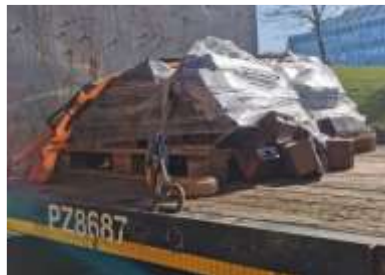
- Packing conditions of project equipment were inadequate to provide appropriate containment and support of the equipment and goods during transportation and handling;
- Transportation and packing activities were subcontracted to third parties;
- Specified and appropriate packing instructions were not implemented;
- The obligation to exercise the **Stop work authority** was applicable in both cases, but was only applied in one.

*Post Incident #2 – showing how plastic sheeting failed to maintain pads on pallets*

- Take into account the whole process of transportation from start to end. This requires packing the load in appropriate conditions to satisfy all transport activities from load out to off load;
- Ensure formal packing instructions are fit for purpose;
- Ensure packing instructions and expectations are communicated to third parties' subcontractors in a timely manner, prior to packing and transportation activities;
- If it's unsafe – **STOP THE JOB**: Communicate clearly the understanding that all parties including subcontractors have the obligation and expectation to exercise **stop work authority** when required;

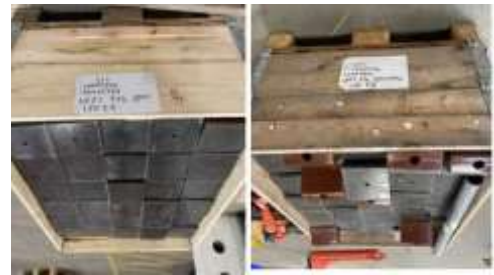
*Post Incident #2 - showing appropriate wooden crates on pallets to take the load*

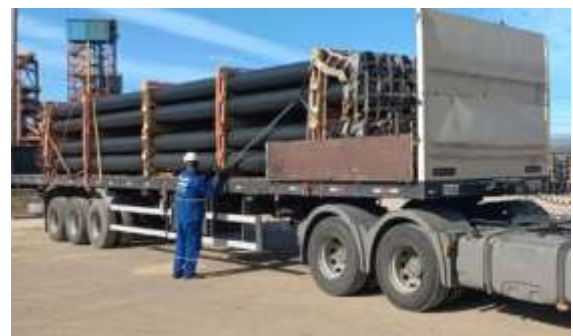
*Post Incident #1 - showing new packaging specification implemented*
