## 1 MAIB: Worker falls between vessel and quay

## 2 Accidental swallowing of paint thinners

### 3 Near miss: pipe dropped from pipe supports

## 4 Oil tank sight glass push buttons wired open

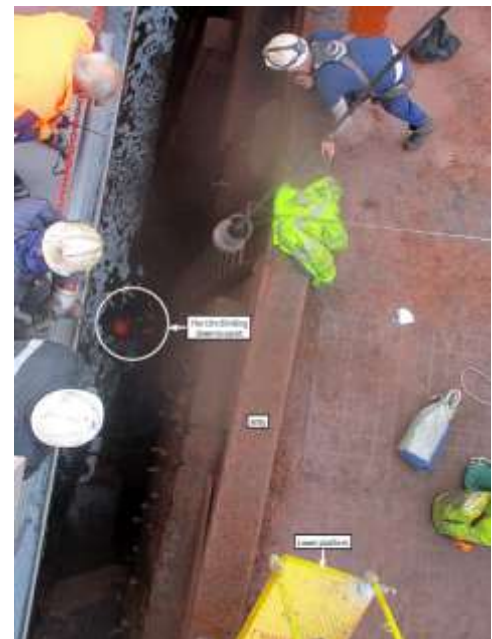
The shore worker ignored the crew's direction and walked along the stowed gangway, intending to jump ashore from its lower platform. At the lower platform, the shore worker slipped, lost his balance and fell over 8m into the sea between ship and shore, suffering significant injuries.

*Showing the actual rescue of the shore worker*

- **Equipment:** Safe means of access is crucial. When rigged, and with a safety net in place, the gangway represented a safe means of access; however, the tidal state meant it was no longer safe to be used. The crew acted to remedy this and rig alternative means of access, but the shore worker was impatient to leave and,

tempted by what he perceived to be an easy jump to the jetty, he contravened the crew's instructions and took an unsafe route off the vessel.

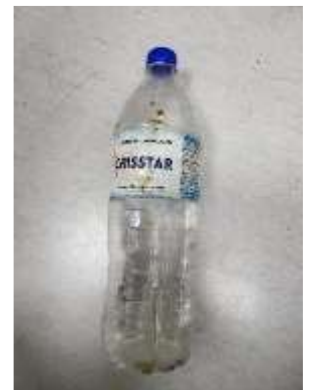
A crew member thought they were drinking water from a used mineral water bottle and actually drank paint thinners by mistake. The content of the bottle was not marked, and the bottle was incorrect for the temporary storage of the chemical.

A crew member, making stencils in the workshop, cleaned the stencils using paint thinners, which had been poured from the original clearly marked and labelled container into a used mineral water bottle. Upon completion, the unlabelled mineral water bottle containing the thinners was left in the workshop in a place where drinking water bottles were often left. The following day another crew member picked up the bottle and drank from it. As a precautionary measure this crew member was sent ashore for medical examination which revealed no consequences.

- The risks of using a mineral water bottle for a chemical were not appreciated;
- There were no dedicated small bottles/containers on board – an old water bottle had to be used to hold a limited amount of the thinners;
- The bottle containing the chemical product was not marked with its temporary content;
- Clear liquid, in appearance very similar to water, was stored in a water bottle and could therefore be easily confused with the original content;
- Poor housekeeping: at the end of the task, the chemical product remaining in the water bottle was not disposed of nor returned to the original container, but was left at the workstation.

- If it is necessary to decant chemicals from their original containers: always decant the chemicals in the chemical storage area, use a container in good condition and of type appropriate for the chemical – never use bottles normally used for, or associated with, drinking water;
- Ensure there are some appropriate containers or bottles for this kind of task;
- Ensure that chemicals and hazardous substances are stored appropriately and not left out – tidy up afterwards!

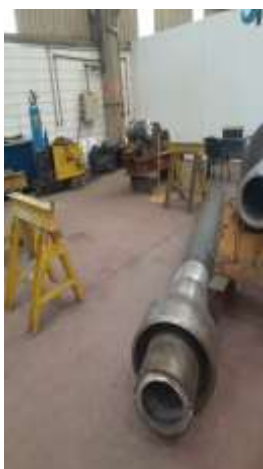
During the cleaning of a section of pipe at a third-party facility, the pipe rolled off the pipe support easels and dropped to the floor. There was no injury to personnel nor damage. The incident happened when a worker was using an angle grinder with an abrasive sanding wheel to clean the pipe. The pipe was supported by two easels at either end with only minimal wedges or restraint to prevent the pipe rolling off the supports. The worker turned the pipe to get to the underside and during this action the pipe rolled off the supports dropping to the ground.

*Dropped pipe from pipe supports*

- There were inadequate supports used for working on and storing pipes;
- There was a failure in procedures and risk assessments, to address the manual handling aspects of pipes on temporary supports;
- There was a failure to learn from previous industry incidents;
- Previous inspections and audits had failed to verify controls and preventive measures;
- Human factors, risk perception and competency of personnel involved in operations.

- Ensure effective risk assessment of temporary pipe stand / support arrangements;
- Use rollers or other mechanical devices to turn a pipe;
- Managing third party suppliers and contractors:
  - Set clear expectations on what should and should not be done;
  - Have formal agreements in place on the level of oversight, mode of control and accountability;
  - Schedule audits, inspections, and verifications of third party operations;

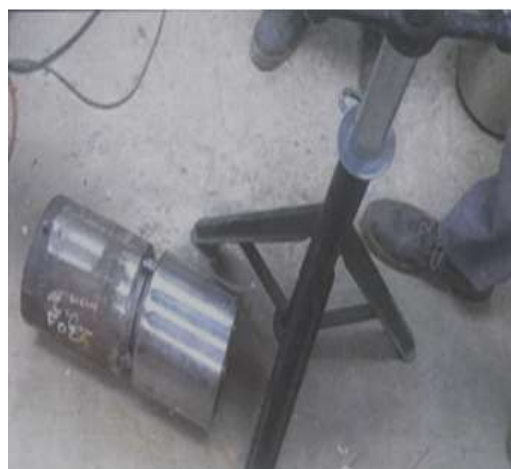
*Previous Incident - Dropped welding coupon from support single stand*

Our member reports that this is the third incident in the last 12 months with a similar cause – inadequate supports used while working on pipes.

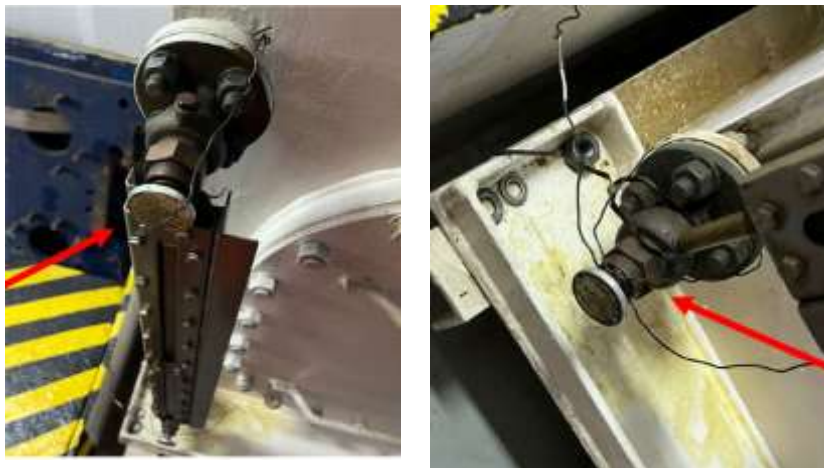
On a visit to an engine room, a serious *bypassing of safety controls* was observed. Both top and bottom level check push buttons on an Oil Tank Sight Glass were inhibited by wire. The sight glass is used to check the oil level in storage tanks. It is designed such that a button has to be pushed to check and verify the level of the oil tank. The button allows a connection between the sight glass and the oil tank. Whilst the button was wired open, if the glass tube were to be accidentally broken or damaged, then the contents of the tank could easily spill into the engine room with consequent further serious hazard of slips/trips, fire, and lack of oil where it was intended.

Top and bottom side of sight closing devices blocked by wire

- Unsafe behaviour – this was an intentional override of a design feature related to safety-critical equipment
  - The oil level gauge closing device had been inhibited with wire and remained in open position for a long time.
