## Engineering Advice Note (EAN) No. 183

### URGENT SAFETY ADVICE - TMS8 SIDE PROTECTION GUARDS

**Affected parts: All Systems which use Saab Seaeye TMS8 system.**

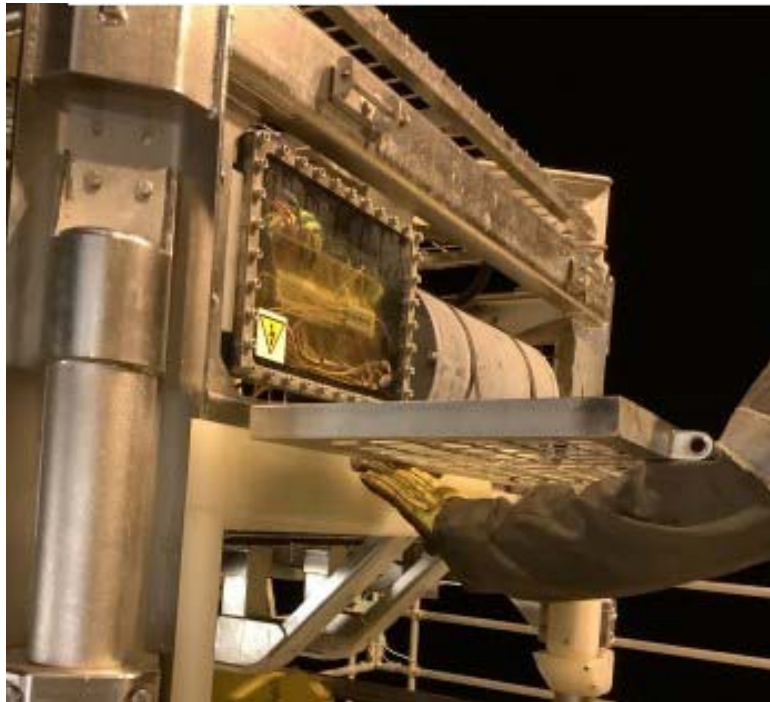
Picture #1

An incident occurred whereby a person working on a Saab Seaeye TMS8 sustained a finger injury as they were closing/locking a protection guard on the TMS8. The person lost grip of the guard and with only the lower pins being secured, the guard fell back down and the persons ring finger got caught between the guard and the TMS frame (see example picture #1).

Please follow the below procedure to remove and refit the guards in order to prevent this type of incident from reoccurring.

- **Correct PPE to be worn when handling the guards.**
- **2 people are recommended for safe removal and refitting.**
- **Never remove the top pins first as the guard will fall down if unsupported, risking injury or damage.**
- **Do not attempt to work with the guard only secured by two pins (either top or bottom).**
- **Do not prop or tie up the guard in any way.**
- **Complete removal of the guard from the TMS8 is required before any further work is carried out.**

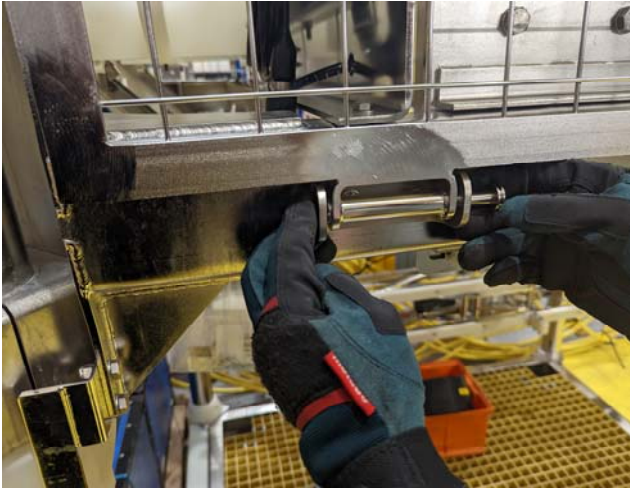
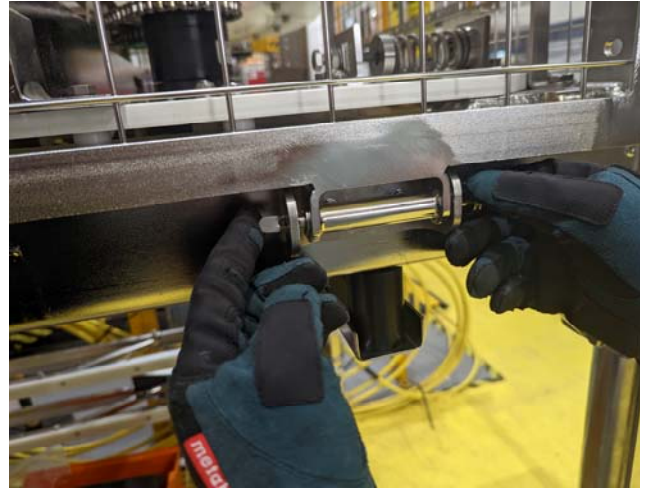
Removal: Step 1

Remove the two bottom pins only.

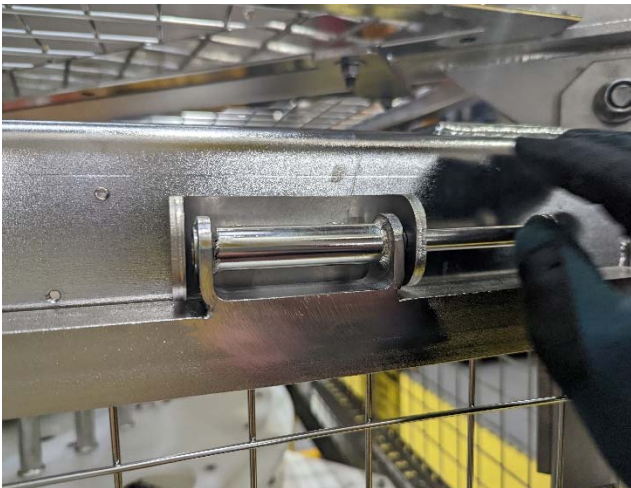
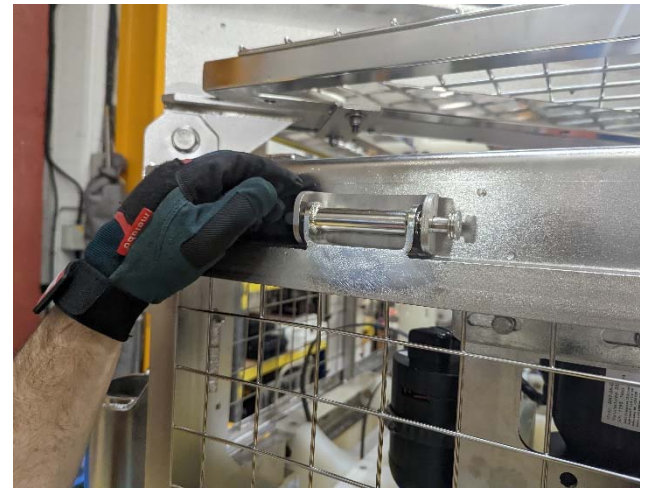
Removal – Step 2

With two people, support the guard from both ends securely and remove the two top pins.

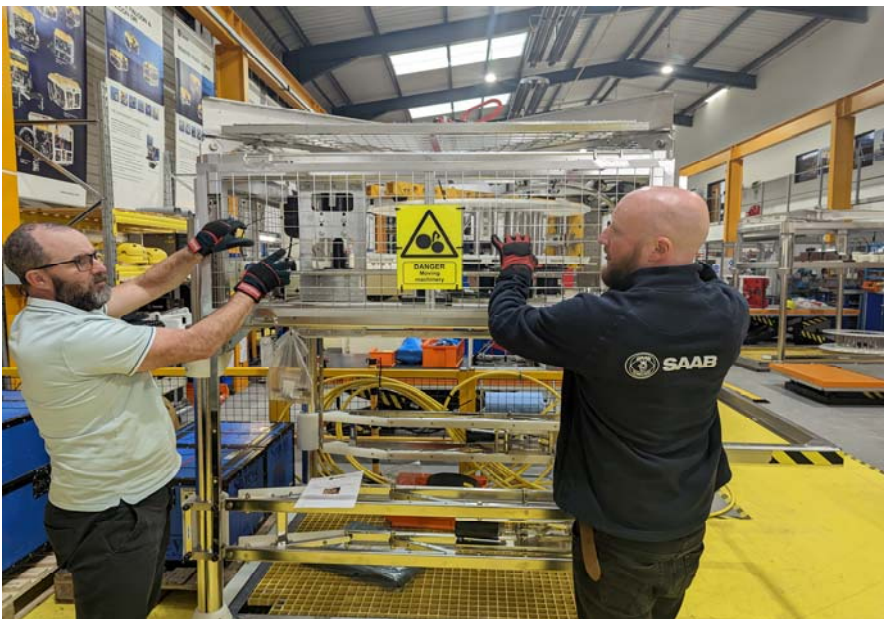
Removal – Step 3

With two people, carefully take the guard away from the TMS frame and store in a suitable location.

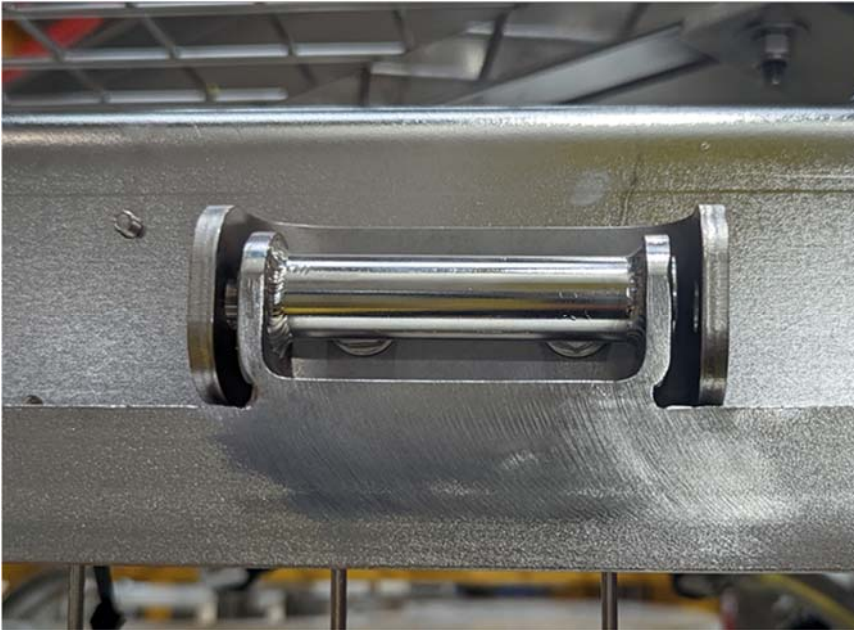
### Refitting – Step 1

With 2 people, lift the guard into position, locating the guard into the two top receptacles.

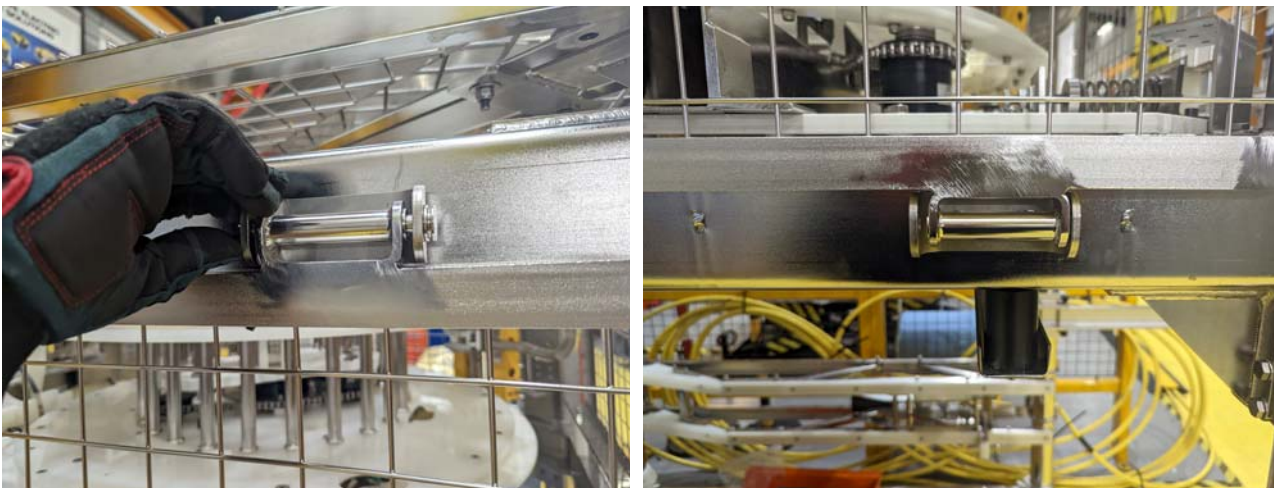
### Refitting – Step 2

Fit the 2 top pins, and carefully locate the guard into the two bottom receptacles. Close the top drop nose pins end securing pivot catches.

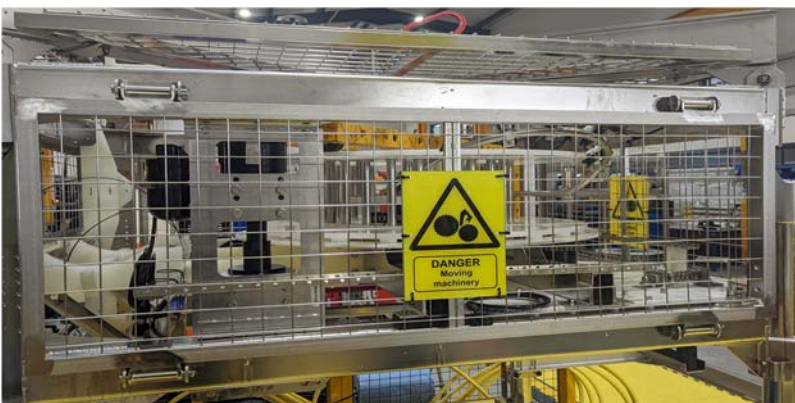
### Refitting – Step 3

Fit the two bottom pins and check that all drop nose pins have had their end securing pivot catch closed over to prevent them from falling out.
