1 Serious finger injury in power operated watertight sliding door

2 LTI: serious hand injury - fingers lost in unexpected hatch closure

3 Finger injury during lifting operations

4 Finger injury during shackle handling

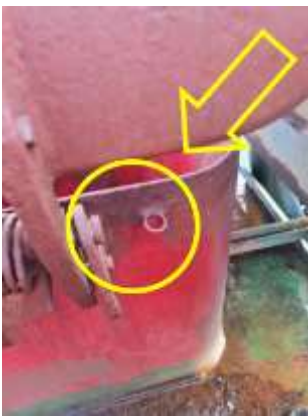
Safety lock pins missing

- There were no safety locking pins for the main engine room emergency hatch cover. Routine inspection was conducted on the emergency hatch cover as required in the planned maintenance system. The checklist for the routine inspection was marked as completed, but the job was not actually done;
- Poor spatial awareness: the injured person was not aware of the pinch point; therefore he didn’t stop the job when he saw that there were no safety lock pins on the hatch;
- The injured person improvised an inadequate and inappropriate method of securing the hatch cover;
- The toolbox talk did not highlight potential hazards such as line of fire, pinch point, etc. and its mitigation.

- Review and modify existing planned maintenance system onboard to ensure it is properly implemented and is not just a “checklist tick”;
- Reiterate importance of thorough toolbox talks before the job – take the time to think things through;
- Don’t just improvise safety equipment – stop the job, think it through, get it right;
- Are there areas in your work where you might be tempted to “just do it anyway?” without the right safety equipment?

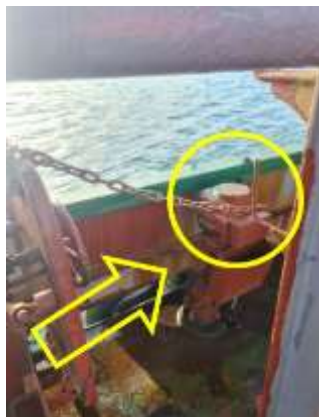
A crew person was checking the water tightness of the engine room’s emergency hatch cover. Safety lock pins, used to prevent the hatch cover from closing, were missing. To hold the hatch cover from closing, the crew person improvised using a nearby chain which he hooked to a hose support. However, the improvised arrangement failed and the hatch cover closed unexpectedly. The injured person had his left hand in the mouth of the hatch, and the hatch cover landed on his fingers. The tips of his two longest fingers were very badly injured, and had to be amputated.

Hatch cover held by chain and hooked to a hose support

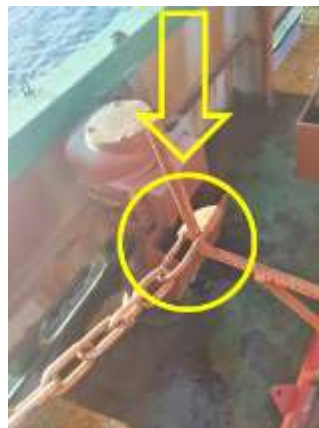
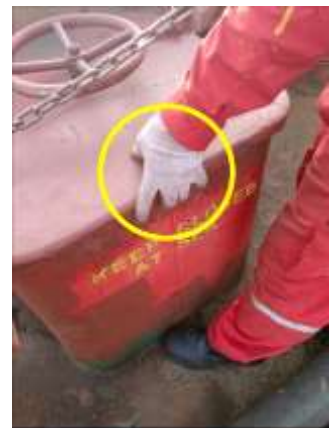
Hand trapped by fallen hatch **(RE-ENACTMENT)**

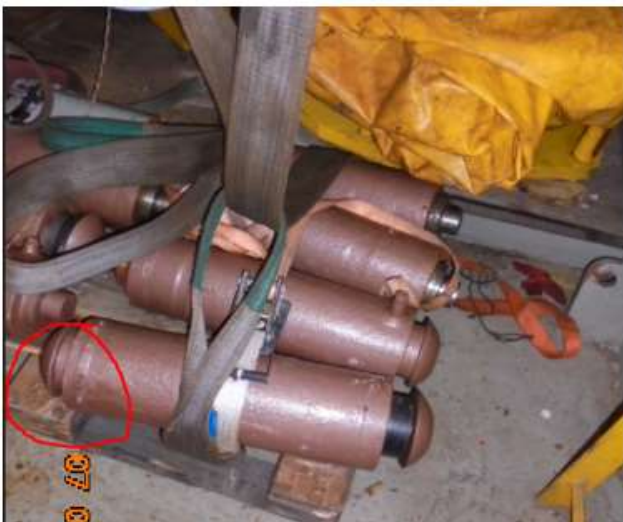
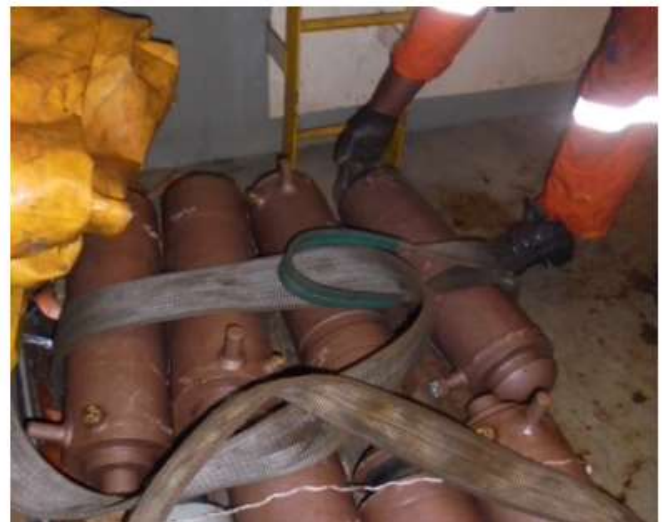
With a vessel alongside, crew were using the vessel crane to move a pallet of cylinders (part of the vessel’s hydraulic system) from one deck to another. This was in preparation for departure from port. The Second Engineer passed by and decided to assist the crew in positioning the pallet. When the pallet was moved into place, the engineer got one of his hands trapped below one of the cylinders, and the middle finger of his right hand was pinched and injured.

- None of the crew involved in the lifting activity had had any formal training in lifting in spite of company procedures requiring this;

- The Second Engineer intervened to help – with the best of intentions – when he ought not have done. He was not part of the lifting crew, he did not attend the toolbox talk, nor was he part of the risk assessment discussions;
- No-one stopped the job – any one of the crew had the authority and obligation to stop the job and take time out to think things through;
- The Second Engineer was not wearing any gloves at the time as he was not part of the job.

Congestion with other material and equipment made moving these cylinders necessary.

- Don't just pitch in and help without thinking – that may not be any help at all!
- Keep the workplace neat, tidy and uncongested;
- Use the right PPE and gloves before starting work;
- Stop the job and rethink if the circumstances change.

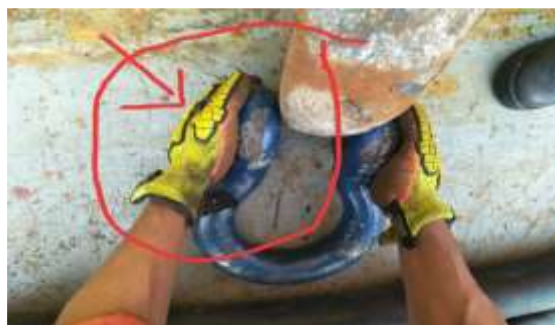
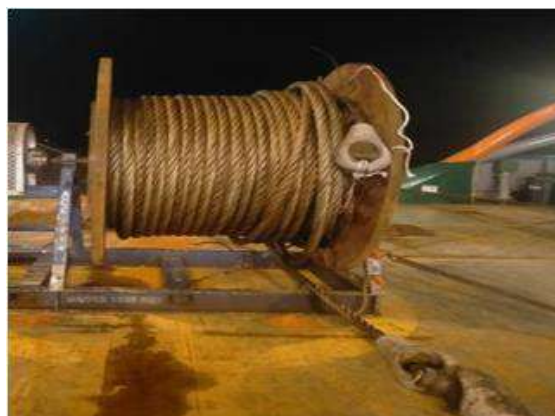
During a pennant wire spooling operation, the injured person was trying to remove a 35 tonne SWL shackle from the pennant eye. While trying to jiggle the shackle, it landed on his left middle finger causing a crush injury 1.5cm long.

- The task supervisor (the Bosun) saw the crew person holding the shackle but did not warn him or intervene;
- There was no last minute risk assessment carried out;
- The shackle as initially used was the wrong size.

- The task supervisor is in charge to control the operation, ensure it is safely conducted, and that the proper tools are used. It is the responsibility of the task supervisor to intervene;
- Use appropriate tools such as crow bars and hammers to release heavy shackles, rather than your hands. Do not expose your hands by handling heavy items.

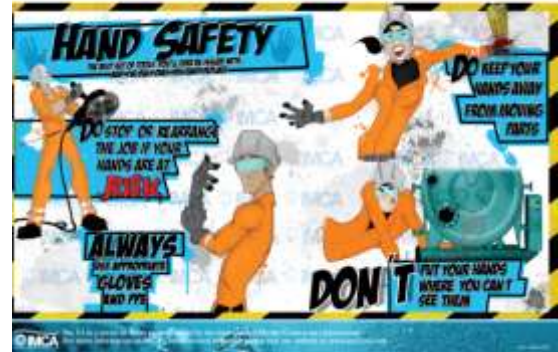
If we look more closely at the most recent ten incidents involving injuries to hands and fingers, some worthwhile conclusions may be drawn from what our members identified as having gone wrong.

Contributory factor	
Poor or incorrect PPE	6/10
Equipment in use was not adequate	5/10
Lack of awareness of risk or inadequate risk assessment	5/10
Poor spatial awareness - fingers were in the wrong place at the wrong time	4/10
Lack of supervision	4/10
Lack of communication or poor communication	3/10
Procedures were not followed, corners were cut	2/10
Someone could have stopped the job – but didn't.	2/10
Someone stepped in and helped with a task when they should have stood back	2/10
