IMCA Safety Flashes summarise key safety matters and incidents, allowing lessons to be more easily learnt for the benefit of all. The effectiveness of the IMCA Safety Flash system depends on members sharing information and so avoiding repeat incidents. Please consider adding safetyreports@imca-int.com to your internal distribution list for safety alerts or manually submitting information on incidents you consider may be relevant. All information is anonymised or sanitised, as appropriate.

1 Fatality during transfer of pipes

2 Getting fall arrest equipment right

4 MSF: Air Cylinder – High Pressure Discharge

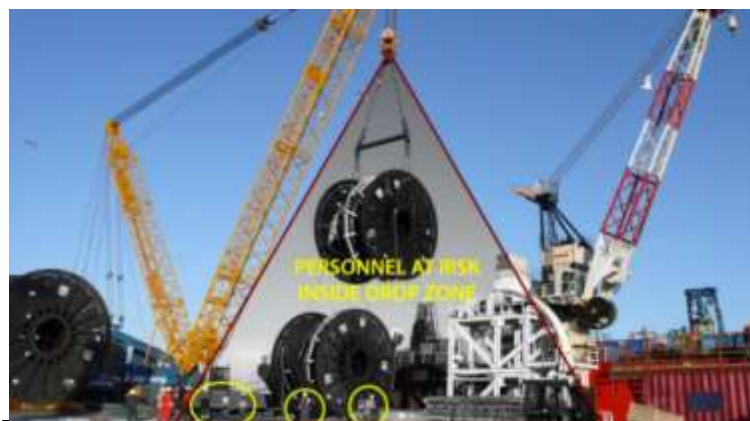
Image: DROPS forum

- Lifting operations:
 - Never exceed safe working load (SWL) during lifting operations;
 - Never walk under a suspended load (see Step Change video linked below);
 - Identify all entrapment and crush areas;
 - Be aware of sudden load movement and loads swinging;
 - Ensure effective barriers are in place to prevent unauthorised access.
- Objects with roll or fall potential:
 - Secure all loads that have the potential to roll before lifting, loading, unloading or transporting;
 - Pay close attention when moving loads with all forms of transport;
 - What will you do if the load shifts? Stay out of the line of fire;
 - Secure objects that can roll such as tools, cylinders and poles.
- Dropped object cone of exposure (drop zones):

A controlled 'drop zone' should be half the height of the potential drop where possible with the area increased if potential exists for the falling object to be deflected by an obstacle, structure, wind and weather conditions.

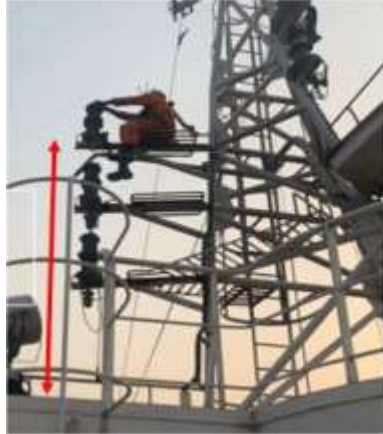
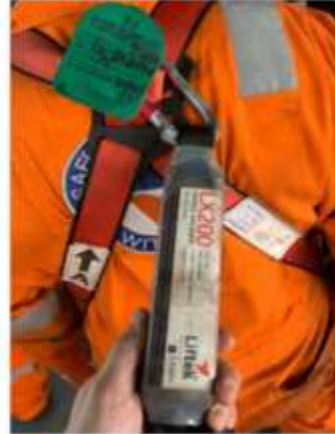
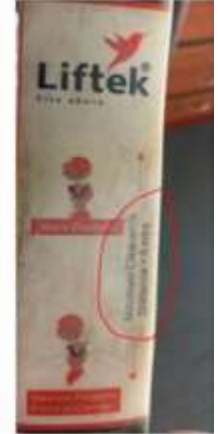
A crew person was changing the lamp bulbs on the vessel mast, working at a height of around 4m above the deck. The person was wearing a full set of PPE including a certified safety harness with a lanyard equipped with a shock absorber. There was a Permit to Work in place.

However, the total length of all this safety equipment had not been properly taken into account.

- 1.75m: the safety lanyard shock absorber;
- 2m: the lanyard itself;
- 1.9m: the approximate height of the person being protected.

This added up to 5.65m, whereas the person was working 4m above the deck. In the case of a fall from height, the fall arrest equipment would have been of no use and the person could have fallen to deck unprotected. He did not fall – no-one was injured.

- Right: the crew person was wearing fall arrest equipment and there was a Permit to Work in place – some incomplete assessment of risk had at least taken place;
- Wrong:
 - The risk assessment was not adequate; no-one thought to check that the proposed work height relative to the length of the fall arrest equipment;
 - No-one noticed or considered that the fall arrest safety lanyard was clearly marked “Minimum 6m clearance distance” (see image);

Correctly calculate your fall arrest!

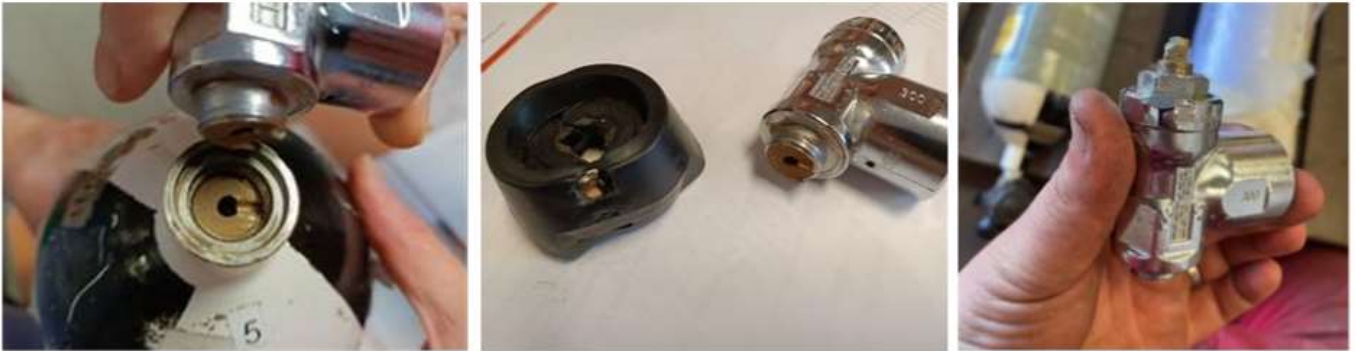
The cylinder and associated fittings were sent for further investigation, and the investigator noted that there was evidence that the pillar valve had *“seen a heavy impact, the nut retaining the handwheel has been pushed through the handwheel itself and ...what is left of the spindle has also seen a heavy impact along with the valve itself.”* It was the opinion of the investigator that the cylinder had been dropped onto the valve causing it to break. This was considered a very serious incident that ultimately could have caused a fatality.

- When moving pressurised cylinders around the vessel extreme care should be exercised;
- When decanting cylinders for transportation, the cylinder should be held securely with the valve being slightly cracked open with the contents being released in a slow and controlled manner;
- Always make sure that the valve end of the cylinder is pointing away from yourself and any colleagues;
- When conducting this operation full PPE should be worn;
- The vessel owner is investigating the fitting of Excess Flow Valves when individual cylinders pass through the maintenance workshop.

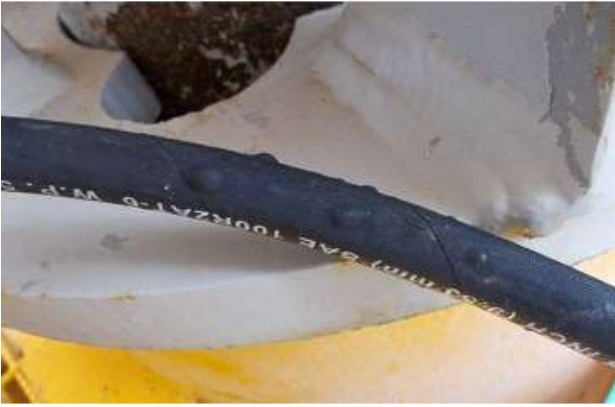
During a recent offshore inspection, a BSEE inspector observed operator personnel installing a 30m high pressure hose, with a Maximum Working Pressure (MWP) of 5000 psi, to test pressure safety valves on pipeline pumps. The hose used was designed for hydraulic fluid and was not suitable for high-pressure nitrogen; when nitrogen gas at 2500 psi was injected into the hydraulic hose, the hose blistered, allowing nitrogen gas to leak.

Incompatible hydraulic hose blistered during use

- Selecting hoses based on size, temperature, application, material to be conveyed, pressure, ends or couplings, and delivery;
- Sizing the inside diameter (I.D.) and outside diameter (O.D.) appropriately to minimize pressure loss and reduce heat generation;

- Ensuring the hose is correct for the gas or fluid being carried;
- Checking for compatibility between the fluid and the hose materials, along with connections, couplings, and O-rings;

- Immediately stopping usage or replacing hoses when they become damaged, cracked, cut, abraded, blistered, soft, kinked, crushed, flattened, or twisted;

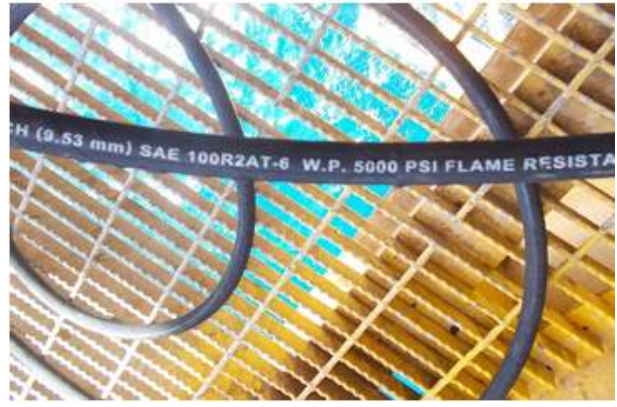
Hose with application information
