1 Job stopped safely: safe working load limits exceeded

2 Unprotected openings in floor grating – work stopped

3 Uncertified bosun’s chairs

4 Fire in the laundry room

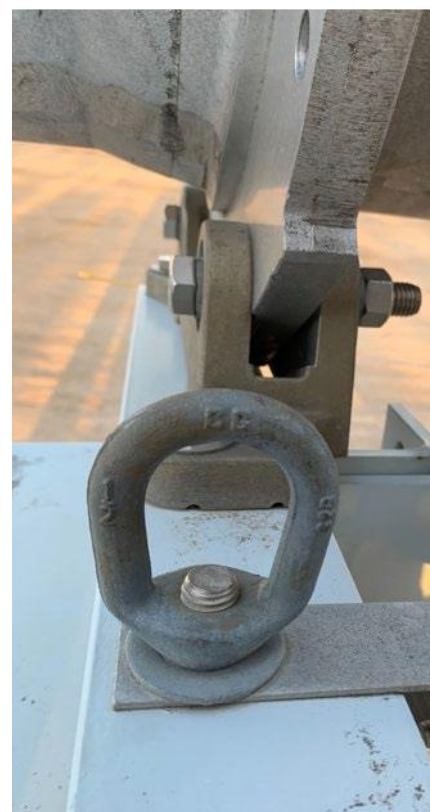
Work was stopped during the practical evaluation portion of rigger training in an onshore industry. It was discovered that the application of eye-nuts were not consistent with their intended use. The task was to install rigging and lift something using a 4-leg bridle chain with adjustable length legs. The attachment points, for the 4-leg bridle chain to the load were four machined eye-nuts (see illustration). A student questioned the safe working load limit of the 1/2" eye-nut, which was assumed to be installed by the manufacturer of the item being lifted. After researching the eye-nut, a note was found accompanied with the load chart stating that the eye-nut installed was "for in-line picks only." At that point, work was stopped. The rigging plan to be used involved rigging on the eye-nuts at a 60° angle. Not only were the eye-nuts not being used as intended, but additionally when picking with sling-angles, load capacities are reduced, which would have put the eye-nuts above their safe working load limit.

- The instructor of the class had encouraged a "questioning attitude";
- The student did not assume the manufacturer-supplied eye-nuts were suitable for the task and questioned the rigging plan;
- Work was stopped;
- This was a real-time example of the importance of inspecting and verifying every link in a rigging plan.

- Encourage a questioning attitude and a culture where "there are no stupid questions".

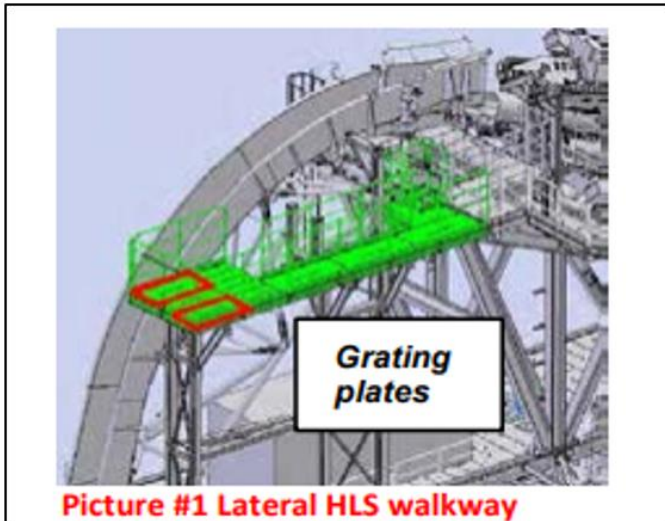
Picture #1 Lateral HLS walkway

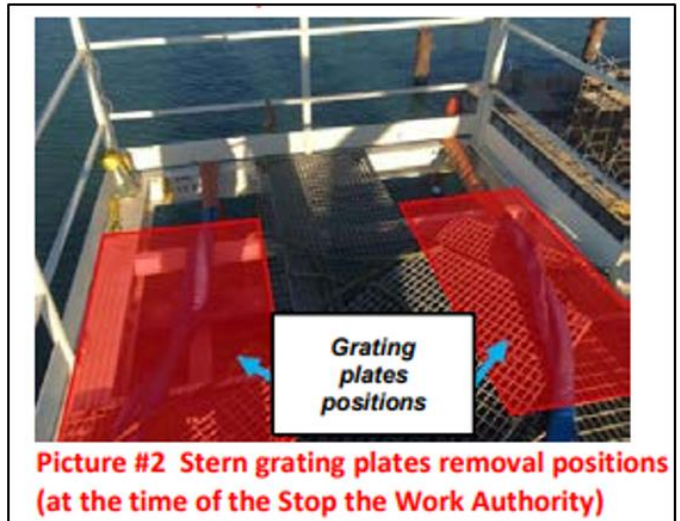
Two workers removed grating panels at height on a horizontal lay system, in order to gain access to lift points for further removal of a lateral walkway section. The removed grating created an open hole with the likelihood that someone could have fallen through it.

Picture #2 Stern grating plates removal positions
(at the time of the Stop the Work Authority)

- Assessed the feasibility of installing accessible lifting points removing the need to remove grating plates;

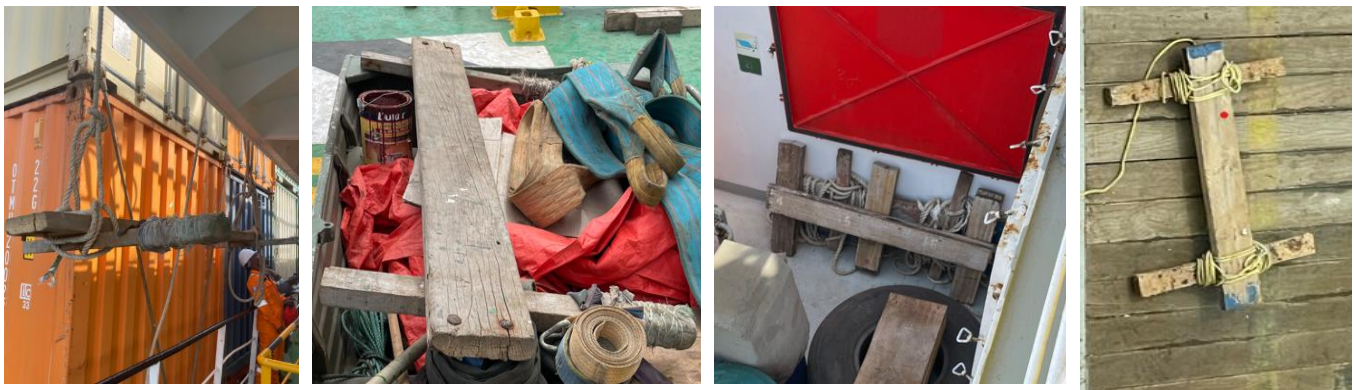
A member conducting management visits to vessels discovered three separate cases where “Bosun’s Chairs” or similar support structures or working at height activities related to painting and repair works, had been fabricated by crew from wooden boards and ropes.

- The unsafe “home-made” equipment was removed and destroyed;
- Arrangements were put in place for only suitably designed and certified fall arrest and man-riding equipment to be used for Working at Height activities.

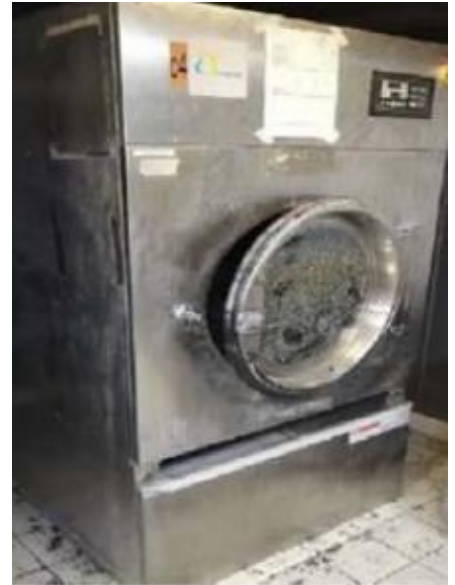
The fire team found the source of the fire which was coming from an industrial tumble dryer in the laundry room. The fire was safely extinguished before the personnel muster was complete.

- The air flow of the tumble dryer heating system may have allowed flammable material (particulate) to be conveyed through the electrical heating elements and pushed into the drum containing the clothes. The electrical elements are not protected (isolated) and are positioned very close to the actual rotating drum;
- The dryer had undergone recent maintenance (troubleshooting) and the control panel and set-up parameters had been changed during this process, and were different from the original;
- There was no smoke detection in the laundry – only heat detectors – and the alarm was by the smoke detector adjacent the door of the laundry in the corridor because the door was partially open;
- The type of tumble dryer conformed to no known industrial standard.

- Use equipment complying with a recognized industrial design standard;
- Use spare parts that are either original and/or fully compatible with the equipment;
- Review fire/smoke detection system to identify potential improvements particularly in laundry area.
