## Hand and finger injuries

### 1 LTI: fingers severed by spinning fan blade

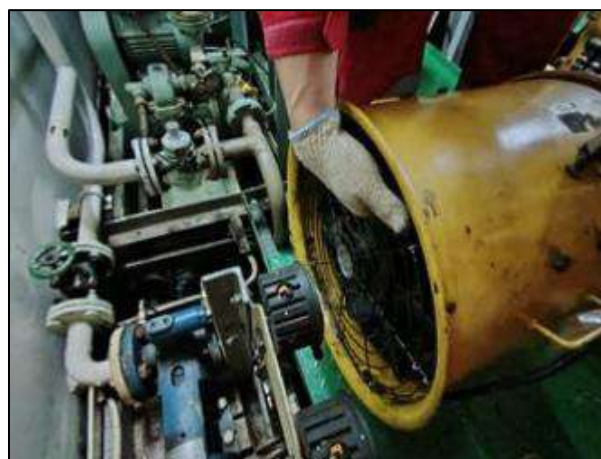
A worker on a vessel suffered life-changing hand injuries. The incident occurred during housekeeping in the engine room. After turning off power to a portable blower (used for ventilation of a confined space), the worker tried to move the portable blower by hand, grabbing the side of the fan instead of using the designated handle. Unfortunately, he was unaware that the fan blade was still spinning, and he stuck his fingers into the blade housing area to get a grip. There was no sufficient blade guard, and the spinning fan blade severed his index, middle, and ring fingers.

- The equipment used was neither suitable nor safe:
  - the handle for the portable blower was obstructed with rope and webbing sling;
  - the portable blower had been modified since appropriate air ducting was not available on board;
  - the opening into the blade housing area was big enough to allow access to fingers;
- The worker was unaware that the fan blades continue to spin for a time after the power is turned off;
- The noise made by the spinning blade (which would have been a warning) was inaudible due to the noise of the engine;

*Demonstration after the fact of what happened.*

- The worker could not see the spinning blades due to the position of the portable blower;
- There was no toolbox talk carried out, nor control of work.

- Always assume rotating machinery can cause harm, even after the power is off. Residual momentum can keep blades spinning for a significant time;
- Never reach into blind areas. Know where you put your hands, do not try to reach into places where you can't see your hands or fingers;
- Never bypass designated handles or guards. They are there to protect you.

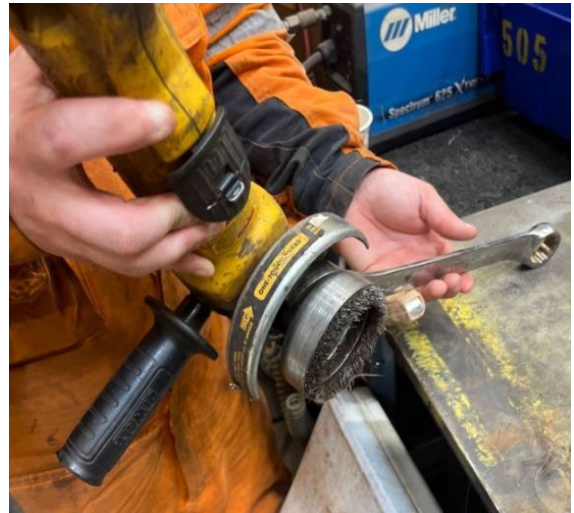
A worker injured themselves while attempting to change a wire wheel attachment fitted to a handheld angle grinder. In that process, the IP fractured the 5th digit ('pinky') of the left hand between the table and a wrench.

- The method being used to change the wire wheel was incorrect – the worker did not in fact know how to change the wheel;
- The worker had not received any formal power tool / abrasive wheel training and was not fully familiar with this type of equipment. Reliance was placed in ‘on the job’ training along with the IP’s experience, rather than on formal training and competence evaluation;
- The worker was not wearing impact resistant gloves;
- There was a failure of the safe system of work:
  - Grinding was not covered by the Hot Work Permit to Work;
  - The worker was not assigned to the Permit to Work;
  - A task risk assessment for the job was not reviewed.
- As grinding was not a planned activity, there was no supervision of the task - the appropriate level of supervision is essential.

- Updated task risk assessment to include all hazards and control measures;
- Required the worker in this specific case to take formal Power tool/abrasive wheels training;
- A review of general training and competency evaluation requirements for the use of power tool and abrasive wheels;
- Revisited and discussed supervisors’ responsibilities.

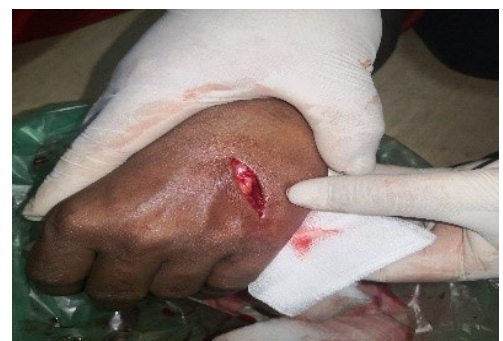
A member of the galley team suffered a serious hand injury when washing a glass during a period of heavy weather. The glass being washed slipped, hit the sink, and broke. The glass fragments struck the injured person’s left hand, causing an injury requiring seven stitches. The vessel was rolling in seas of approximately 2.5m.

- Think carefully about what activities are conducted during bad weather – ensure crew have full awareness of the increased risks during heavy weather;
- Wearing gloves while washing dishes could have provided additional protection;

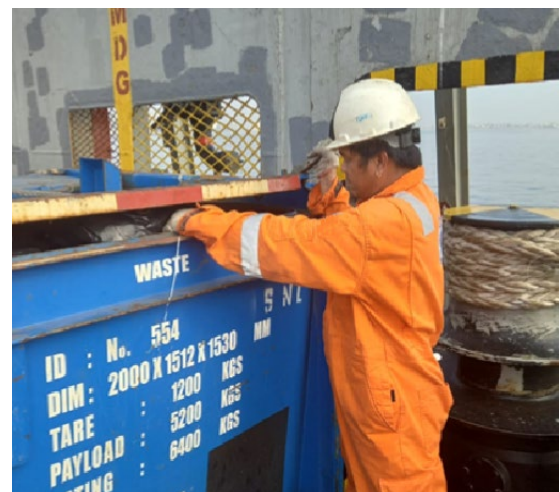
A crew member was disposing of waste at a skip on the deck of a vessel, when the heavy cover of the skip unexpectedly and accidentally closed. The cover struck the individual's arm, causing an injury. The crew member received first aid onboard and further attended a medical facility ashore. No bones were broken; the person was able to return to the vessel and continue with light duties.

- The heavy metal skip cover was not adequately secured. ing before handling waste. The crew person did not secure the cover open when putting in the waste, and as a result the cover closed on his arm, causing injury.
- There was a lack of hazard appreciation - weight of skip cover and potential for injury was not considered.

Person puts waste in a skip – re-enactment

- Lifting the heavy cover or lid of a skip with one hand and putting waste in with the other, might save time because it is quick - but it is certainly worth avoiding a possible arm or wrist injury by securing the cover properly before putting your hand and arm "in the line of fire";
- Check relevant closing and securing mechanisms to ensure they functioning properly to prevent accidental closing;
- Consider a "hazard hunt" to identify any similar latent conditions onboard.

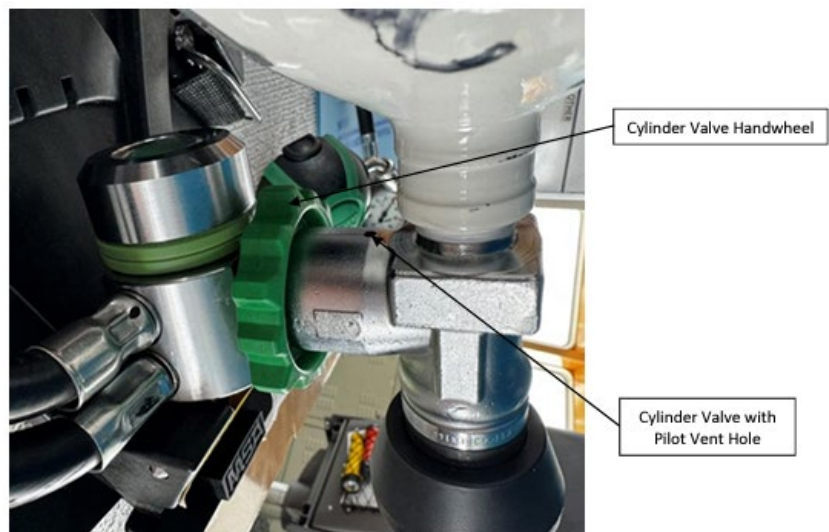
The Marine Safety Forum (MSF) has published [Safety Alert 24-05](#) relating to a finger injury caused by a release of high pressure air. The incident occurred during a vessel fire drill; the fire team were being assisted with putting on Breathing Apparatus (BA) sets. The assisting crewmember inadvertently opened the BA set valve resulting in a release of high pressure air. As a result, the crew members' finger was impregnated by the high pressure air. The finger that was impregnated showed immediate signs of swelling and the medical support teams advised medevac by helicopter. The injured crew member required surgical treatment, to confirm the extent of the injury and ensure there was no debris injected, and to reduce the risk of infection and tissue damage.

Investigation found that there was a momentary high-pressure air release from the Pilot Vent Hole - a safety feature in 300 bar rated cylinder valves. The injured crewmember must have inadvertently placed his finger over the Pilot Vent Hole at the moment there was a momentary release of pressure.

- When replacing a BA bottle on a BA set always ensure that the Cylinder Valve Handwheel connection is tightened as per manufacturer's instructions;
- After changing the BA bottle, pressurize the system and listen for any leaks. Test for bubbles caused by leaks using soapy water at the connection points. Tighten connections, if necessary, but close the main valve first;
- Ensure the pressure gauge reflects the correct pressure;
- Conduct a breathing check by inhaling through the mask to ensure air is flowing correctly;
- Verify the low-pressure alarm is functioning properly by momentarily turning off the air supply. When conducting planned maintenance checks the above should also be adhered to and checked;
- When putting on BA, manufacturer's instructions should be followed, and if any leaks are observed the main cylinder valve must be closed prior to tightening.
