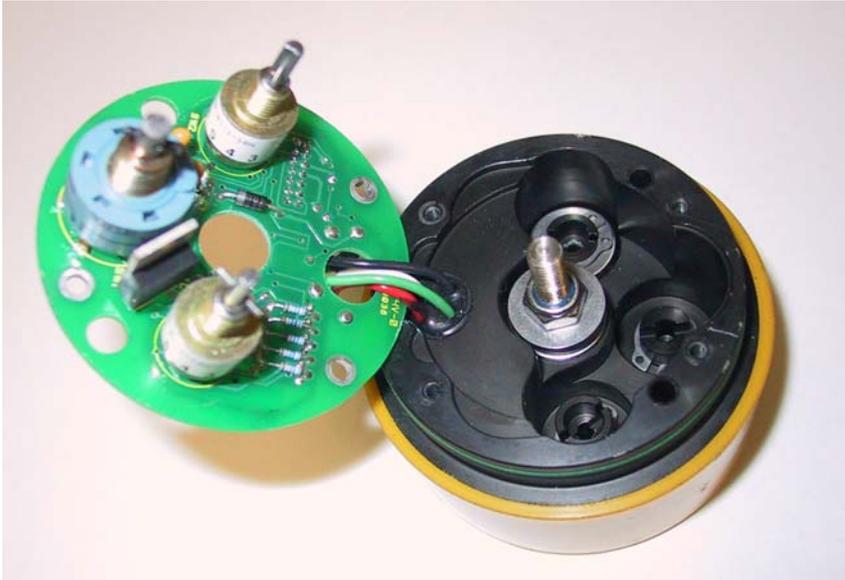
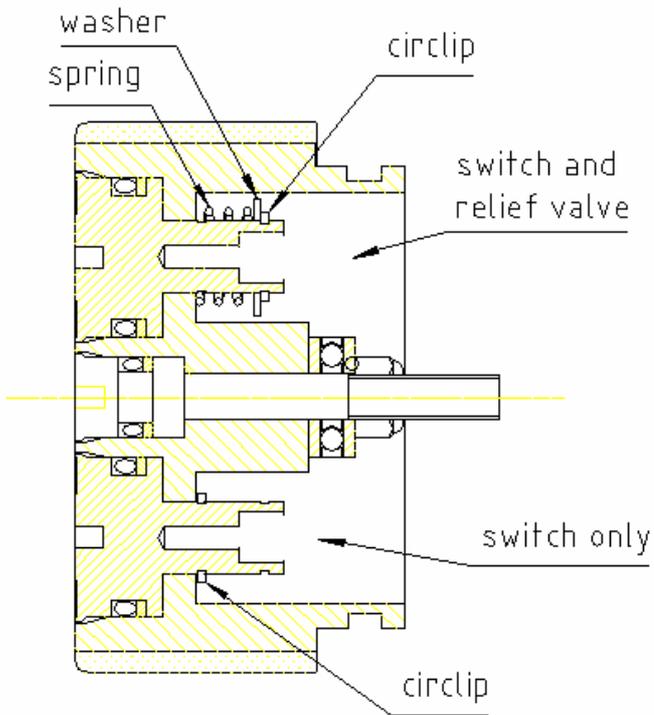
Do not at any stage during this procedure operate (open) the pressure relief valve. If the valve is opened, there is a risk of catching debris or grit on the o-ring, causing the RPT to leak. If the valve is operated/moved the RPT must undergo a new pressure test. To avoid this, make sure the outside of the valve is properly supported during the next step in this procedure.

Replace the spring, washer and top circlip, in this order.

6. Refit the PCB and replace the endcap.
