IMCA Safety Flash 03/11

April 2011

I Failure of Hydraulic Fitting at Pressure

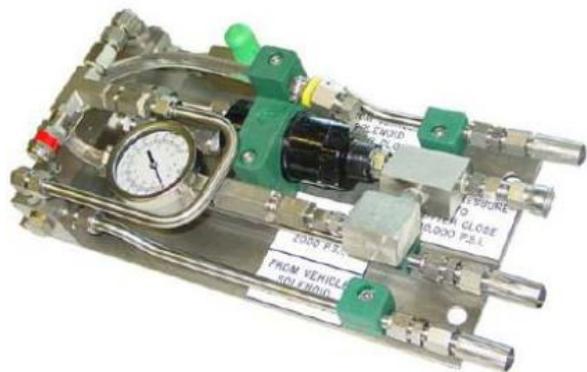
The fitting that failed connected a pressure gauge to the high pressure (output side) side of the intensifier and was an integral and permanent component of the equipment. The gauge was being used to monitor output pressure on the circuit while the cutter test was performed. This connection failure resulted in the high velocity ejection of the gauge under very high pressure. There were no injuries. The intensifier in question was removed.

Figure – Typical intensifier panel

- ◆ The hydraulic fittings that connected the gauge to the intensifier were not 690 bar rated;
- ◆ The other hydraulic fittings in this part of the circuit were not 690 bar rated;
- ◆ Urgent checks revealed that there were several intensifier panels with non-rated fittings in service elsewhere.

- ◆ All on-deck testing involving high pressure intensifiers was stopped immediately and any required testing was conducted in the water with a wire sample, until confirmation of correct fitting was made;
- ◆ All worksites checked intensifiers and verified the specification with tooling department(s) and arranged for replacement or upgrade as necessary;
- ◆ Steps were taken to upgrade affected units held onshore and these were systematically changed out with affected units offshore until all panels had the correct fittings.

It should be noted that this specification shortfall may not be limited to ROV intensifiers and therefore vigilance is recommended with all high pressure hydraulic equipment.
