IMCA Safety Flash 03/16

January 2016

I Lost Time Injury (LTI): Stored Pressure Release - Crewman Lost an Eye

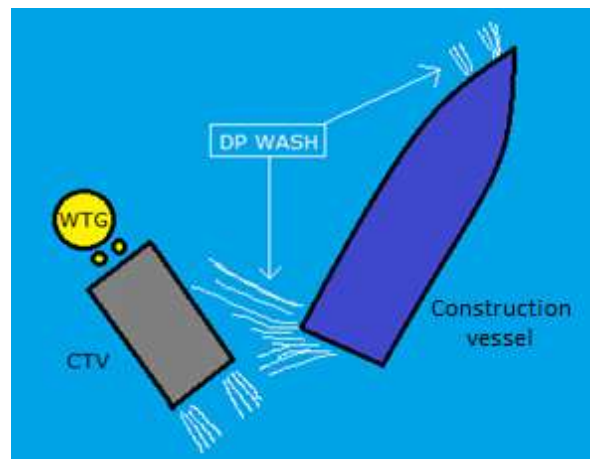
A CTV was requested to attend a wind turbine generator monopile to transfer some personnel, whilst a construction vessel was nearby in dynamic positioning (DP) mode. The personnel were successfully transferred to the foundation, but as the Master activated astern gear and pulled away from the monopile, the CTV went through the thruster wash caused by the construction vessel (which was in DP mode). This caused the CTV to move in an unpredictable and uncontrollable way – the CTV passed within 4 metres of the construction vessel itself.

The client required that procedures be reviewed and reconsidered:

- ◆ When personnel are not on the wind turbine generator, the construction vessel should maintain a clear distance between itself and the tower of approximately 50m;
- ◆ After personnel have safely accessed the wind turbine tower, the construction vessel can then move into position to complete works.
