IMCA Safety Flash 06/07

July 2007

1 Diver Injury Using Cavitation Blaster

2 Weld Failure on Kirby Morgan KMI7B 505-055 Neck Clamp

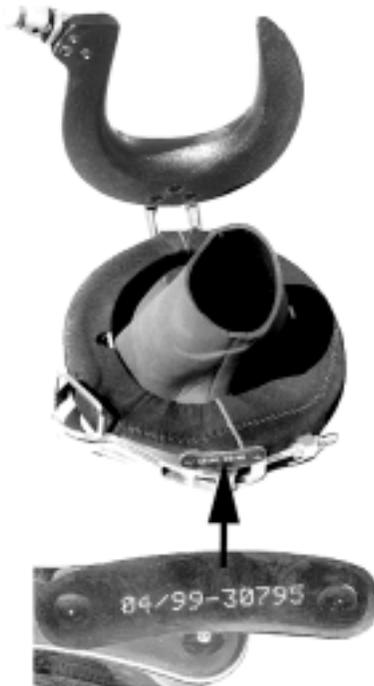
Visually inspect the moving parts of the clamp assembly including the three pins (A) in the over-center lever assembly, and the three clevis blocks. Visually inspect for bent or broken pins or a bent or broken handle and locking bail (B).

Check to ensure the adjustment stud (C) is not bent or damaged. Visually inspect the welded area (D) around the base of the stud for signs of stress or weld cracking.

The neck clamp assembly, like all other mechanical parts, will wear over time, thus requiring routine maintenance and eventual replacement. DSI strongly recommends that all Kirby Morgan SuperLite-17 A/B /MK 21 Neck Clamp Assemblies be carefully inspected for signs of damage and wear at least semi-annually and checked daily for proper adjustment prior to commencement of dive operations. Worn or damaged neck clamps and especially those damaged from improper adjustment pose a potentially serious safety hazard to the user. All neck clamp assemblies will eventually become worn to a point where they must be replaced. Proper routine inspection should reveal wear and damage before it becomes a danger to the user.

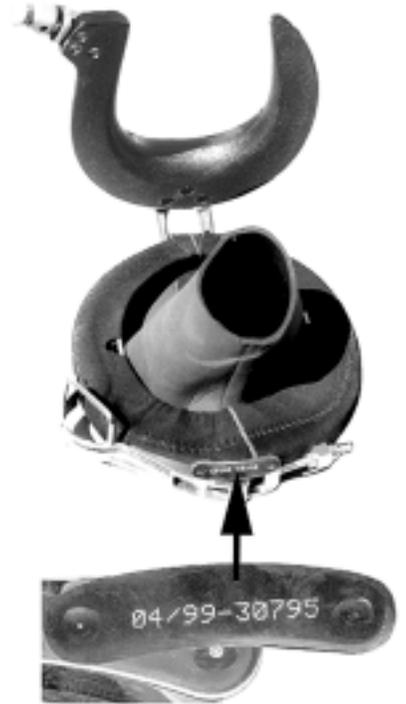
All metal parts should be inspected for cracks or corrosion and replaced immediately if this type of damage is found. While some surface rust or corrosion is to be expected, severe corrosion can lead to the eventual failure of the part.

If any part doesn't look right, don't use it.
