IMCA Safety Flash 08/10

December 2010

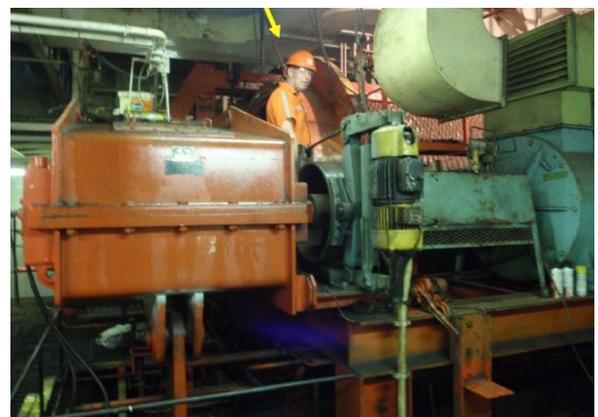
A member has reported an incident in which a member of the crew was injured when a steel wedge came loose and hit him on the right hand. The injured person was working in a winch room replacing the band brakes of a winch and had completed similar work on two other winches without any problems.

During the insertion of the brake belt pin with the help of a hydraulic jack, a steel wedge (weight 2.4 kilograms) was used to hold the foundation plate in the right position. Just before the pin was fully inserted in the pad eye/hinge-point, the wedge came loose with a lot of energy, and hit the injured person who was not wearing gloves, against his right hand. The injured person received the necessary medical treatment (four stitches) and was subsequently able to continue work under restricted conditions.

- ◆ There were two direct causes of the incident:
 - the injured person's position with respect to the job he was doing
 - the improper position of equipment used – the steel wedge;
- ◆ The root cause of the incident was considered to be **inadequate experience/supervision** (the injured person had less than three months' experience on this vessel);
- ◆ A significant contributing factor was that the injured person was not using available PPE (gloves) and was performing the task in a tight/cramped working area.

Overview of worksite and position of injured person (injured person NOT shown)
