IMCA Safety Flash 08/19

April 2019

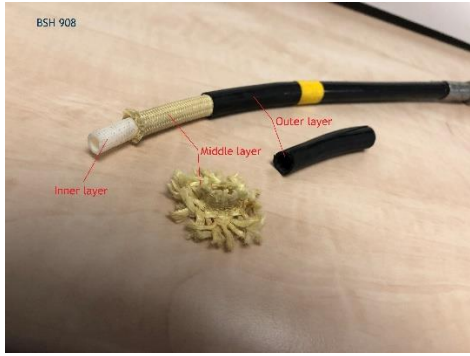
Investigation suggested that one type of HP hose is prone to damage near the ferrule connector, caused by bending and stressing, regardless of the use of a bend restrictor present at this location. The damage was not sustained in one single occasion but is believed to have developed over time.

- ◆ Hose type 1: fatigue like damage may occur near the ferrule over time. When this damage occurs, it can lead to loss of the bail-out within a dive. In order to reduce the risk of this type of damage occurring, annual replacement may be required, depending on usage.
- ◆ Hose type 2: does not show the same fatigue damage development as the construction is more flexible and rugged.

Hose Type 1	Hose Type 2
Picture

Appearance	Thin, smooth, black, shiny	Thick, black, dull-coloured
Dimensions	Outside diameter 10.8mm	Outside diameter 12.5mm
Composition	3 layers: <ul style="list-style-type: none"> Thin layer, plastic-like type (shrink fit) Soft woven middle layer Rigid inner layer, hard plastic-like tube 	3 layers: <ul style="list-style-type: none"> Thick outer layer, rubber compound Soft woven middle layer Flexible thick inner layer, rubber compound
Other findings	Layers can move freely from each other Outer layer easily cut with knife Stiff, hard to bend, inner layer tends to buckle	Layers are vulcanized to each other In general, hard to cut with a knife Easier to bend, smaller bending radius, inner layer does not tend to buckle
