## IMCA Safety Flash 10/09

July 2009

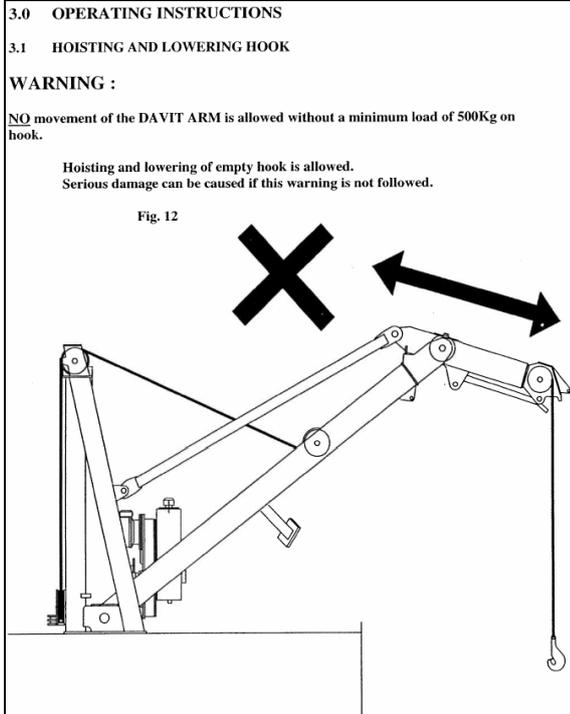
*Suggested warning placard to be placed near lifeboat operating station*

- ◆ Warning notices should be posted adjacent to each lifeboat operating station (see the diagram below);
- ◆ A thorough inspection of tilt plates should be included in monthly planned maintenance checks;

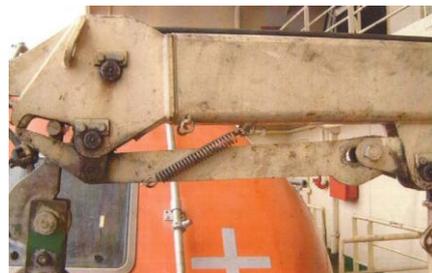
Following a refit, sea trials were being conducted on a member's vessel in preparation for a return to operations. Defects were discovered on the davit tilt arms on both the forward and aft legs of two lifeboat davits. Both tilt plates on each leg of the aft davits were found to be cracked and distorted. It was evident after inspection that the initial defects were historical and may have existed for some time unnoticed. The defects may have been compounded by load tests conducted during the recent refit, during which the davits had been upgraded to allow new lifeboats to be installed.

Following further investigation with the close co-operation of the original equipment manufacturer it was concluded that the defects to the davit tilt arms were caused by the incorrect operation of the davits. The davit arms had previously been brought inboard of the vessel without the required minimum 500kg weights attached to the davit hooks. A clear warning that this should not take place is included in this specific manufacturer's documentation.

*Lifeboat davit*

- ◆ The original equipment manufacturer's documentation for the davits should be consulted and appropriate operating instructions verified to ensure existing practices do not deviate from manufacturer-recommended launching practices, nor compromise the safety and operational integrity of the equipment;

- ◆ Since the defects appear to have originated some time in the past, better quality control is required of bi-annual, annual and five-yearly inspections by specialist contractors to ensure that they are conducting the thorough examination of the equipment properly and to an appropriately high standard.

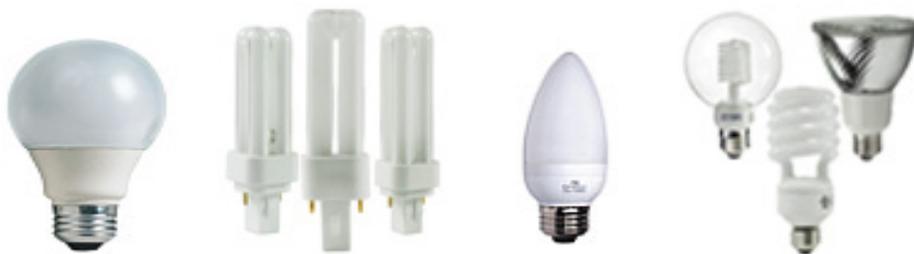
The Coast Guard has learned that CFLs have been installed on the navigation bridges of vessels and in other places capable of causing radio communications interference. Marine inspectors, vessel owners and operators **should be aware** of this potential safety hazard and take proper action as needed.

Below are examples of some compact fluorescent lights with different shapes and sizes.
