# IMCA Safety Flash 10/11

September 2011

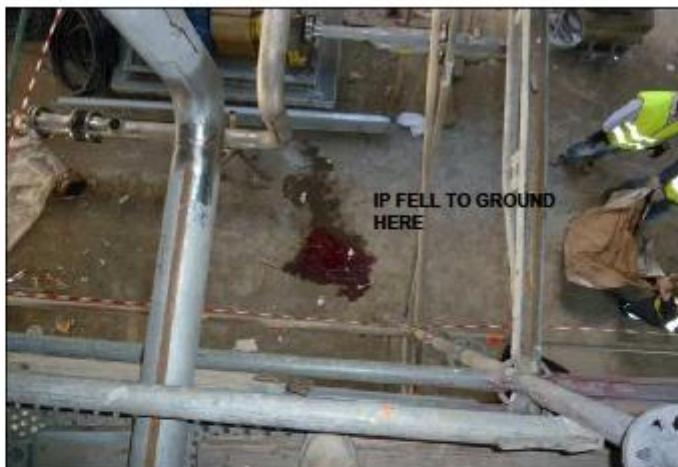
The IP left a safe working platform and climbed out onto a pair of parallel 30cm pipes with the intention of fixing a beam clamp and chain block to a beam. The IP was wearing a safety harness but had not hooked off. He slipped and fell 3.5 meters onto concrete. The IP suffered compound fractures of the left tibia & fibula.

- The IP wore a safety harness in good condition complete with lanyards but failed to clip off while outside the safe working area.
- The IP failed to request scaffolding access to the new work area.
- Two other men in the work gang observed the IP climbing out of the safe working platform and failed to intervene.

- Never work outside a safe working platform without an approved R/A, M/S & PTW.
- Always hook off when outside of a safe working area.
- Always use scaffolding as a first choice. Working outside of a safe working area with a harness is a last resort and subject to PTW.
- Supervisors must enforce safe methods of work.
- Always intervene if you witness an unsafe act. Don't walk by.
