IMCA Safety Flash 11/15

August 2015

I Lost Time Injury (LTI) and Restricted Workday Case (RWC) following Failure of Diving Bell Door System

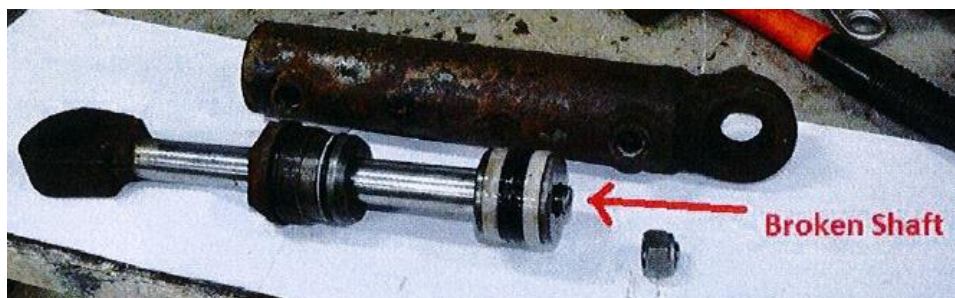
SCREEN GRAB SHOWING POSITON OF THE I.P.'S FOOT TRAPPED BY THE BELL DOOR AFTER THE INTERNAL DOOR DESCENDED ONTO HIS FOOT.

- ◆ The hydraulic ram used to open and close the door had failed;
- ◆ When the ram cylinder was opened, it was identified that the shaft had broken internally at the end where the locking nut holds the piston onto the shaft causing the shaft to pull freely from the cylinder body. This resulted in the door dropping down in an uncontrolled manner;
- ◆ The hand operated hydraulic Enerpac pump had a greater operating pressure than that of the ram and relied on a pressure relief valve to prevent over-pressurisation;
- ◆ Additionally, the failure of the door component prevented free movement of the door during the bellman's attempt to raise it so as to release the trapped diver's feet.

- ◆ Direct Cause:
 - Failure of the hydraulic ram piston rod threaded end at the locking nut inside the ram, resulting in the ram piston rod detaching from the unit, thus allowing the door to fall;
- ◆ Underlying Root Causes:
 - Failure to secure the door in an open position
 - Incorrect placement of divers feet
 - No Planned or Preventive Maintenance System in place for the hydraulic ram
 - Safety Risk Assessment for hydraulic use not applied or assessed
 - No secured guard around trapment area to prevent incorrect foot placement
 - Single point failure, no stage latching of door during raising operation, preventing door closing
 - Too much hydraulic pressure facilitated by hand pump to ensure opening of door;
- ◆ A factor in these root causes was that there was a design failure of the door securing ram system, having a single point failure with no backup.
